Friendship Church Tree Report

180 S. Cypress St., Orange CA 92866

Prepared for:

Gabriel Choi | Job Captain
AO Architects
321 W Chapman Ave. | Orange, CA 92866
714-639-9860

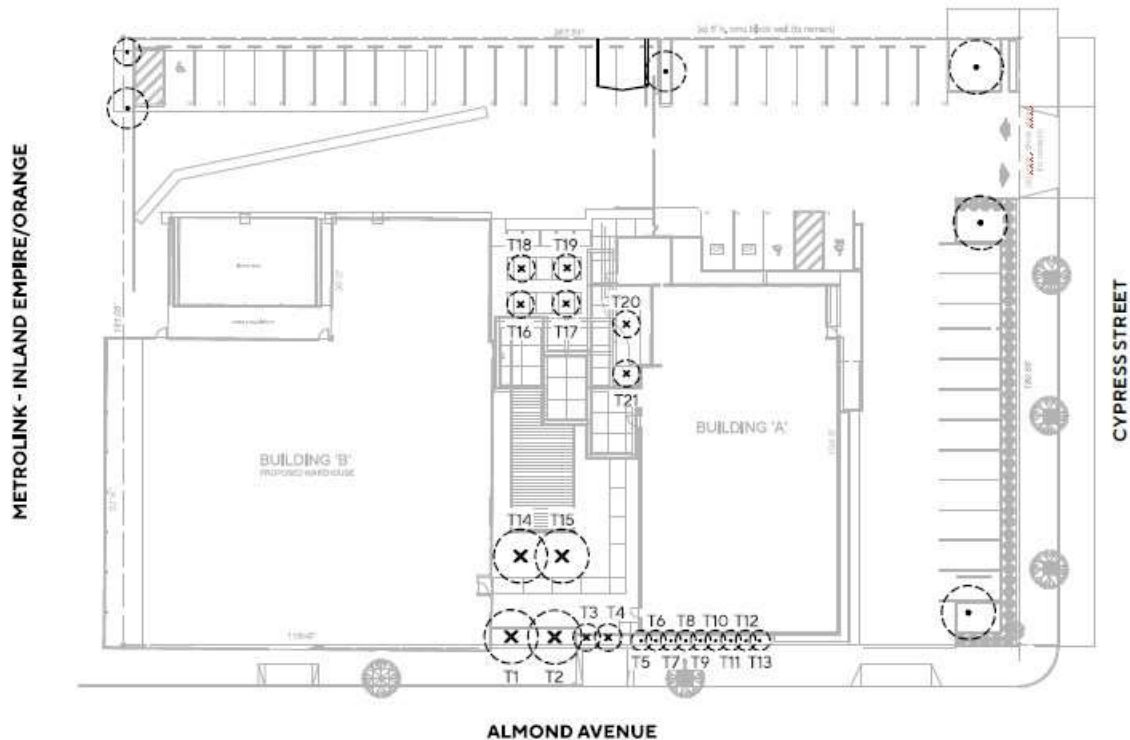
Site Map

#	Species	DBH (in.)	Height (ft.)	General Health	Condition Rating (Poor/Fair/Good)	Intent to Remove
T14	Liquidambar	12	20	Signs of decay in main stem and roots, large unhealed wounds from past topping cuts, wet bark with alcohol-like odor	Poor	Yes
T15	Liquidambar	12	20	Signs of decay in main stem and roots, large unhealed wounds from past topping cuts, wet bark with alcohol-like odor	Poor	Yes
T20	Lemon	8	8	No major structural defects observed, but lacks maintenance, dry soil	Fair	Yes
T21	Tangerine	8	6	No major structural defects observed, but lacks maintenance, dry soil	Fair	Yes
T16	Crape Myrtle	4	7	No major structural defects observed, but lacks maintenance, dry soil	Fair	Yes
T17	Crape Myrtle	4	7	No major structural defects observed, but lacks maintenance, dry soil	Fair	Yes
T18	Crape Myrtle	4	7	No major structural defects observed, but lacks maintenance, dry soil	Fair	Yes
T19	Crape Myrtle	4	7	No major structural defects observed, but lacks maintenance, dry soil	Fair	Yes

T1	Brisbane Box	10	15	Dry soil, Topped, located under power lines, moderate overall health	Fair	Yes
T2	Brisbane Box	10	15	Dry soil, Topped, located under power lines, moderate overall health	Fair	Yes
T3	Podocarpus	8	10	Limited observations on decay, moderate condition with no major defects	Fair	Yes

T4	Podocarpus	8	10	Limited observations on decay, moderate condition with no major defects	Fair	Yes
T5	Podocarpus	8	10	Limited observations on decay, moderate condition with no major defects	Fair	Yes

All trees are to be removed in the project area, Landscape design and new plant material is to be selected and placed by the contractors hired. There are no trees to protect in place. RGS Landscape and Arborcare and I are not the coordinated landscape contractors, I was only hired to assess the project and provide a report as a Tree Professional.
