Center Front Door Was A Window

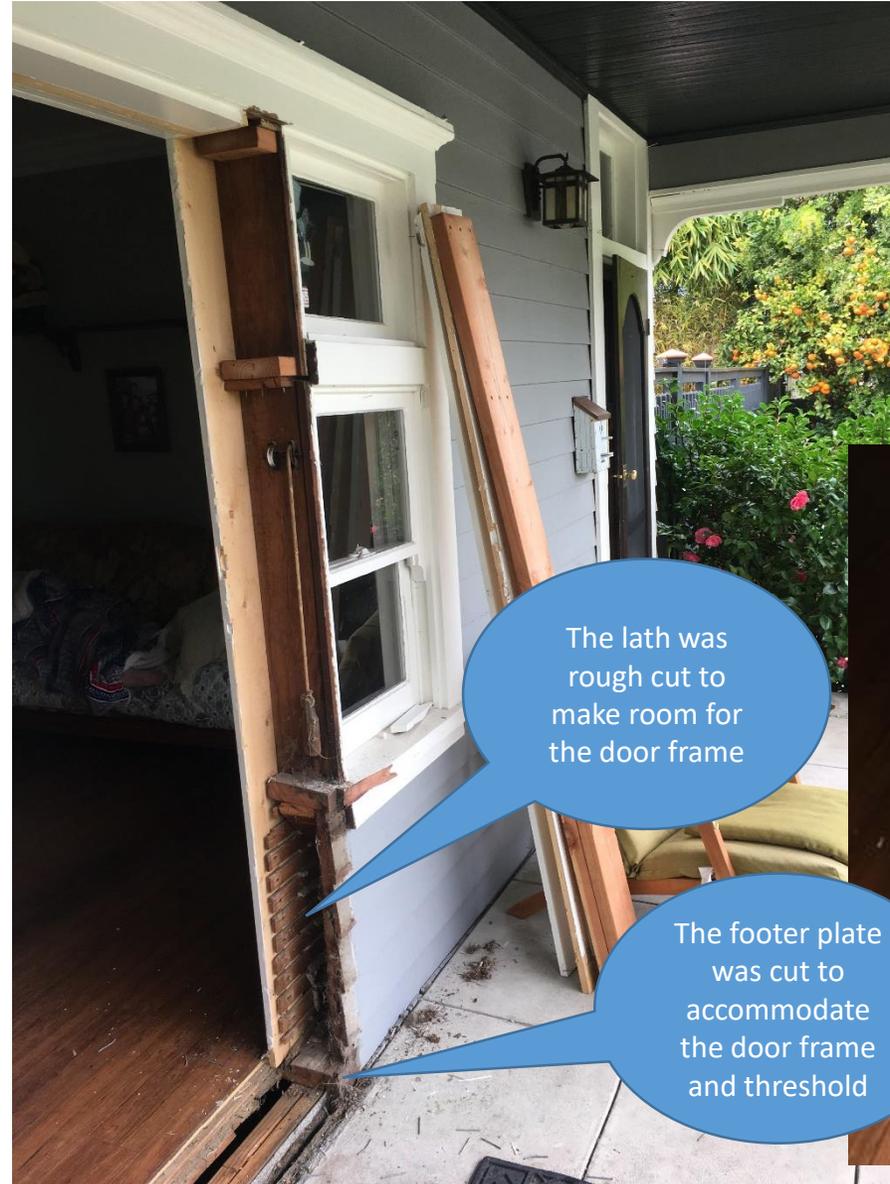
- The lower window sash, along the bottom of the window assembly, was cut in the center to make room for the installation of a door frame.
- The lath and plaster was removed under the sash to make room for the door frame.
- The cuts on the lath are rough and jagged indicating they were cut subsequent to original construction.
- The footer plate was cut to accommodate the installation of the door frame and threshold.

This window sash was cut to install the door frame

The lath was rough cut to make room for the door frame

The footer plate was cut to accommodate the door frame and threshold
