# Steve F. Andresen / Arborist Services

January 22, 2025

RE: Arborist Report – Revision No.1  
City of Orange Conditional Use Permit No. 3230-24, Major Site Plan Review No. 1174-24, and Design Review No. 5151-24  
Village Town Center Commercial Building  
2355 N. Tustin Avenue, Orange California  
APN: 372-642-32

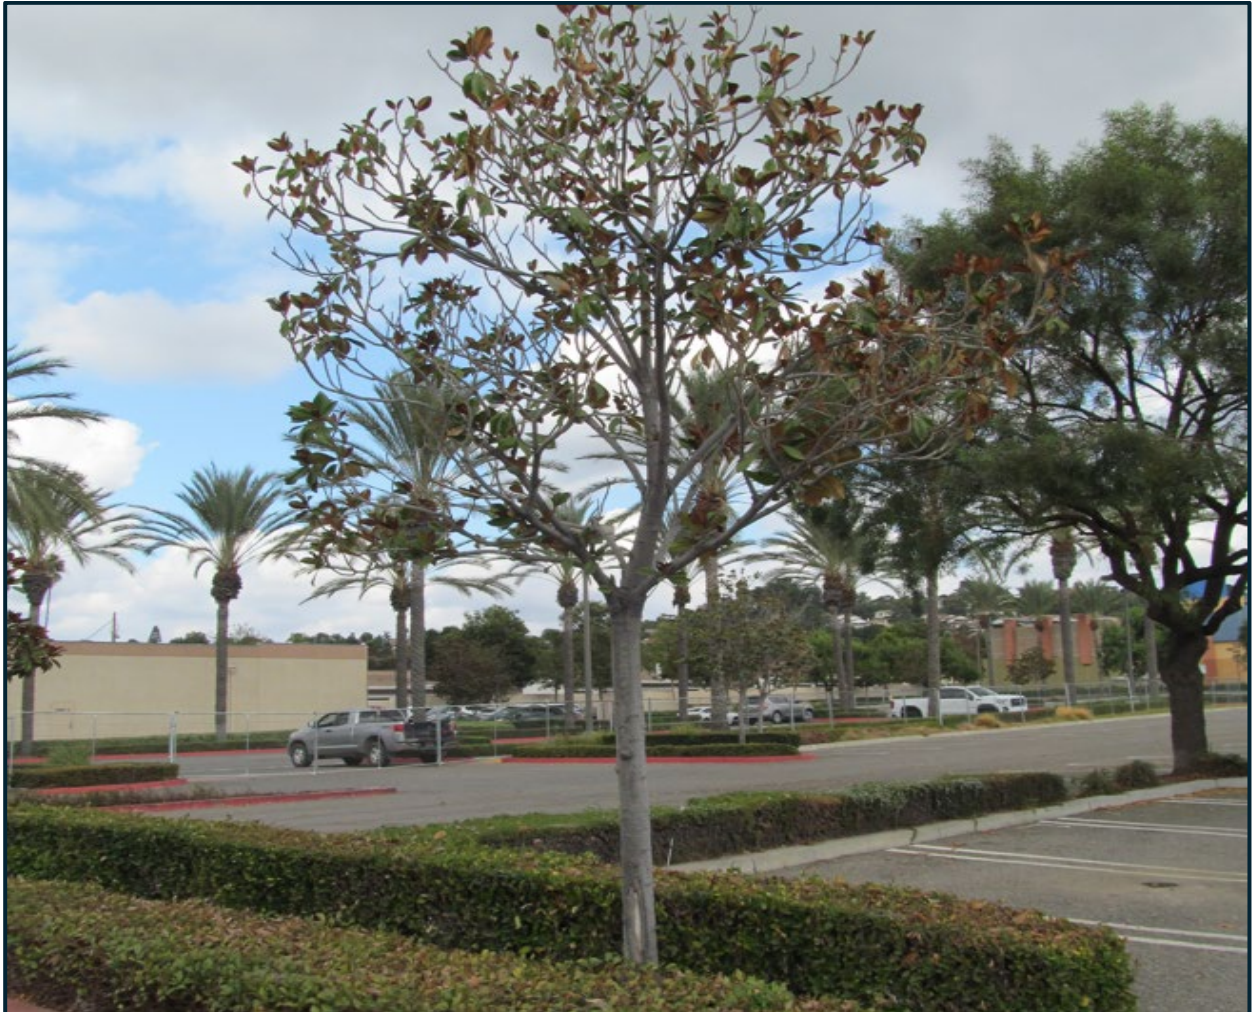
**Magnolia – Tree #2**

Tag ID#	Species	Common Name	Height (Feet)	Spread (Feet)	DBH (Inches)	Health Grade	Aesthetic Grade	Comments
1	<i>Rhus lancea</i>	AFRICAN SUMAC	18	20	16	C	C	Average
2	<i>Magnolia</i>	MAGNOLIA	13	8	4	D	D	Below average
3	<i>Magnolia</i>	MAGNOLIA	12	8	3.5	D	D	Below average
4	<i>Rhus lancea</i>	AFRICAN SUMAC	25	25	18	C	C	Average
5	<i>Rhus lancea</i>	AFRICAN SUMAC	19	16	11	C	C	Average
6	<i>Rhus lancea</i>	AFRICAN SUMAC	18	15	12.5	C	C	Average

There are two species of trees located within the Project area. Those Project tree species are *Rhus lancea* (AFRICAN SUMAC) and MAGNOLIA. The African Sumac trees are a hardy variety and able to withstand neglect. As such, the African Sumac are in average condition for the species and growing conditions. The Magnolia trees can decline over time if not properly monitored and maintained and as such, are graded in below average condition.
