March 25, 2025

## Suitability of Adopting and Retaining 61 Canary Island Pine Trees along Serrano Blvd, and 22 Canary Island Pine Trees along Cannon St.

Micah Jean – City of Orange Tree Services Coordinator  
ISA Board Certified Master Arborist WE-9971BM  
ISA Tree Risk Assessment Qualified | ISA Certified Urban Forest Professional

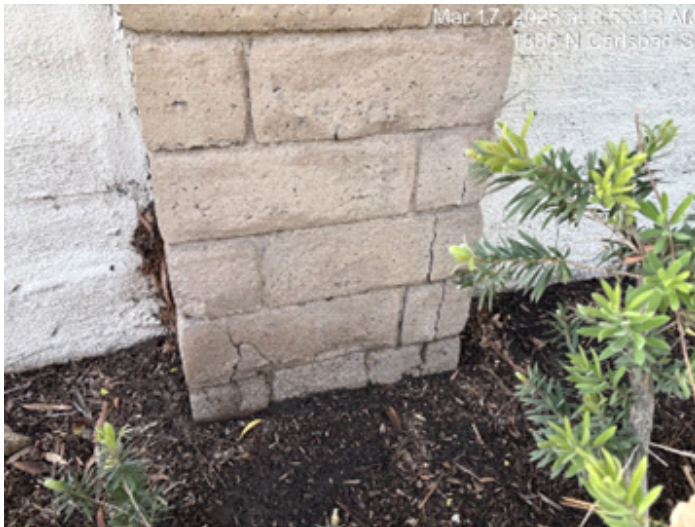
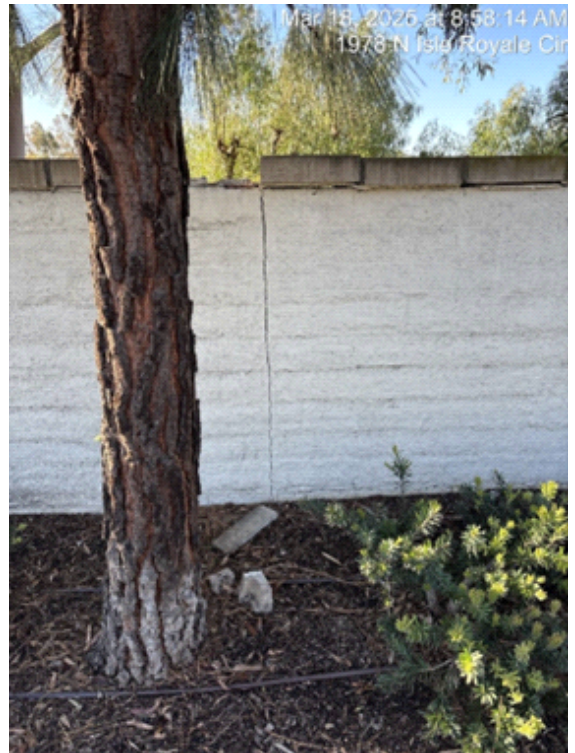
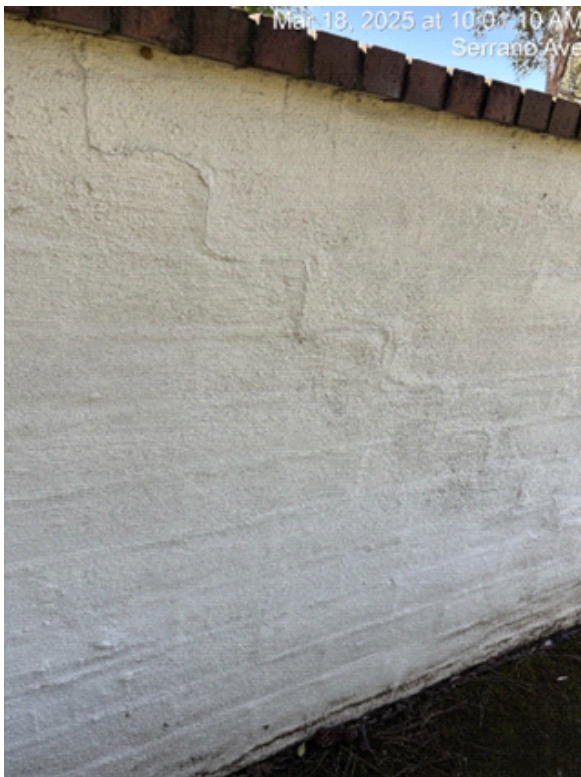
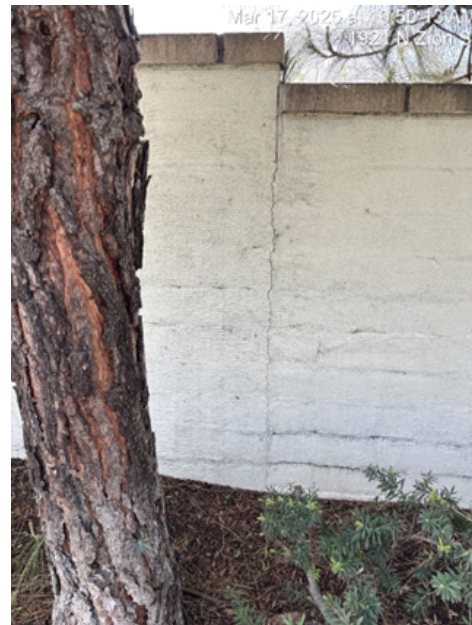
41/61 tree locations observed to have current adjacent infrastructure damage. 27 locations observed to have damage to public infrastructure. 28 locations observed to have damage to adjacent private wall.

28 tree locations on Serrano Ave observed to have current damage to adjacent private wall.

61/61 Canary Island Pine Trees located on Serrano Ave are recommended for removal, if adopted as City responsibility.

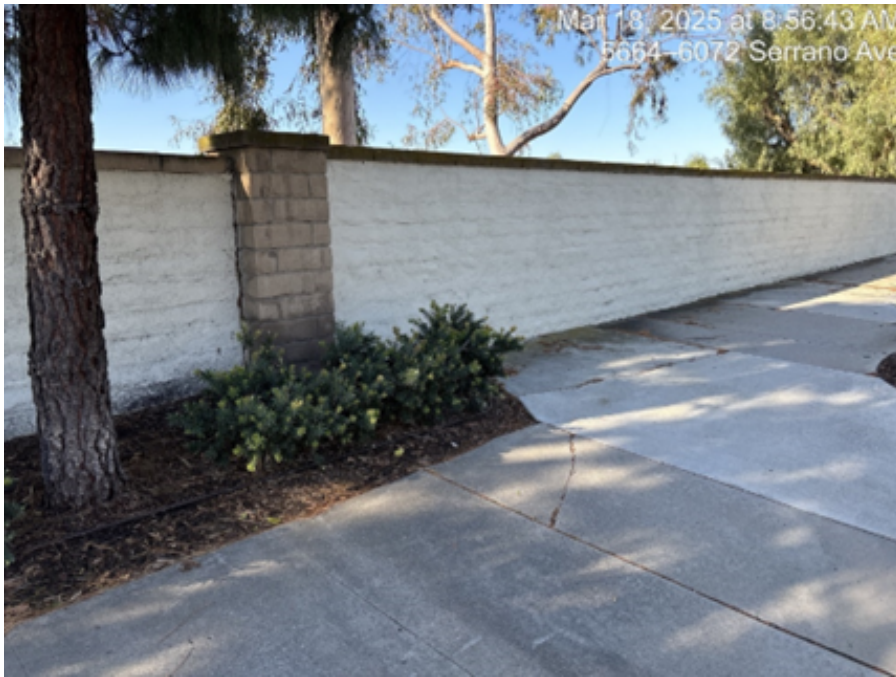
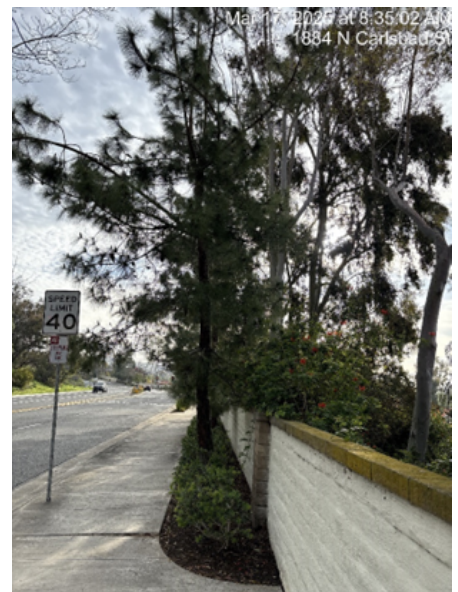
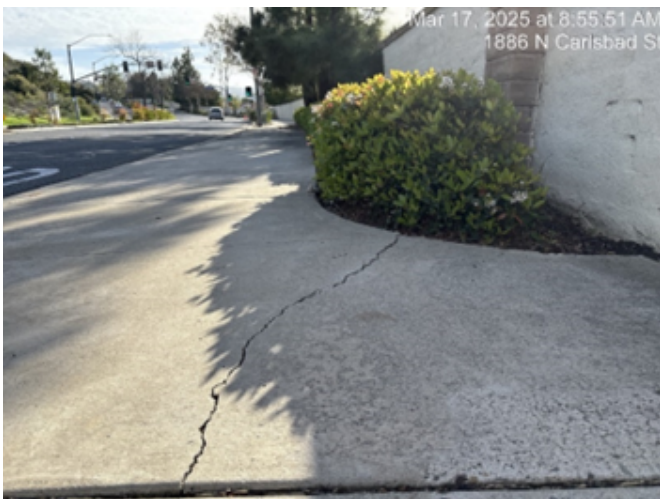
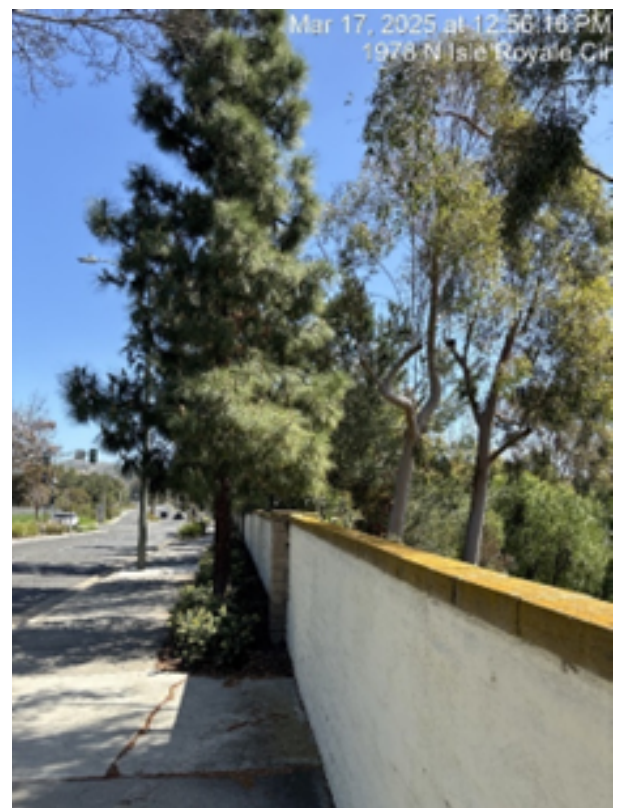
27 tree locations on Serrano Ave observed to have current damage to adjacent public infrastructure.

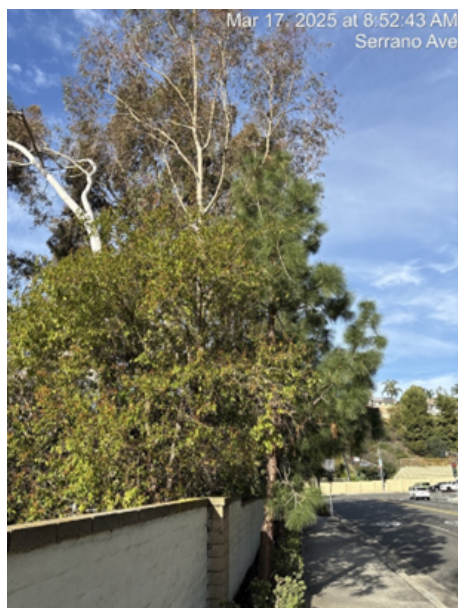
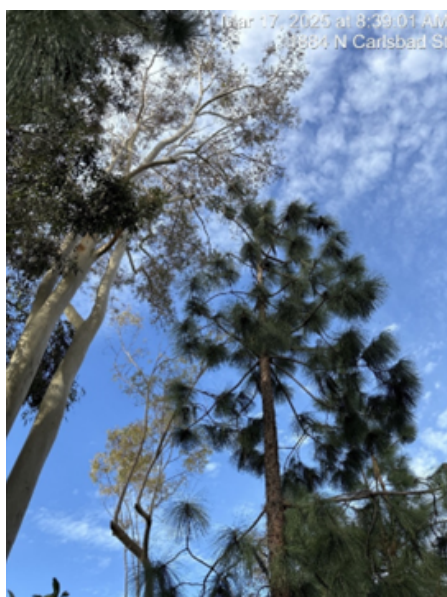
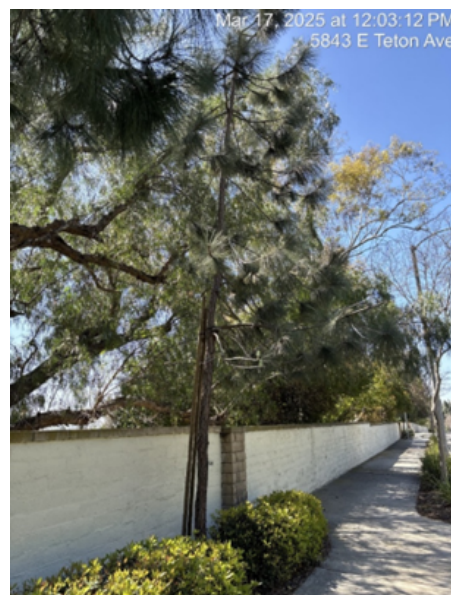
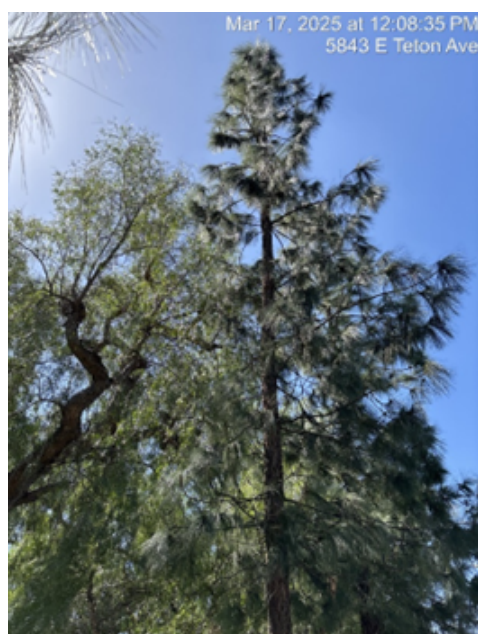
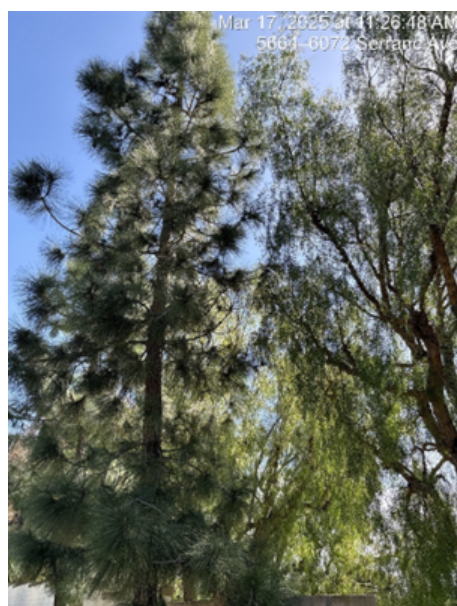
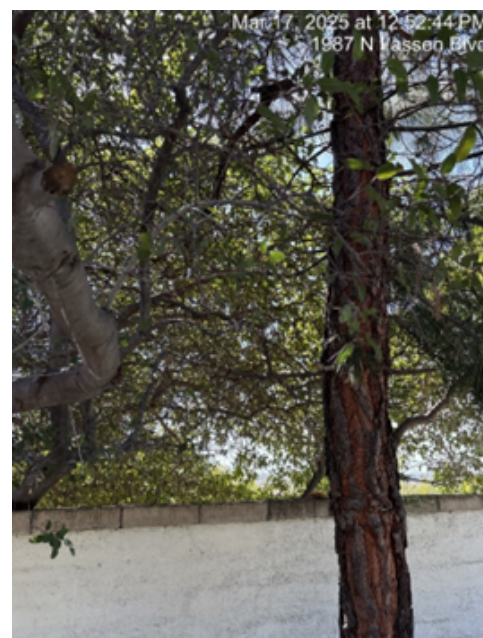
Competition and close proximity of trees may result in modified growth habit, such as leaning. Inadequate space between trees also increases the likelihood of branch failure, as trees make contact during inclement weather.

22 trees on Serrano Ave were observed to have canopies within 10' of private trees. 11 trees were observed to currently be in contact with private tree canopies.

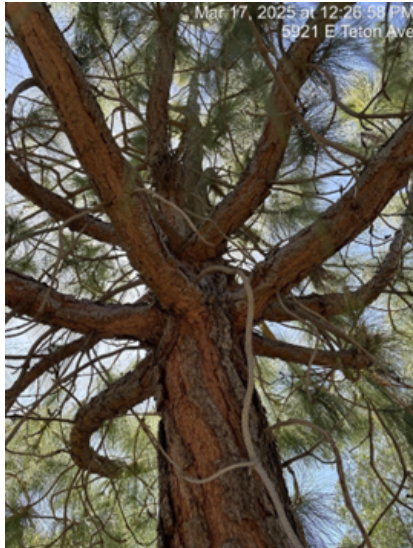
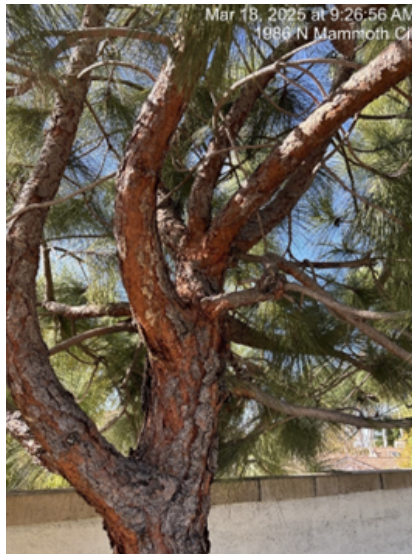
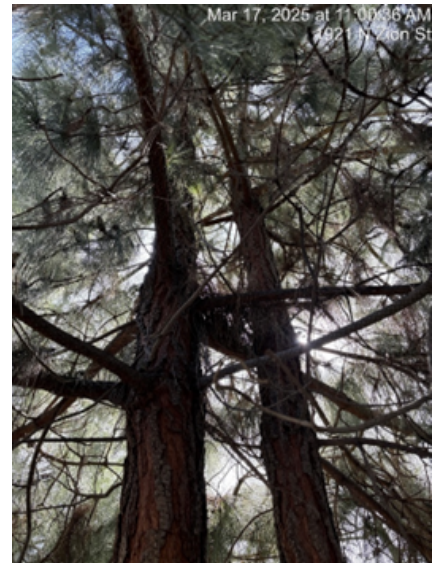
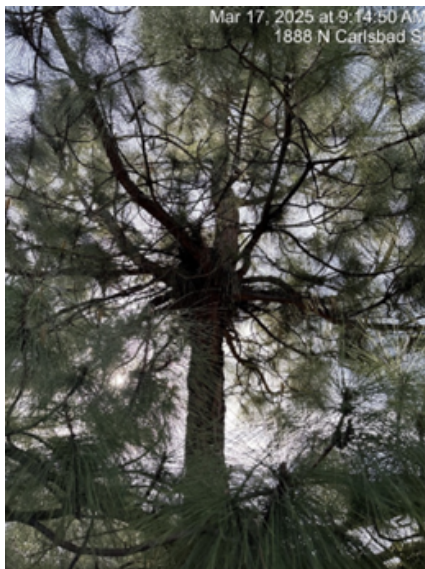
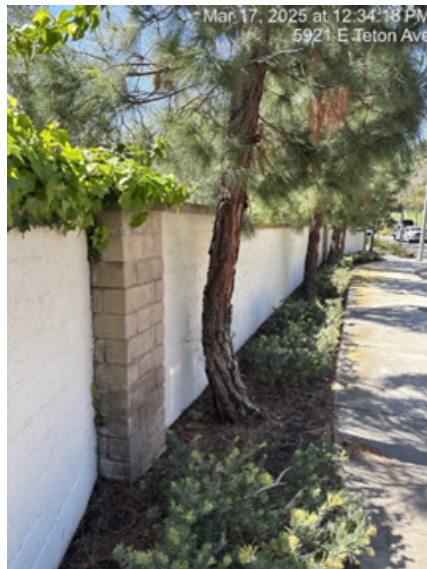
Defects in main stem and branch structure were observed in 15 trees on Serrano Ave. 5 trees were observed with severe defects, such as very poor and non-correctable branch structure, previous topping, and multi-trunk.

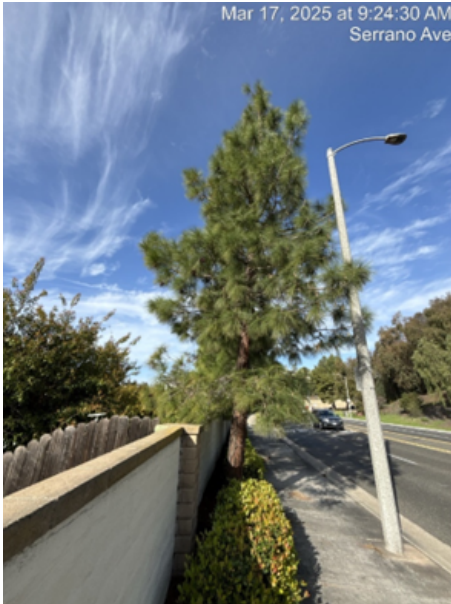
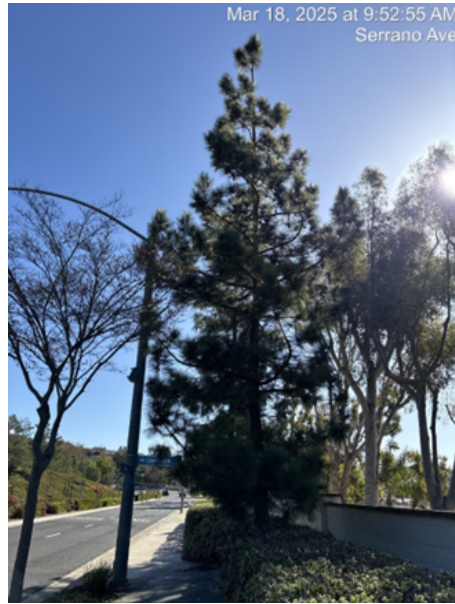
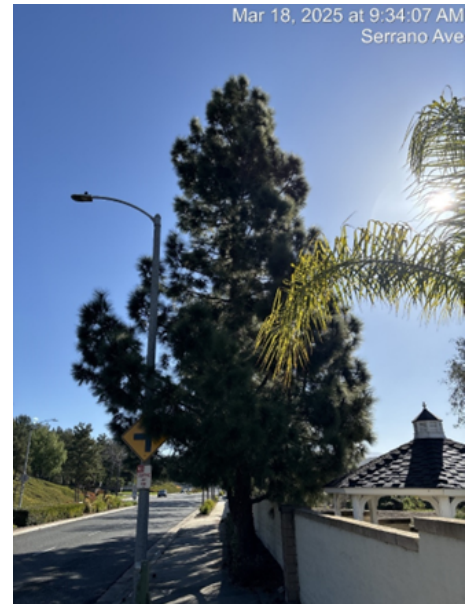
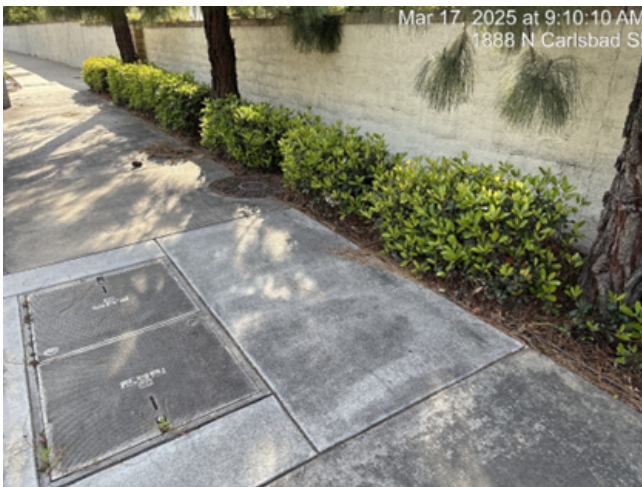
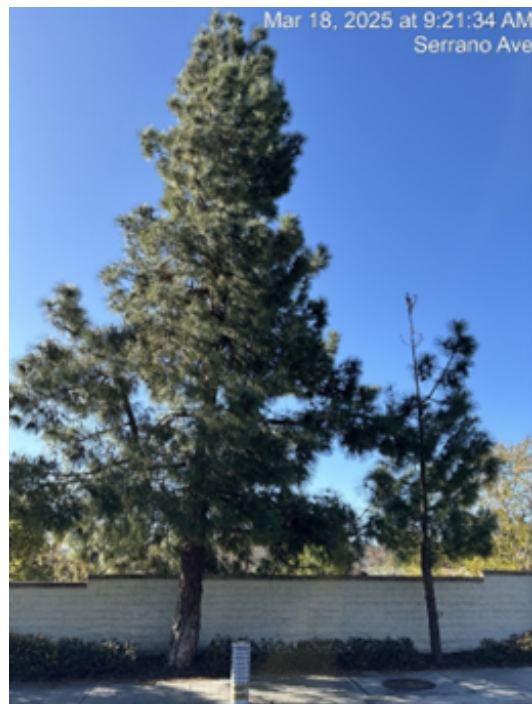
5 trees on Serrano Ave observed to be planted too close to street light poles, and do not meet the minimum required distance established by the Master Street Tree Plan (1999).

Man-hole covers and Utility vaults were observed in close proximity to some trees. Potential future conflict could involve requirement to repair Utility Infrastructure. Presence of underground installations reduce available soil volume and root space.

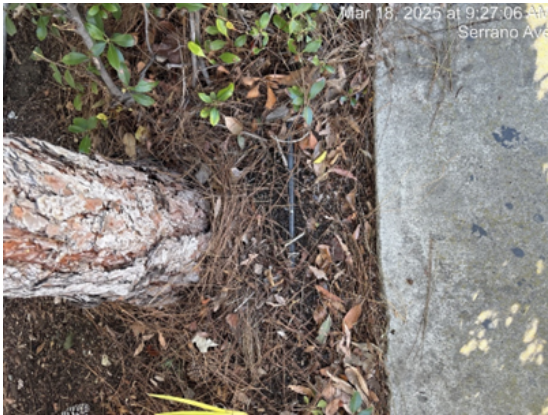
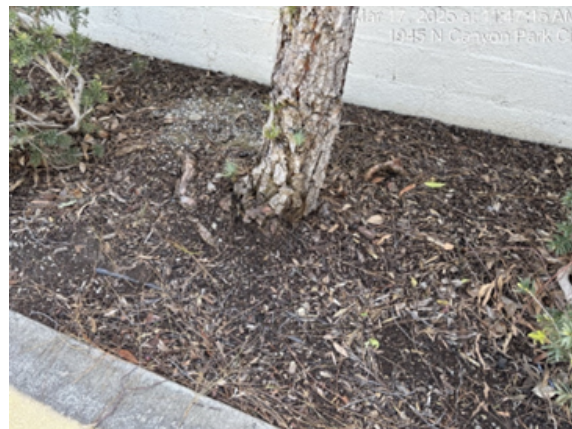
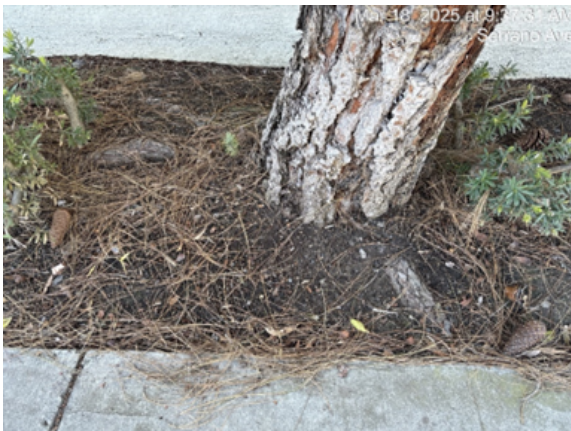
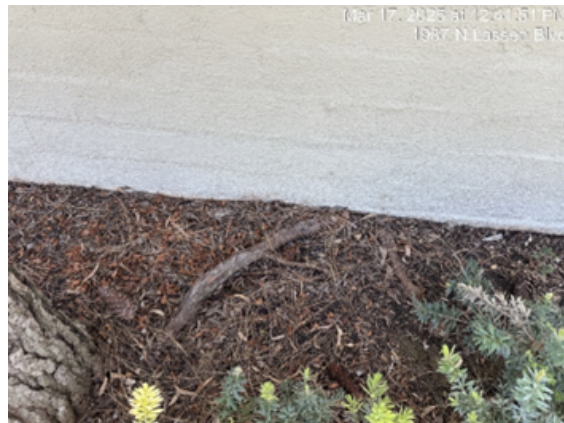
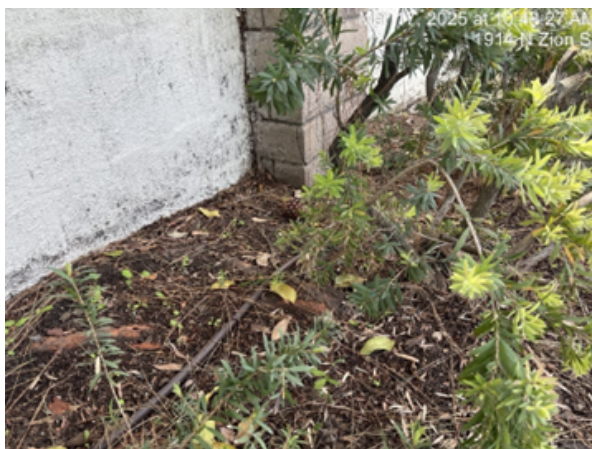
10 locations on Serrano Ave were observed with root barrier. All root barrier appeared improperly installed, with proximity as close as 4" to trunks. Root barrier installed at such close proximity to a trunk undermines the development of the root crown, the natural development of roots, and negatively effects tree health and anchorage.

Exposed surface roots were observed at 5 locations.

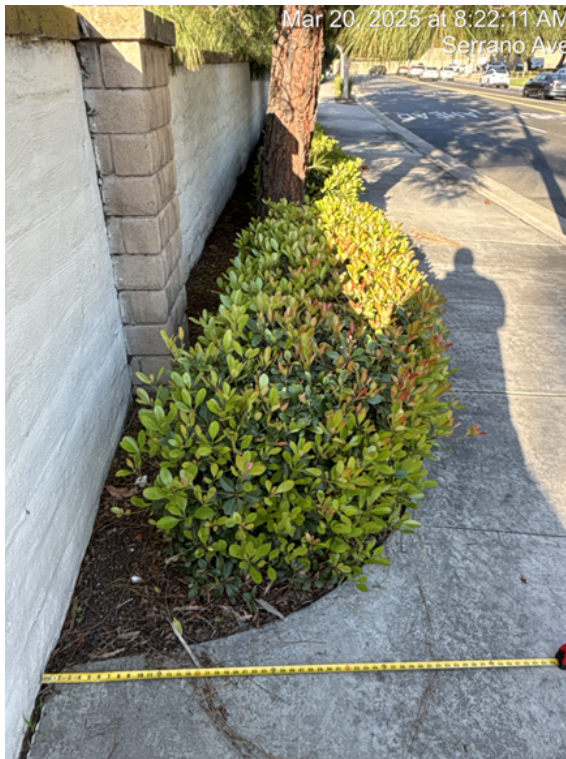
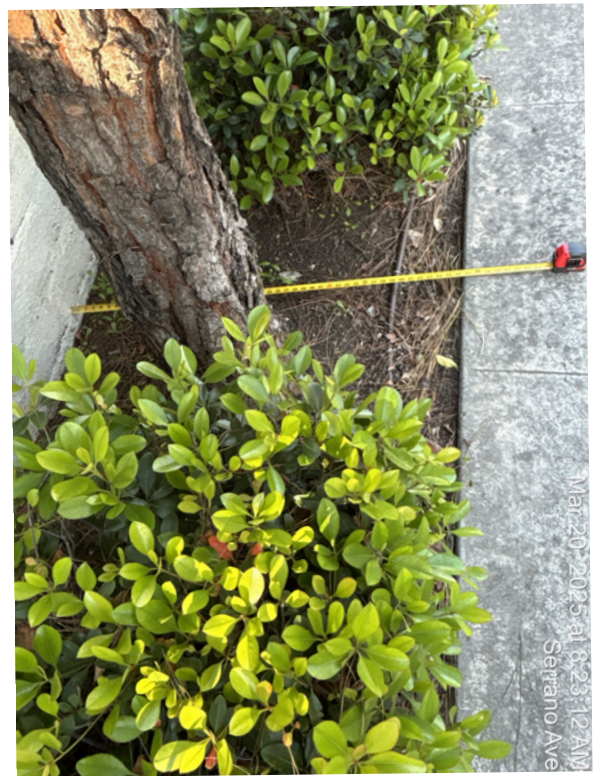
52 trees within the 4’ planters do not meet the minimum requirement of an 8’ x 8’ square, and also do not have adequate soil volume. Trees within the 4’ planter are very likely to cause both public and private infrastructure damage. It is very likely that the future replacement of surrounding infrastructure would require the removal of trees.

**ABOVE:** 52 trees observed to be in 4' wide planters.

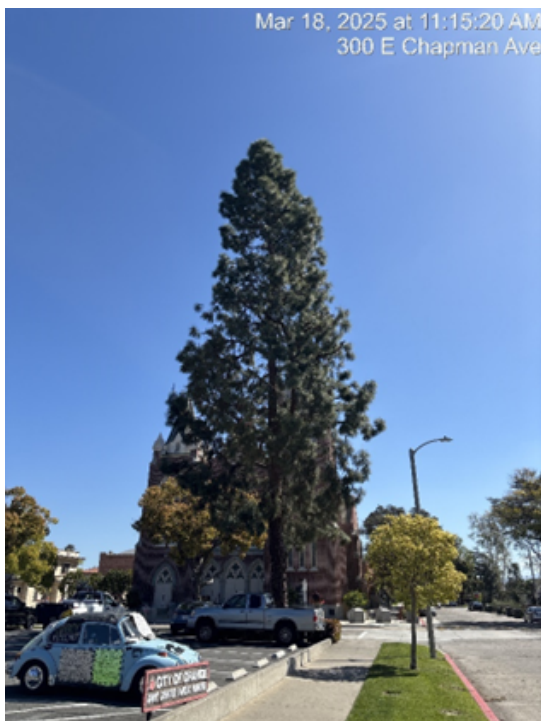
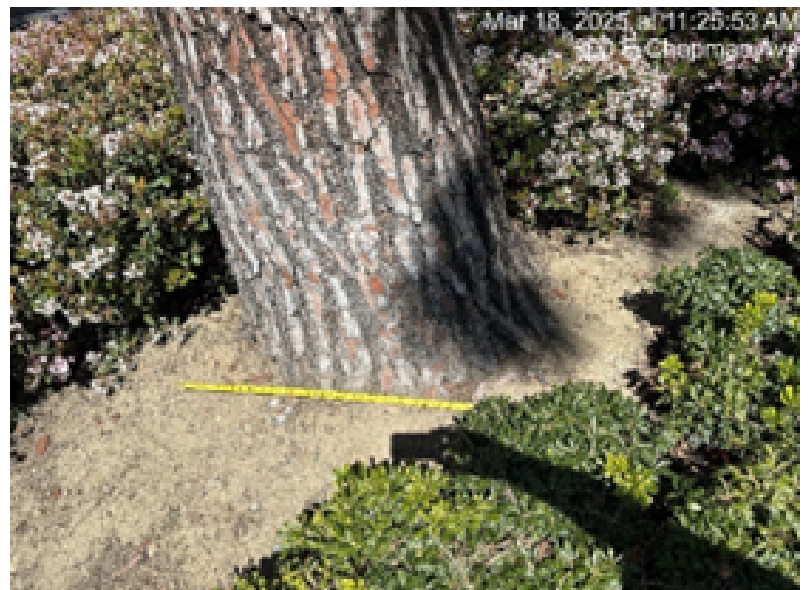
**BELOW:** Example of mature Canary Island Pine at 300 E Chapman Ave parking lot. Tree measured to be 36" DBH, and approximately 40" at base. Note that the trunk flare and root crown extend further on the far side.

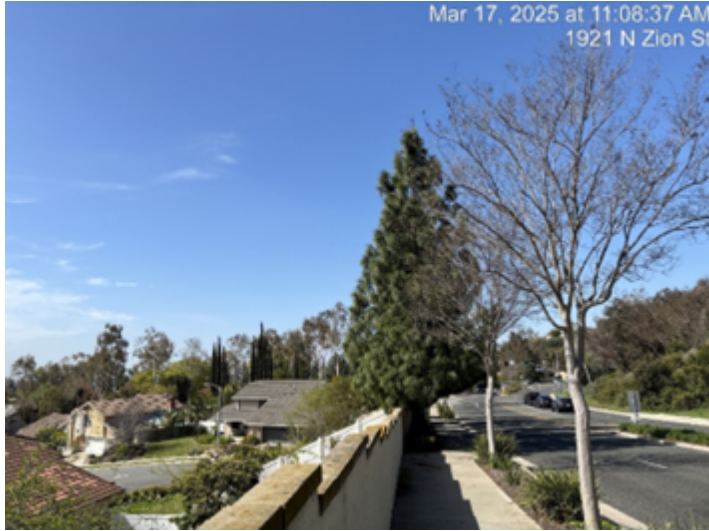
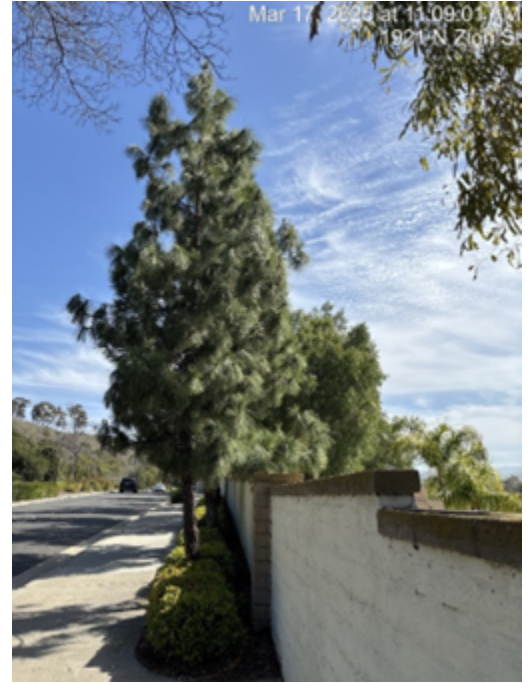
**ABOVE:** 52 trees observed to be in 4' wide planters, with trunk proximity to wall from 7" to 26", and proximity to sidewalk from 9" to 28".
