George Taylor Loudon AIA

## Historical Cultural Resources Assessment Report: Hangar Building 527 West Almond Avenue & 180 South Cypress Street; Orange CA

Proposed Adaptive Reuse Development for the Friends Church Orange

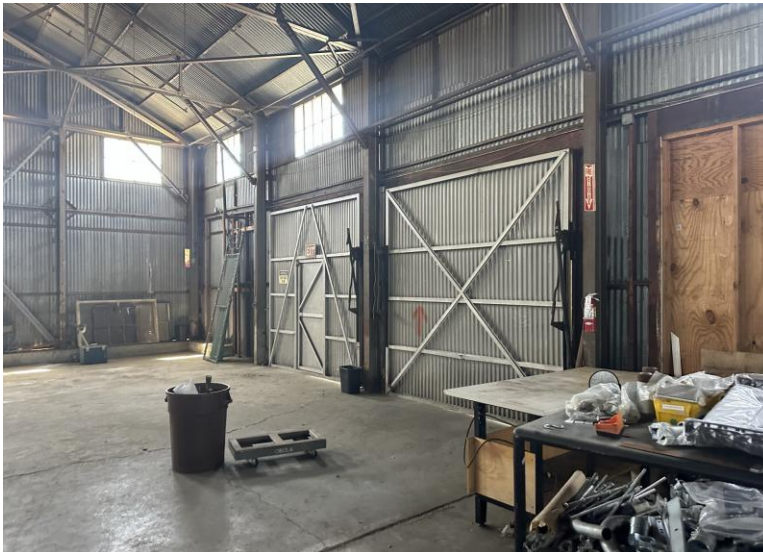
Figure # 4: Structural reconstruction of Hangar Building, southwest façade of interior wall surface interior cross bracing.

This southwest façade is the façade element that was permitted, disassembled and reconstructed 11'-6" towards the east to mitigate the encroachment for the railroad Right-Of-Way. Note the newer steel framing around doors and different diagonal framing and post details in this 2010 alteration, as opposed to the 1925 original.

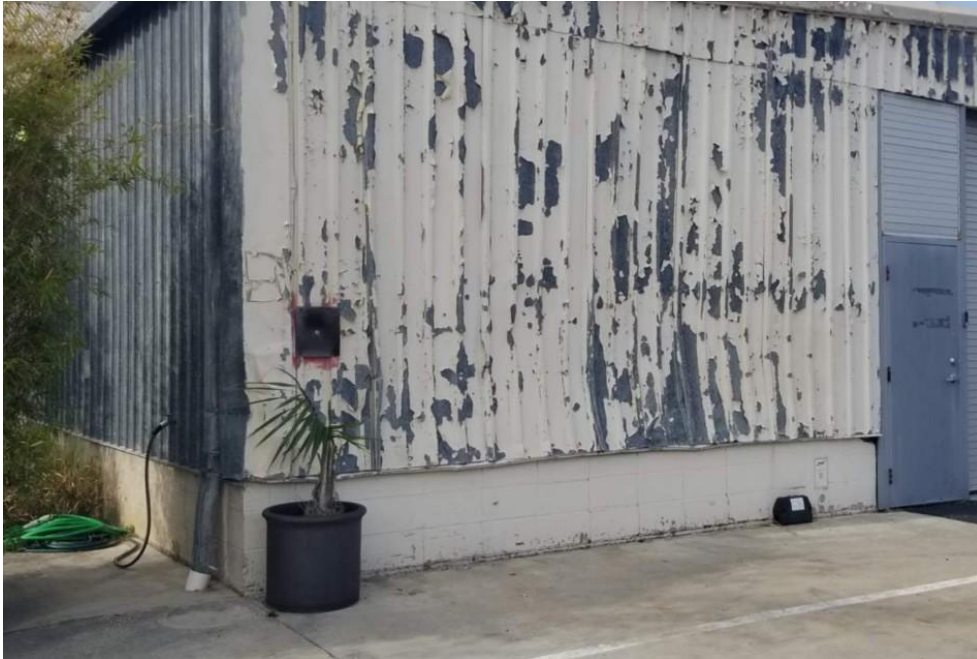
Current conditions of the exterior façade show damages at lower levels from vehicular traffic and some areas of metal finish degradation. In late 2024 the south facing façade was painted. The Hangar Building radiused bowstring roof has areas of built-up roofing material. The northern addition roof has metal panels at a low-slope pair of roof gables. The north elevation addition has a different metal panel façade profile than the original corrugated panels present at the Hangar Building. These wall panels are set above the CMU pony wall at grade continuing to the east façade. These elevations coincide with the areas of the mezzanine floor interior plan addition to the Hangar Building.

Figure # 5: north and east façade existing conditions, 2024. Noted vehicular damages.

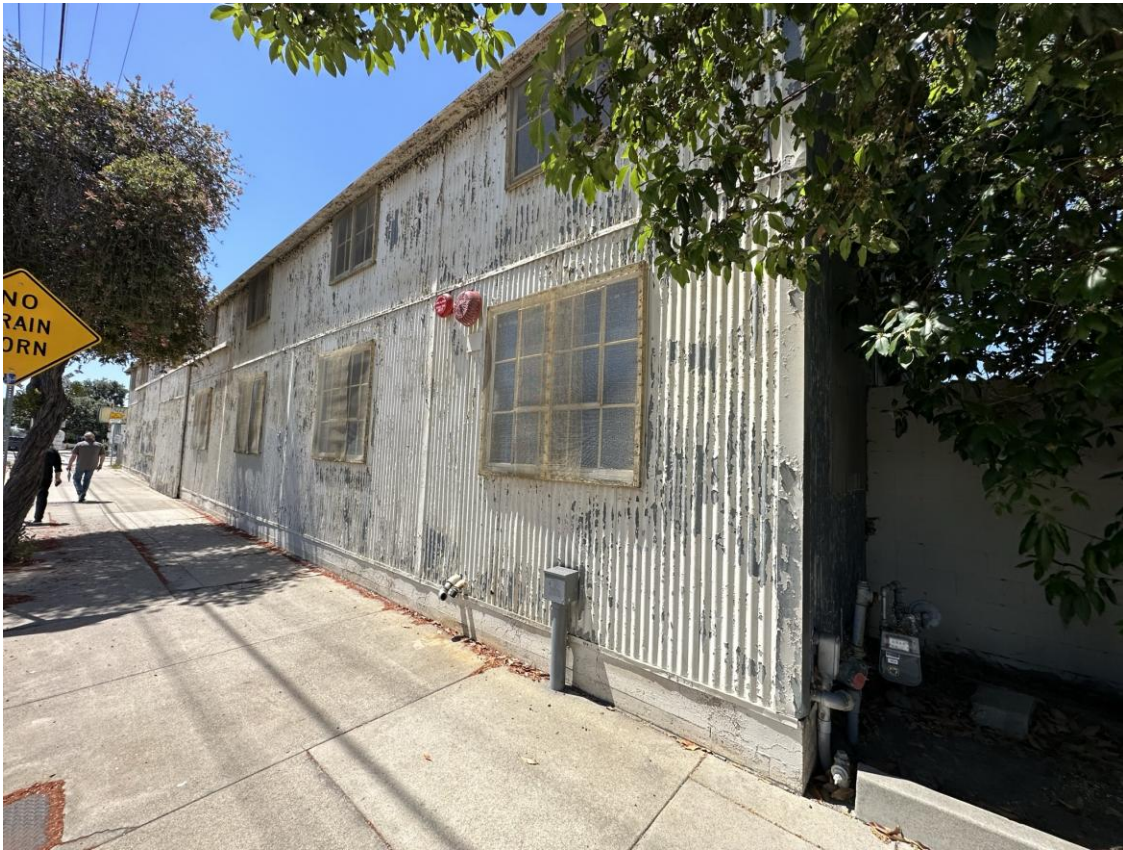
Figure # 9: primary south façade detail, oblique view to the west. Noted condition of corrugated metal wall panels above cast-in-place concrete curb walls. Noted deteriorated condition of wire mesh screening set in wooden frames and then applied to the face of the steel frame windows.

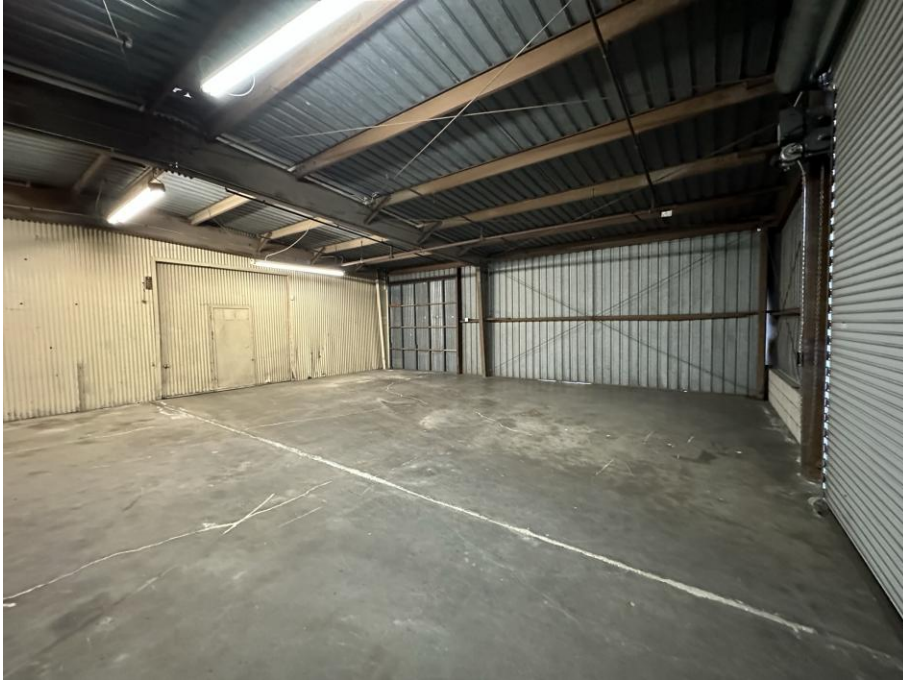
Figure # 12: north façade addition, view to south; ramped slope floor is proposed to be filled in. Rear wall at left is the original north façade of the Hangar Building corrugated metal panel façade. If the north addition were proposed to have this wall removed to accommodate new program use, these original corrugated panels could be retained for re-use elsewhere if necessary.

The Friends Church Orange proposes to construct their church related programs within the existing Hangar Building- effectively creating interior structures within the exterior structure. This Project proposes to rehabilitate the existing Hangar Building for an adaptive reuse of this original structure built c 1925. This Project design intent is to rehabilitate the building's original south and west façades, including a later addition of a loading dock structure along the north façade. A recessed loading dock ramp will be filled up to finish grade elevation.

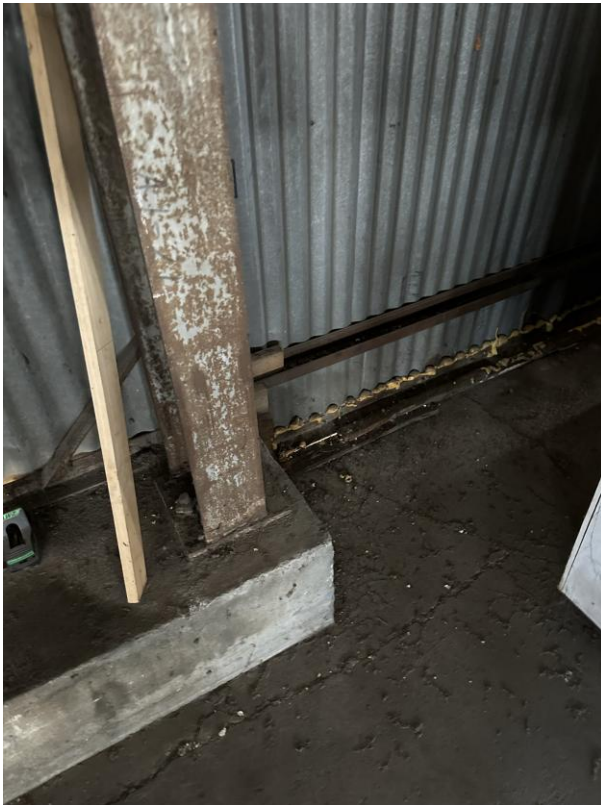
**Figure # 15: Detail of the base of steel columns and a concrete curb at east façade interior wall. Noted that the curb terminates at the location of the original doorway opening in the east façade an atypical detail.**

The proposed new primary entrance door and transom windows are located at the midpoint of the eastern façade. Noted that the detail of the steel base plates supporting the existing steel posts, seated on the concrete curb of the east façade interior wall. Noted that the raised concrete curb terminates at the location of this original doorway opening and threshold.

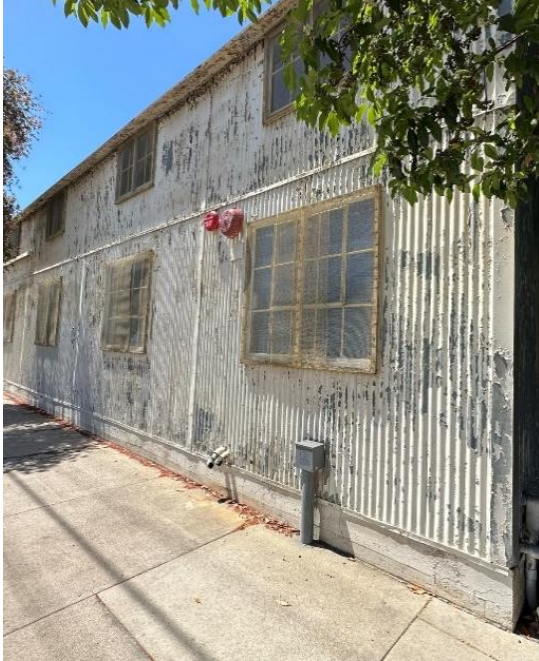
Figure #25: primary south façade detail, oblique view to west. Noted condition of corrugated metal wall panels above cast-in-place concrete pony walls. Noted condition of wire mesh screening set in wooden frames applied to face of the steel frame windows.

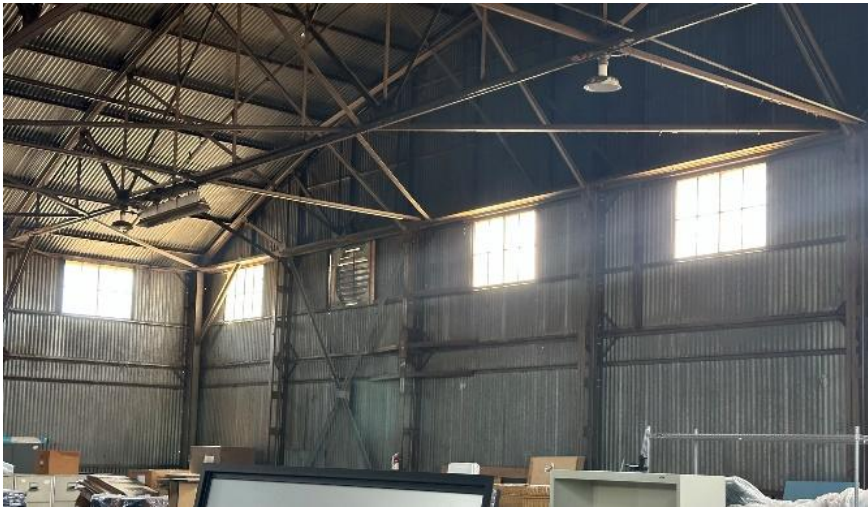
Figure #26:

There is consideration that the later replacement of original steel windows with existing metal louvred units where a mechanical function may be a Title 24 benefit. Nearly all of the remaining examples of the original rectangular steel window sashes and frames including three-over-one awning windows; these windows are all proposed to be repaired and rehabilitated.

**Proposed Façade fenestration, south, west and east window replacements with metal louvred panels: reverse later louvres if not needed and reconstruct metal windows to match existing.**

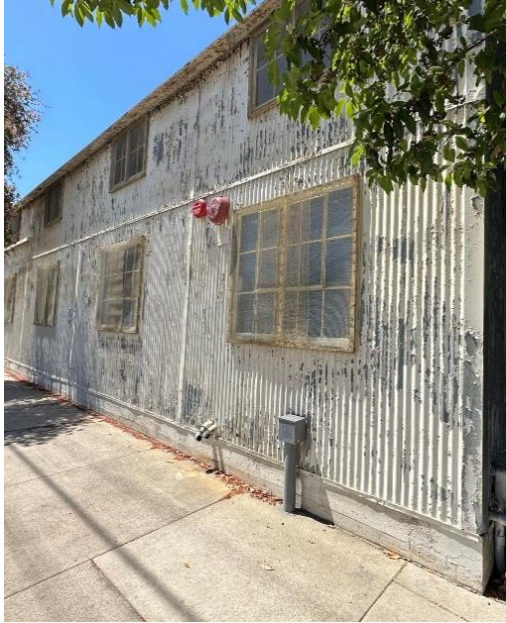
Figure # 27: primary south façade detail, oblique view to west. Noted condition of wire mesh screening set in wooden frames applied to face of the steel frame windows.

At the original rectangular steel window sashes and frames the existing mesh screens set in wooden frames are not compatible units and do not warrant rehabilitation. To achieve the beneficial Title 24 compliance without altering the visual appearance of the muntin bars as seen from the exterior side. A secondary glazed "storm window" detail is proposed at the interior side of the original window units.

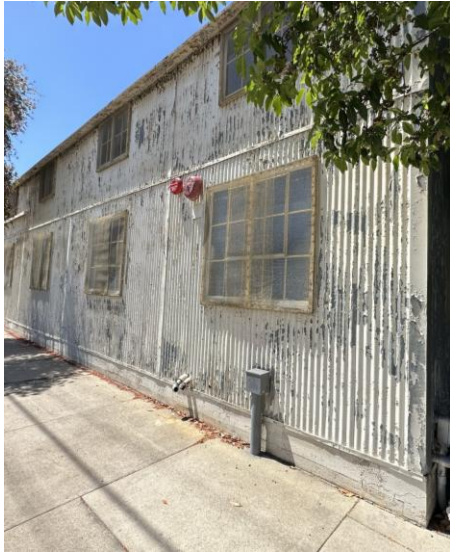
Figure # 28: primary south façade detail of corrugated metal panels and trim where repair and rehabilitation are required actions.

Material deterioration of the south and east exterior facades in particular is notable. At times in multiple locations where rusted conditions have resulted in material loss of original façade finish integrity. The south façade was recently painted completed prior to commencement of preparation for this HRAR. Otherwise, the need for facade panel replacement can be assessed with documentary photographs. The Rehabilitation Standards allow for matching corresponding with original material and profile where the materially secure conditions warrant. Refer to HRAR Figure #2 for the site photograph of the south façade at Almond Avenue prior to the recent painting. At the project site the design project team assessed that some locations of material loss could exceed areas of sufficient material integrity, where areas of patching become a greater extent than original material.

The Secretary's *Standards* prioritize repair and/ or rehabilitation of existing materials rather than complete replacement. Existing metal panels at locations that are visibly too deteriorated for repair/rehabilitation can justify controlled removal when there becomes less original material remaining than bondo or similar synthetic patching compound. A Field Report is recommended to create a façade survey that describes the various conditions and types of material failure and a justification as to why replacement is appropriate over rehabilitation. A replacement patch or “dutch” repair would need to match exactly in profile, dimensions and finish to insure acceptance.

The project design intent is to rehabilitate the original corrugated metal façade with limited alterations of the exterior façade. It is a project requirement that replacement corrugated metal siding will match the material profiles and dimensions of the original materials to match existing. To generate custom profiled materials that sufficiently match the existing original could prove to be an infeasible effort.
