March 25, 2025

Suitability of Adopting and Retaining 61 Canary Island Pine Trees along Serrano Blvd, and 22 Canary Island Pine Trees along Cannon St.

Prepared by:

Micah Jean – City of Orange Tree Services Coordinator
ISA Board Certified Master Arborist WE-9971BM
ISA Tree Risk Assessment Qualified | ISA Certified Urban Forest Professional

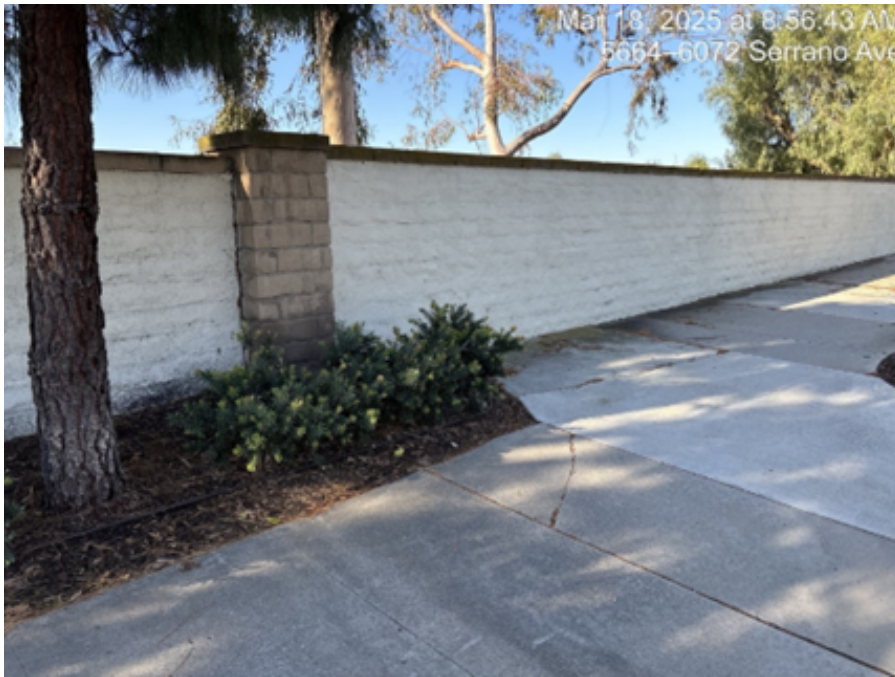
Examples of Current Infrastructure Damage

27 tree locations on Serrano Ave observed to have current damage to adjacent public infrastructure.

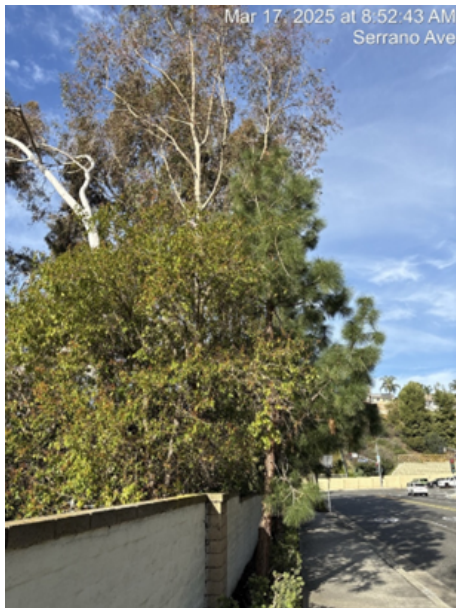
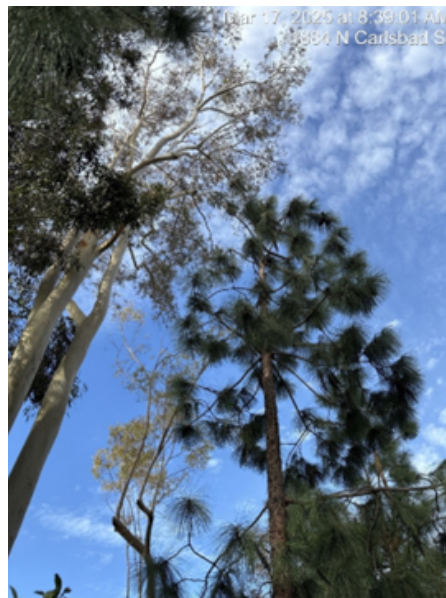
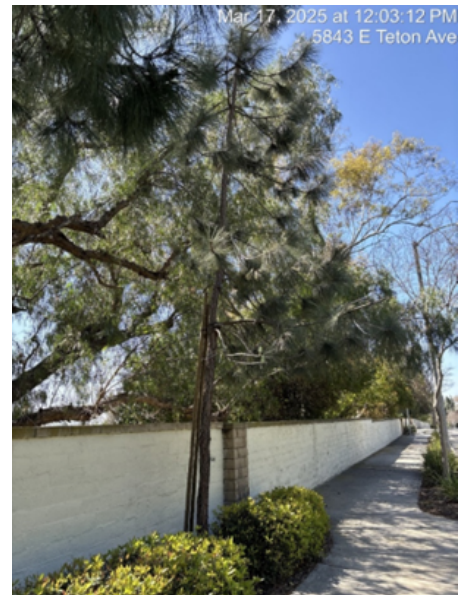
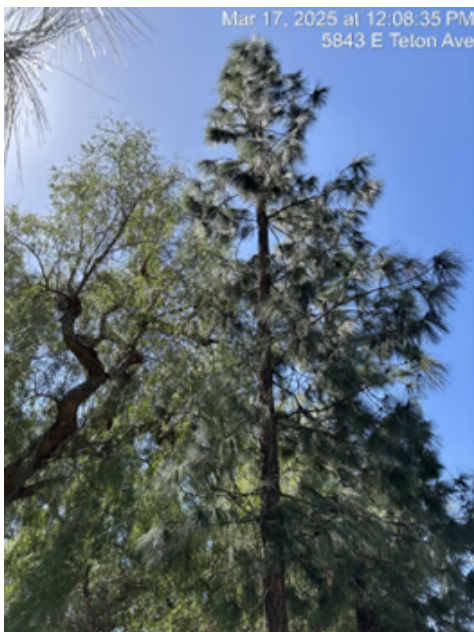
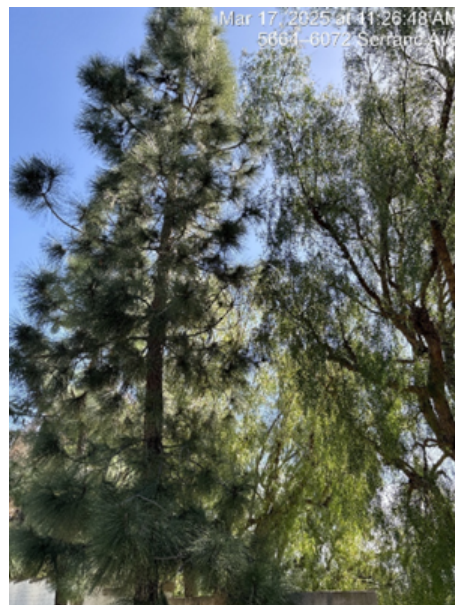
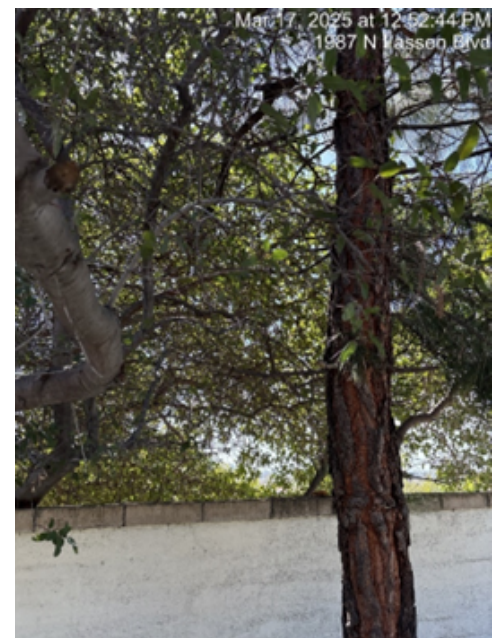
Examples of Current Conflicts with Private Tree Canopies

Competition and close proximity of trees may result in modified growth habit, such as leaning. Inadequate space between trees also increases the likelihood of branch failure, as trees make contact during inclement weather.

22 trees on Serrano Ave were observed to have canopies within 10' of private trees. 11 trees were observed to currently be in contact with private tree canopies.

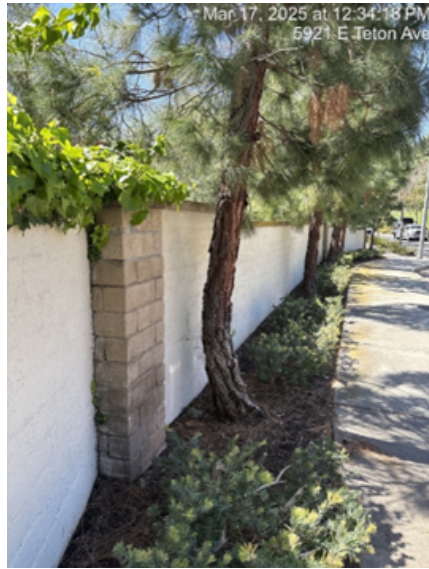
Examples of Observed Defects

Defects in main stem and branch structure were observed in 15 trees on Serrano Ave. 5 trees were observed with severe defects, such as very poor and non-correctable branch structure, previous topping, and multi-trunk.

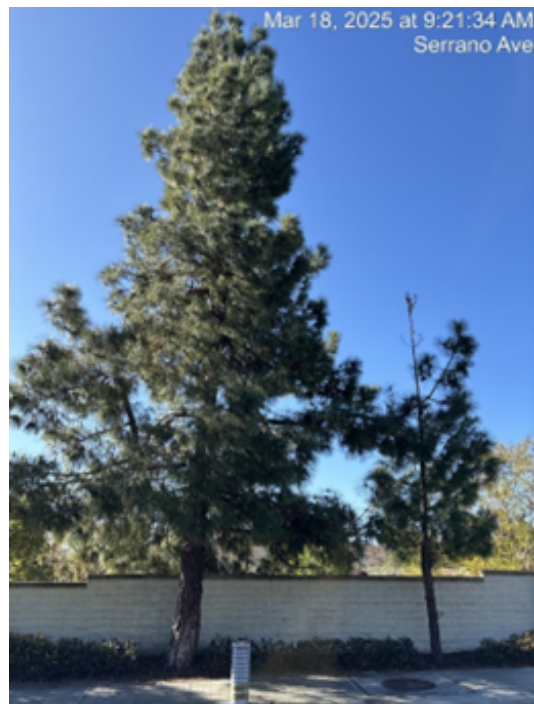
Examples of Potential Utility Conflicts

5 trees on Serrano Ave observed to be planted too close to street light poles, and do not meet the minimum required distance established by the Master Street Tree Plan (1999).

Man-hole covers and Utility vaults were observed in close proximity to some trees. Potential future conflict could involve requirement to repair Utility Infrastructure. Presence of underground installations reduce available soil volume and root space.

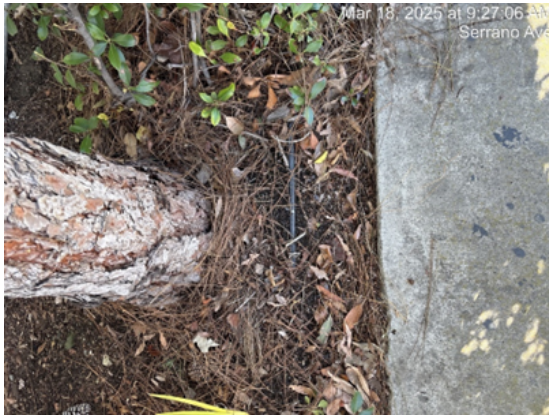
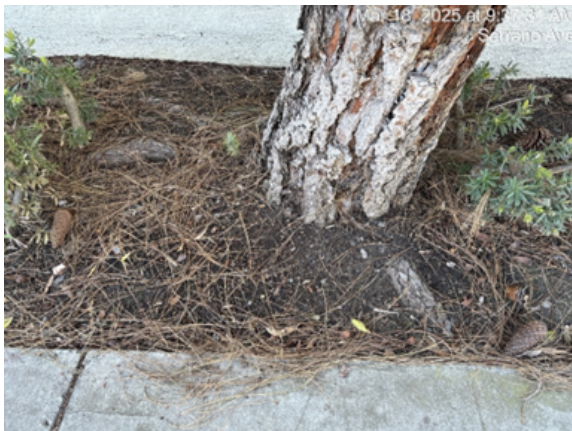
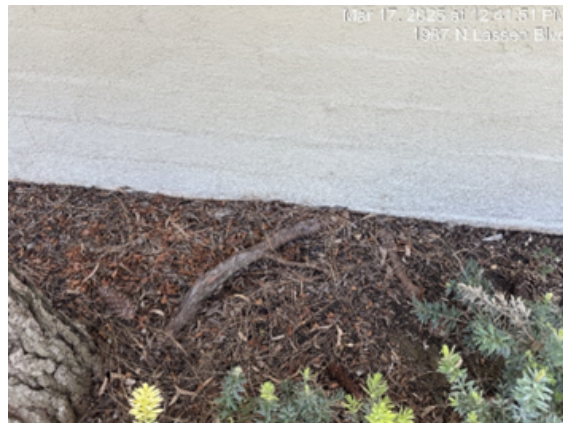
Examples of Surface Roots and Improper Root Barrier Installation

10 locations on Serrano Ave were observed with root barrier. All root barrier appeared improperly installed, with proximity as close as 4" to trunks. Root barrier installed at such close proximity to a trunk undermines the development of the root crown, the natural development of roots, and negatively effects tree health and anchorage.

Exposed surface roots were observed at 5 locations.

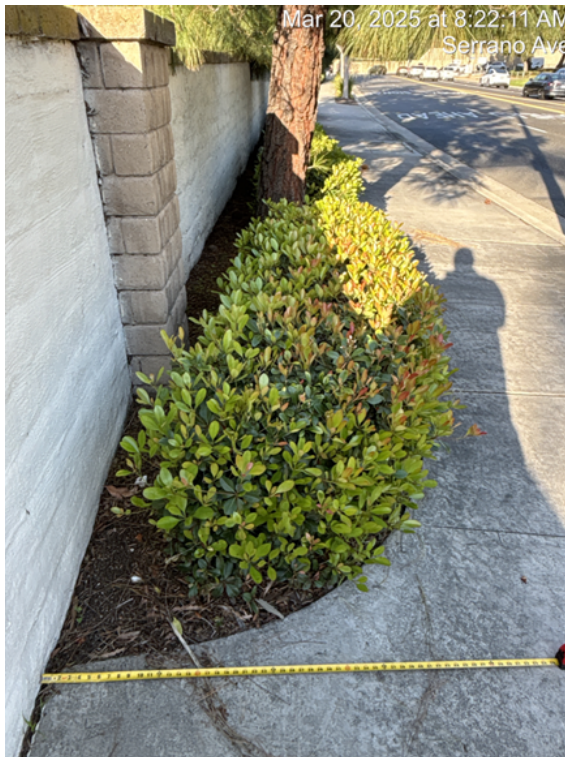
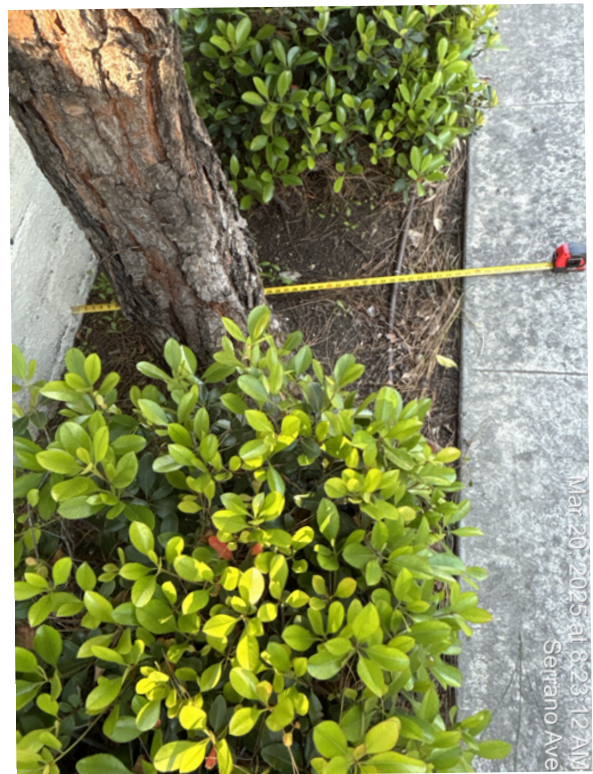
Planter Size

ABOVE: 52 trees observed to be in 4' wide planters.

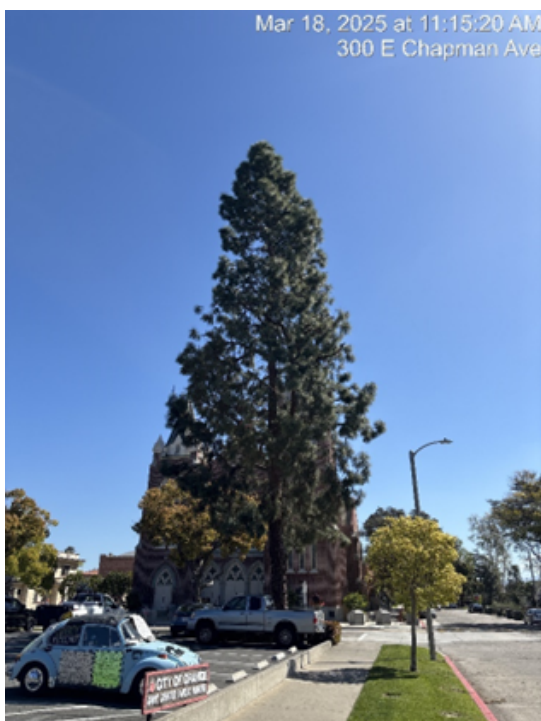
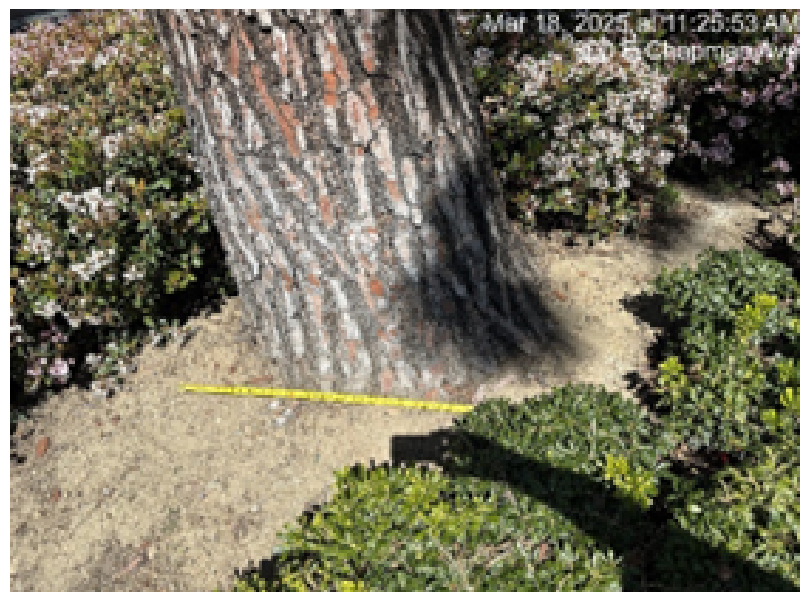
BELOW: Example of mature Canary Island Pine at 300 E Chapman Ave parking lot. Tree measured to be 36" DBH, and approximately 40" at base. Note that the trunk flare and root crown extend further on the far side.

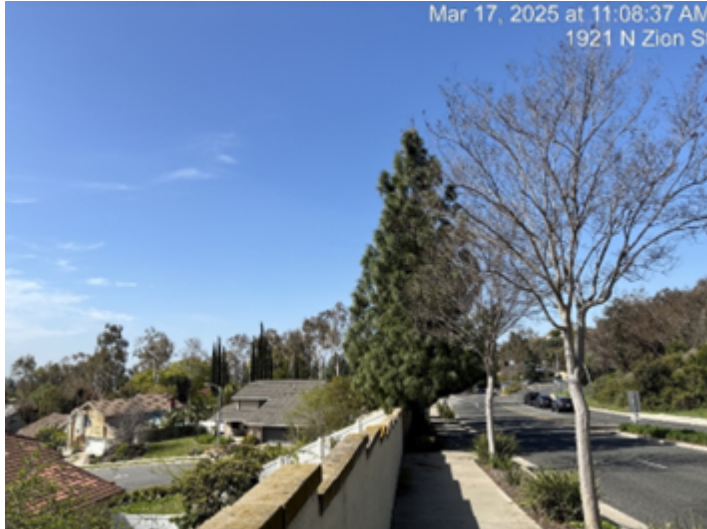
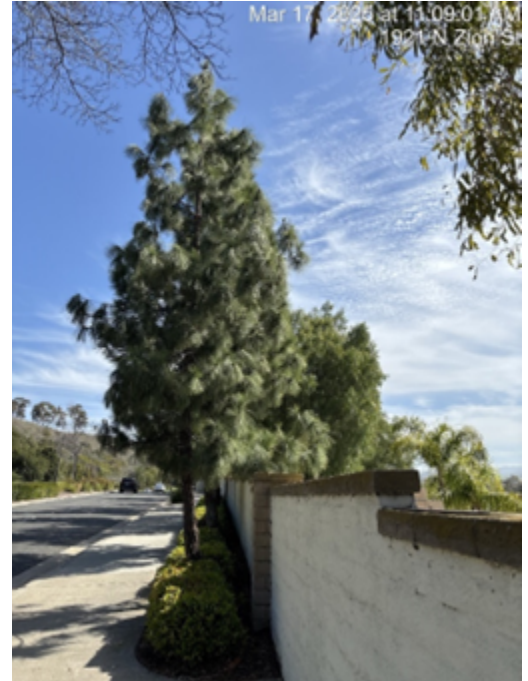
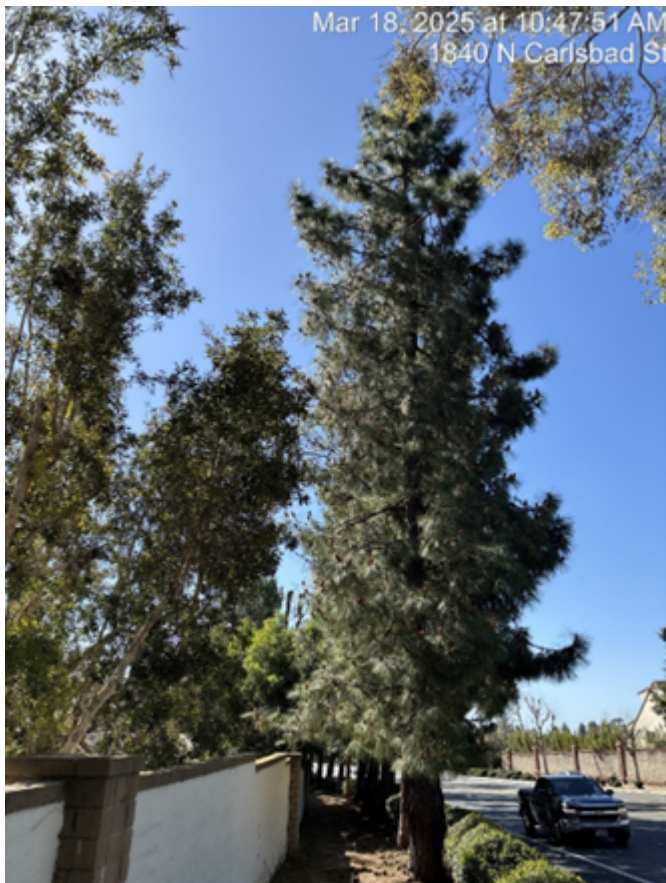
Planter Size, Comparison of Serrano Ave to Cannon St

ABOVE: 52 trees observed to be in 4' wide planters, with trunk proximity to wall from 7" to 26", and proximity to sidewalk from 9" to 28".

LEFT: 22 Canary Island Pine Trees along Cannon, with approximately 7-8' proximity to wall, and approximately 3' proximity to sidewalk.
