March 25, 2025

Suitability of Adopting and Retaining 61 Canary Island Pine Trees along Serrano Blvd, and 22 Canary Island Pine Trees along Cannon St.

Micah Jean – City of Orange Tree Services Coordinator
ISA Board Certified Master Arborist WE-9971BM
ISA Tree Risk Assessment Qualified | ISA Certified Urban Forest Professional

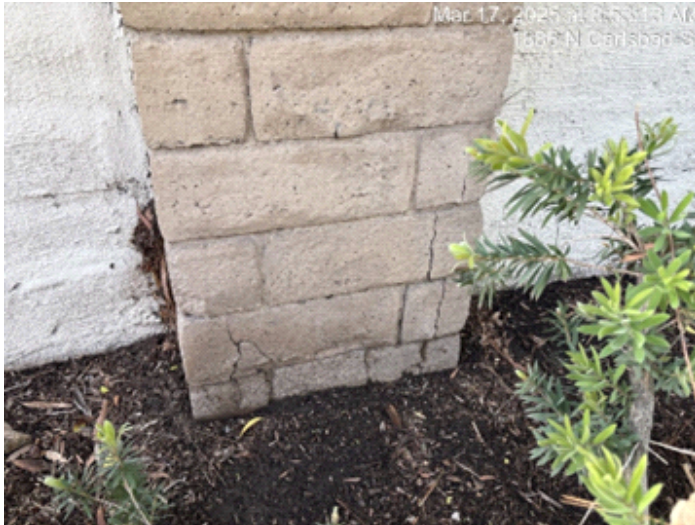
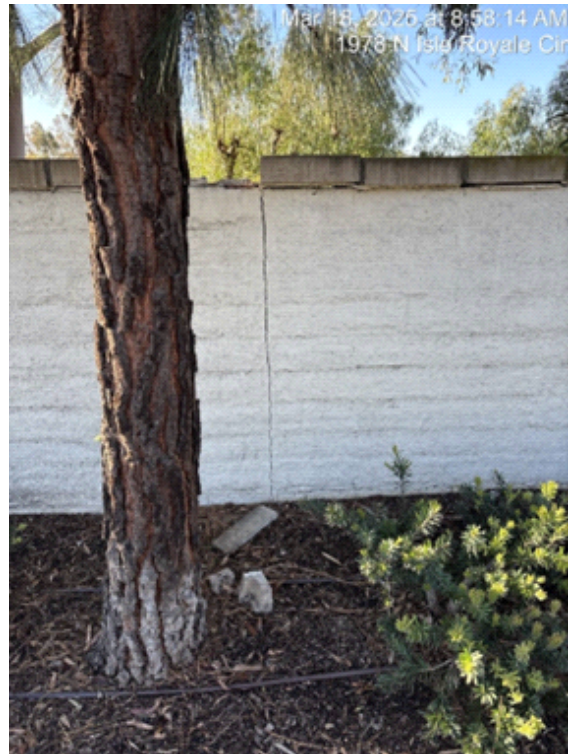
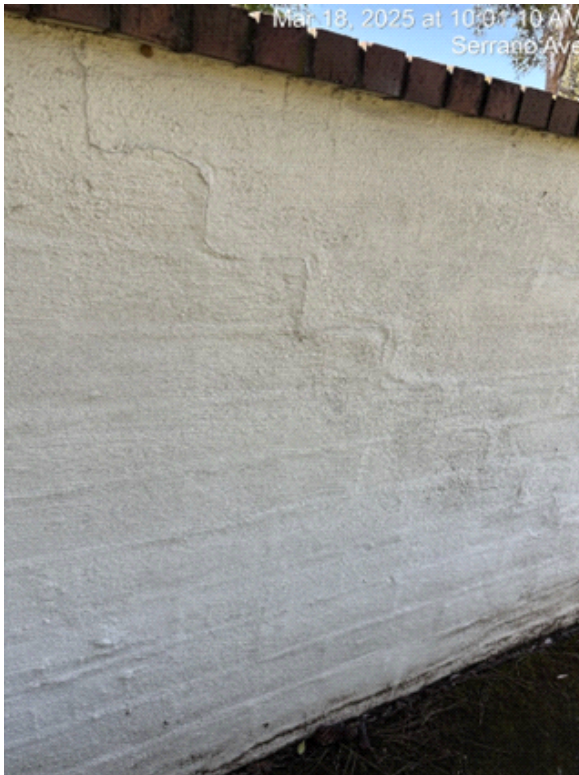
Examples of Current Infrastructure Damage

28 tree locations on Serrano Ave observed to have current damage to adjacent private wall.

61/61 Canary Island Pine Trees located on Serrano Ave are recommended for removal, if adopted as City responsibility.

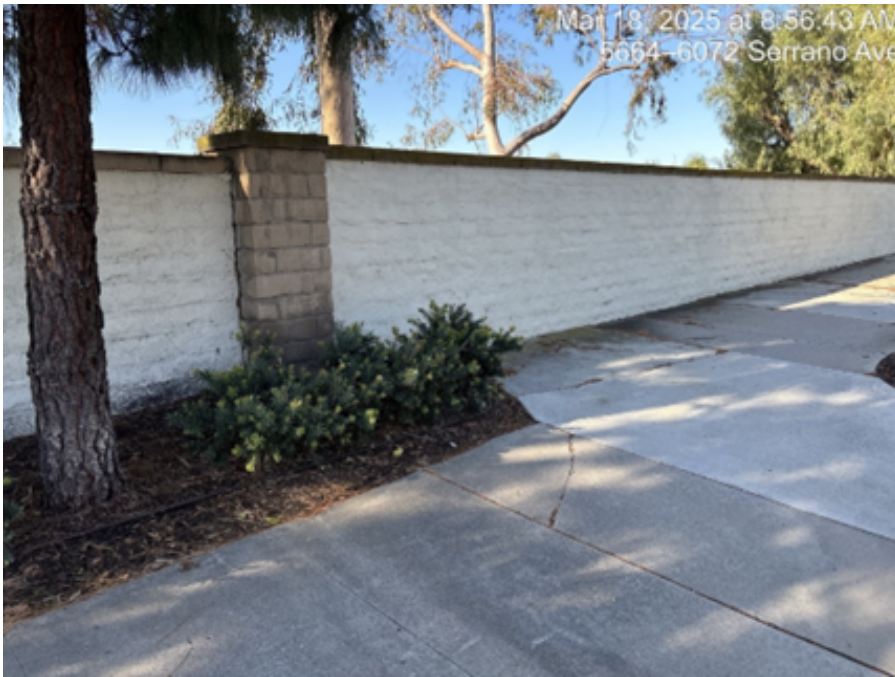
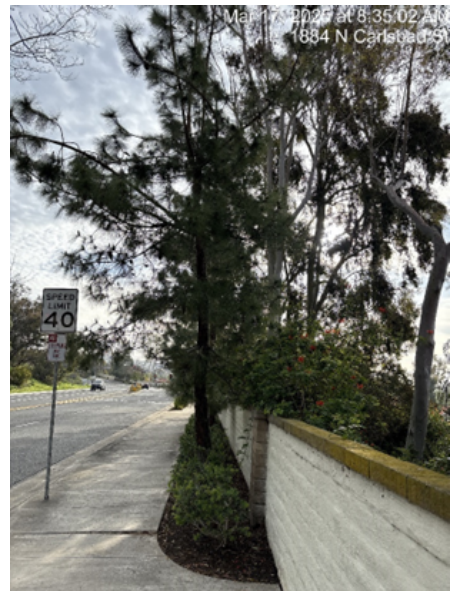
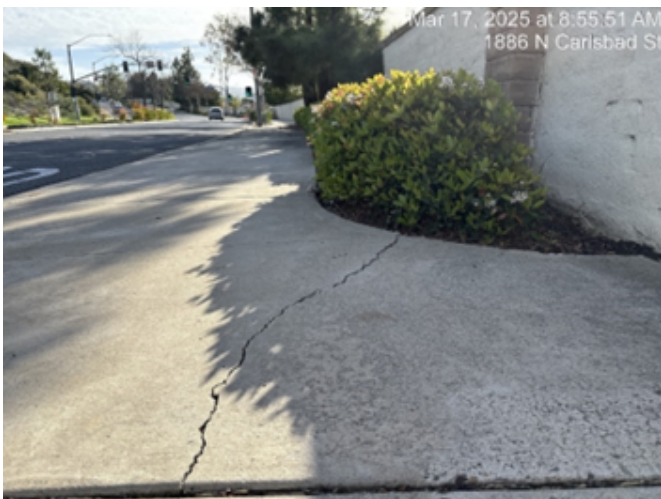
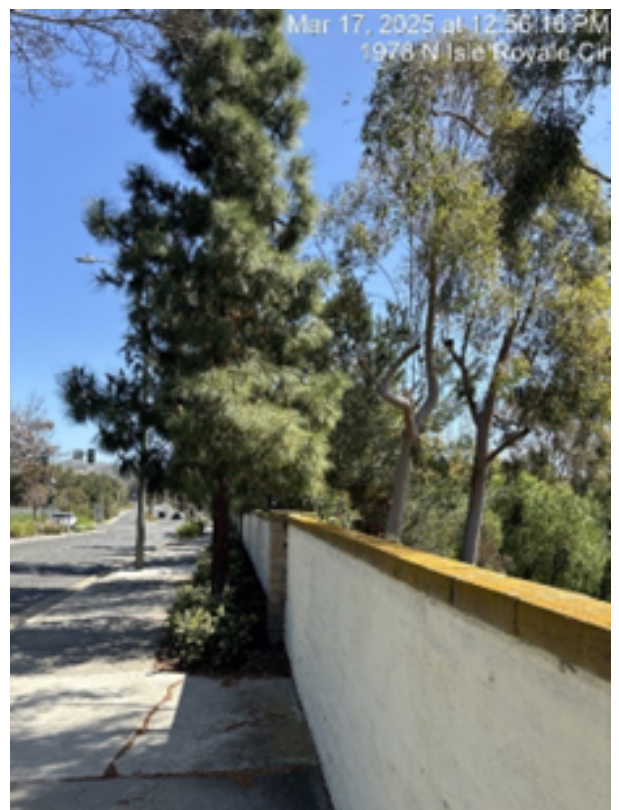
Examples of Current Infrastructure Damage

27 tree locations on Serrano Ave observed to have current damage to adjacent public infrastructure.

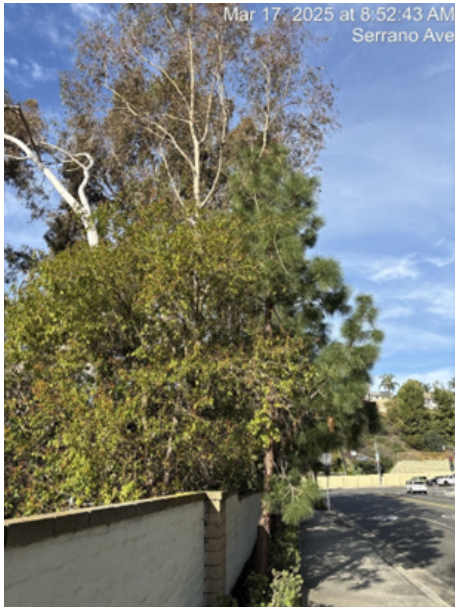
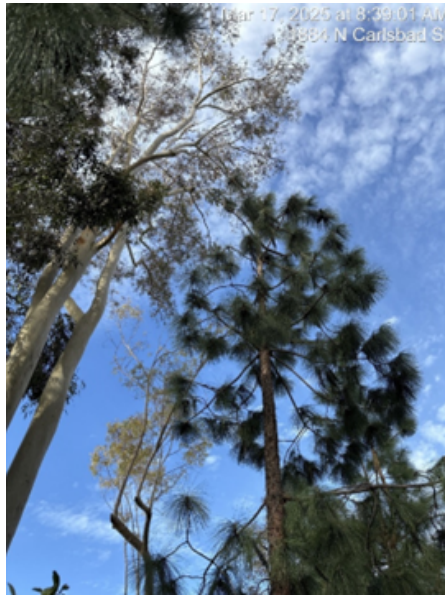
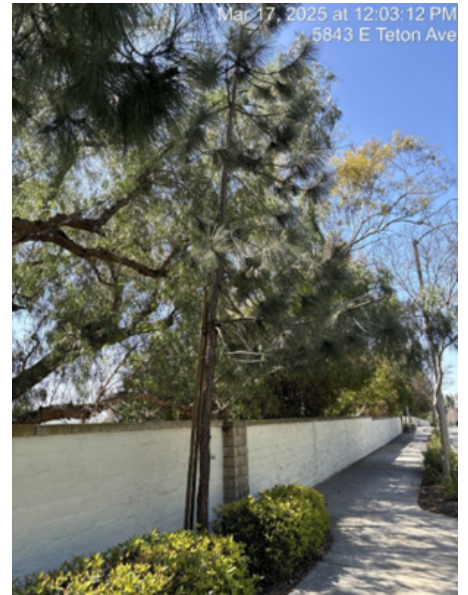
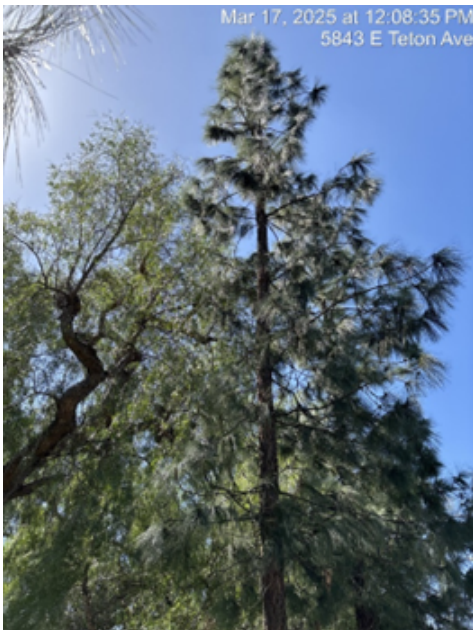
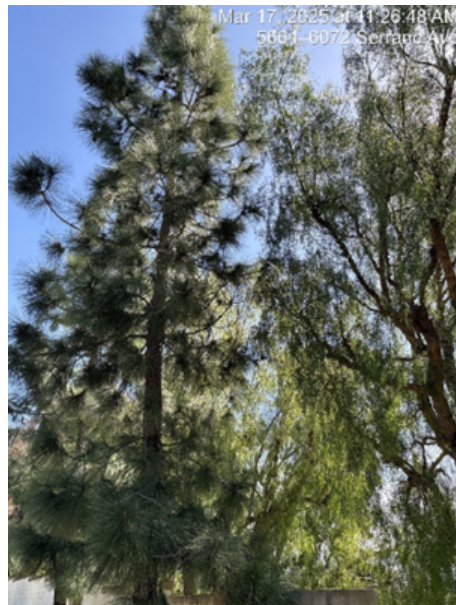
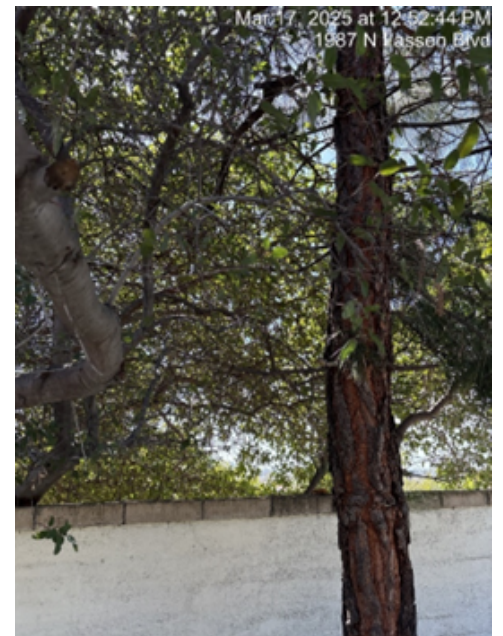
Examples of Current Conflicts with Private Tree Canopies

Competition and close proximity of trees may result in modified growth habit, such as leaning. Inadequate space between trees also increases the likelihood of branch failure, as trees make contact during inclement weather.

22 trees on Serrano Ave were observed to have canopies within 10' of private trees. 11 trees were observed to currently be in contact with private tree canopies.

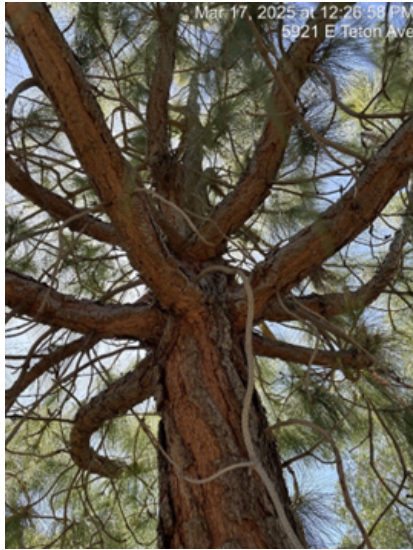
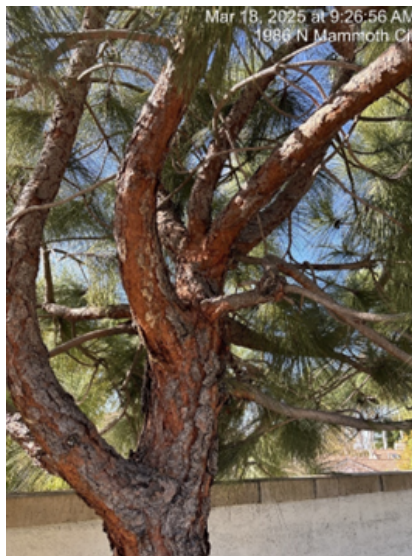
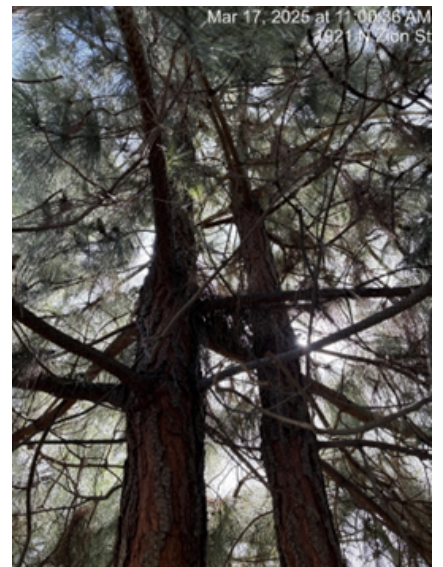
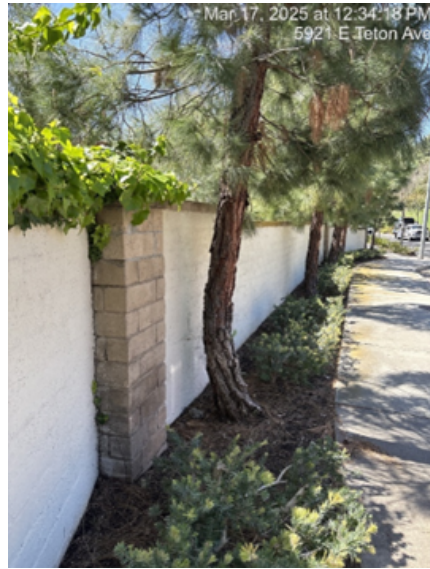
Examples of Observed Defects

Defects in main stem and branch structure were observed in 15 trees on Serrano Ave. 5 trees were observed with severe defects, such as very poor and non-correctable branch structure, previous topping, and multi-trunk.

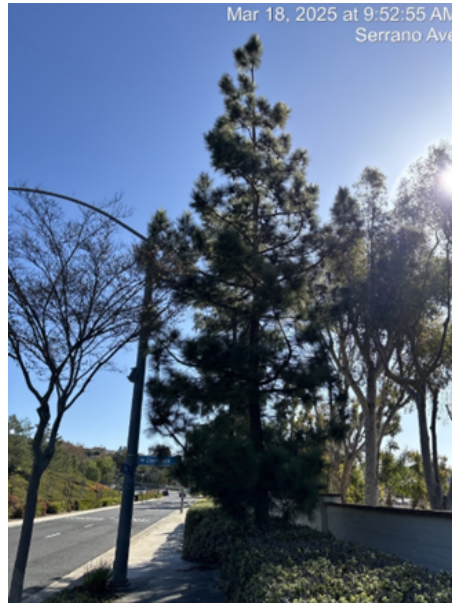
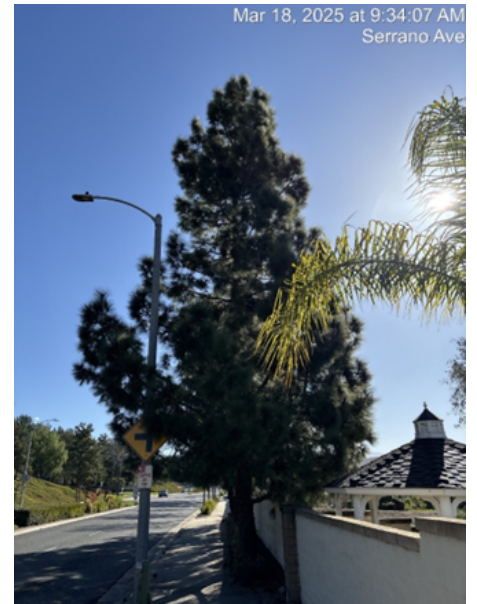
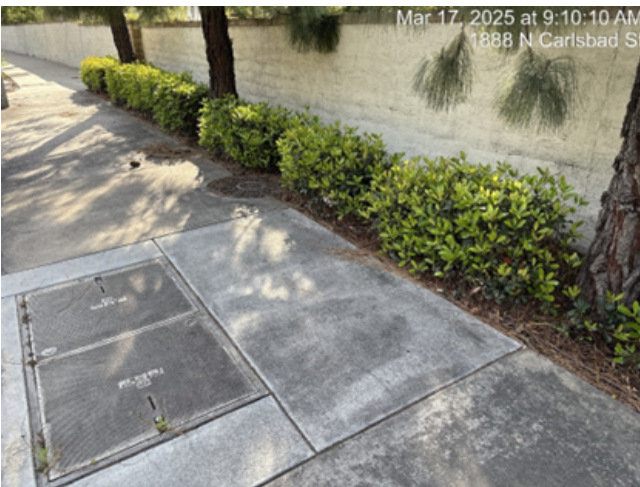
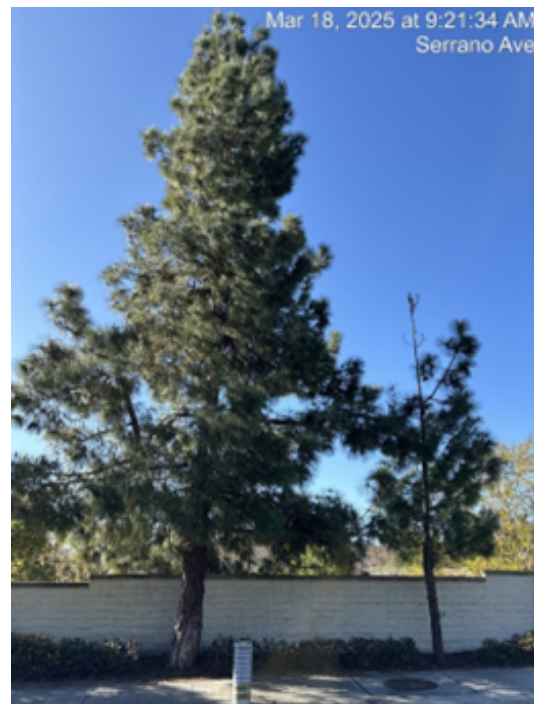
Examples of Potential Utility Conflicts

5 trees on Serrano Ave observed to be planted too close to street light poles, and do not meet the minimum required distance established by the Master Street Tree Plan (1999).

Man-hole covers and Utility vaults were observed in close proximity to some trees. Potential future conflict could involve requirement to repair Utility Infrastructure. Presence of underground installations reduce available soil volume and root space.

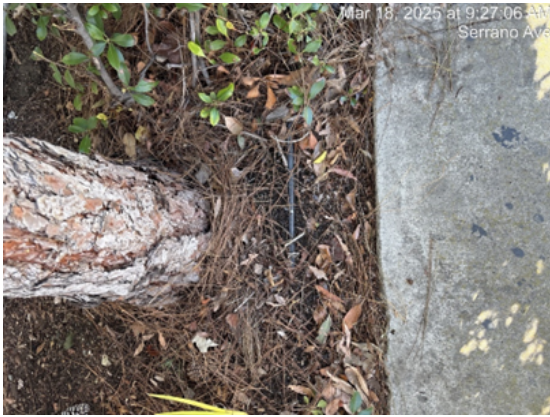
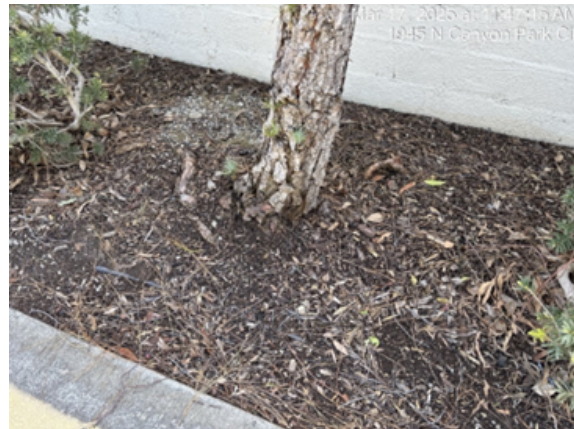
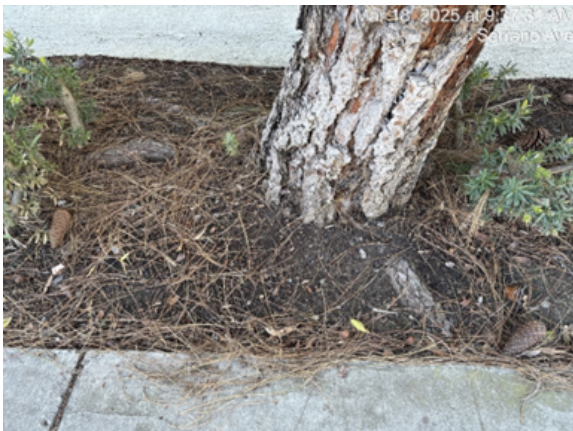
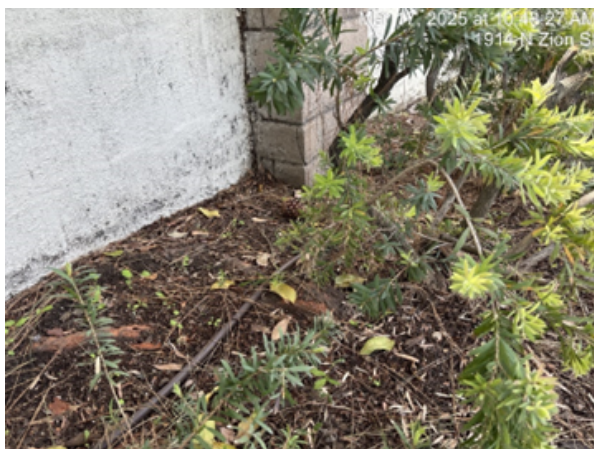
Examples of Surface Roots and Improper Root Barrier Installation

10 locations on Serrano Ave were observed with root barrier. All root barrier appeared improperly installed, with proximity as close as 4" to trunks. Root barrier installed at such close proximity to a trunk undermines the development of the root crown, the natural development of roots, and negativity effects tree health and anchorage.

Exposed surface roots were observed at 5 locations.

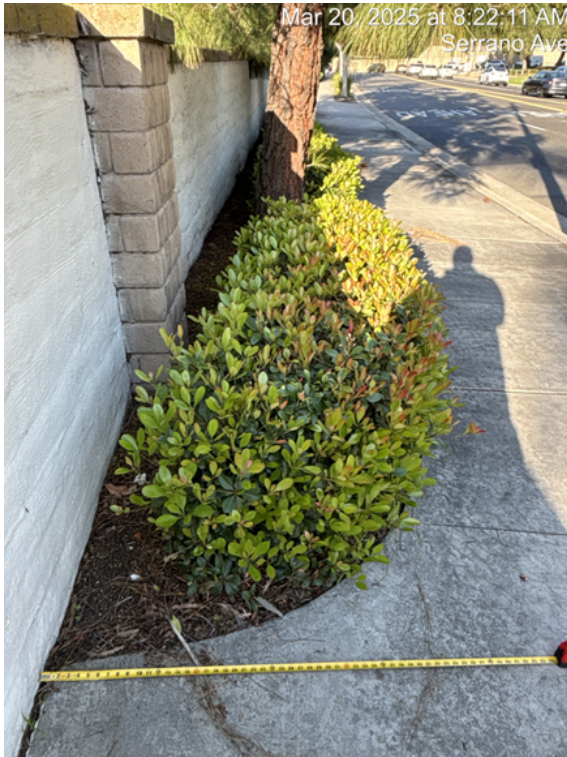
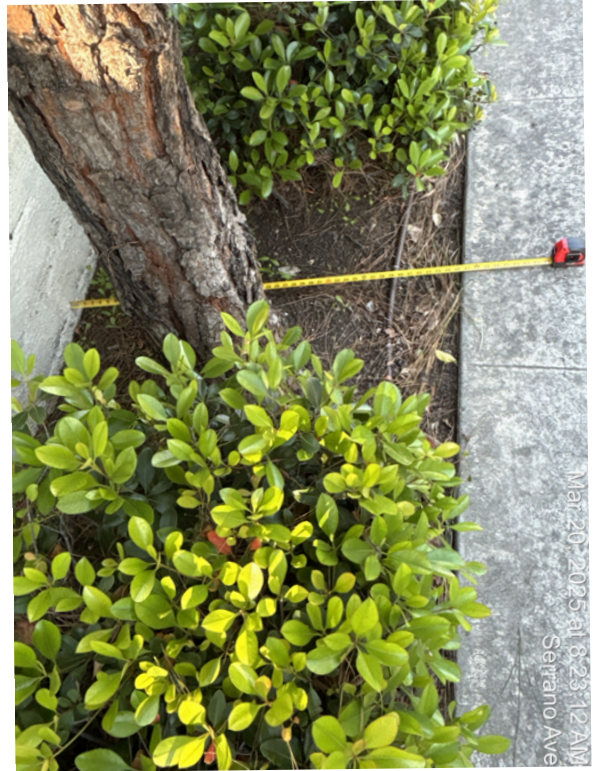
Planter Size

52 trees within the 4' planters do not meet the minimum requirement of an 8' x 8' square, and also do not have adequate soil volume. Trees within the 4' planter are very likely to cause both public and private infrastructure damage. It is very likely that the future replacement of surrounding infrastructure would require the removal of trees.

ABOVE: 52 trees observed to be in 4' wide planters.

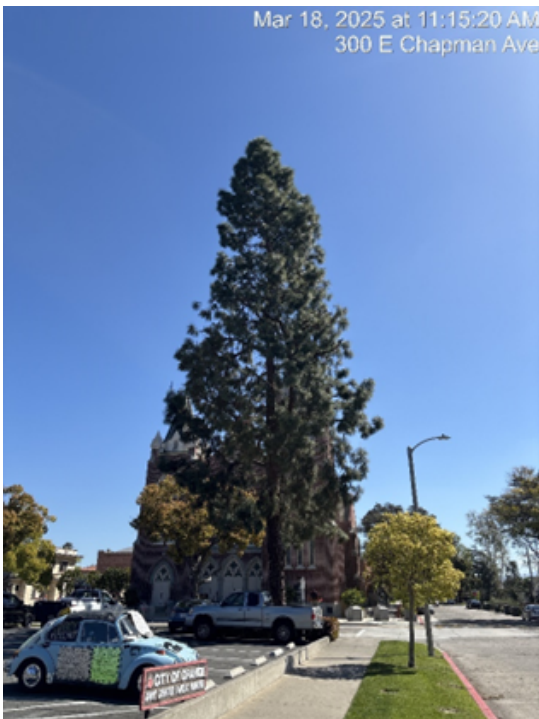
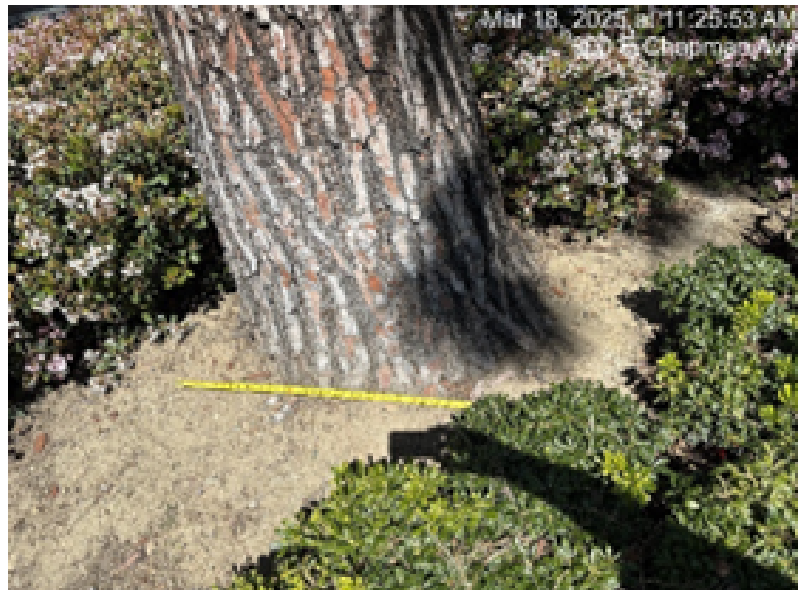
BELOW: Example of mature Canary Island Pine at 300 E Chapman Ave parking lot. Tree measured to be 36" DBH, and approximately 40" at base. Note that the trunk flare and root crown extend further on the far side.

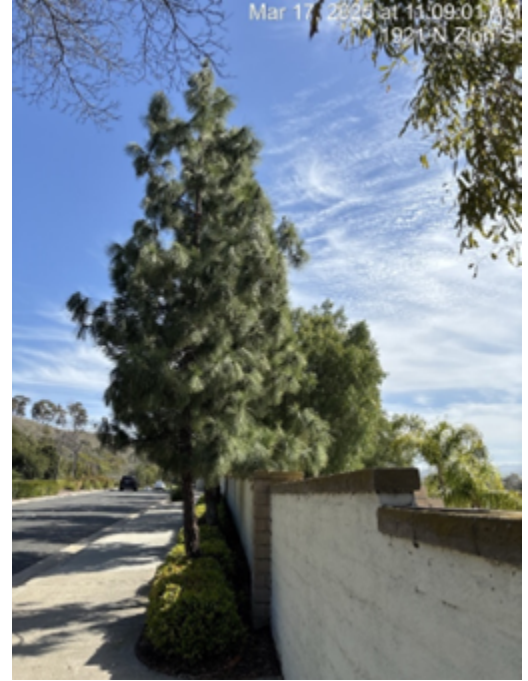
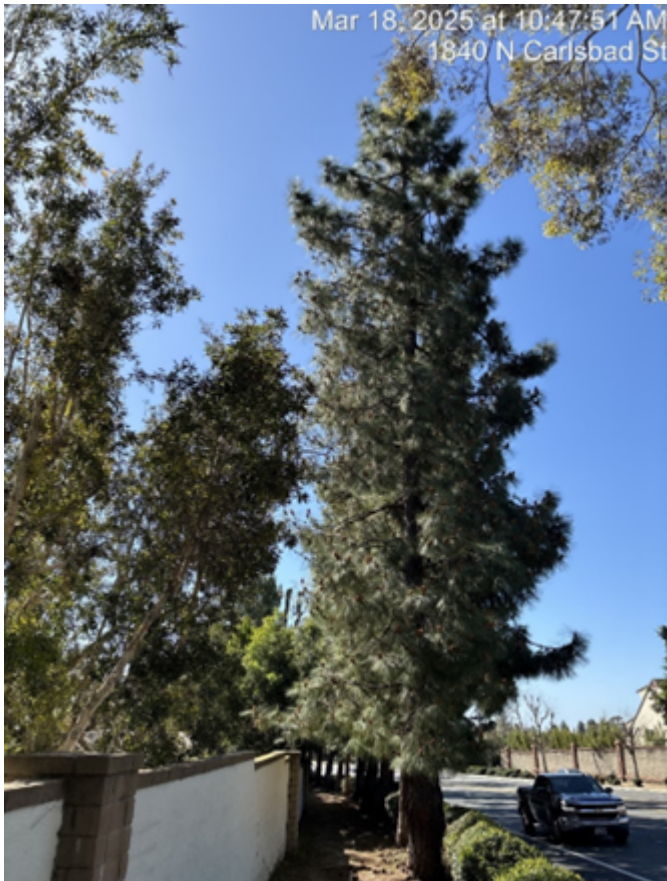
Planter Size, Comparison of Serrano Ave to Cannon St

ABOVE: 52 trees observed to be in 4' wide planters, with trunk proximity to wall from 7" to 26", and proximity to sidewalk from 9" to 28".

LEFT: 22 Canary Island Pine Trees along Cannon, with approximately 7-8' proximity to wall, and approximately 3' proximity to sidewalk.

22/22 Canary Island Pine Trees located on Cannon St are recommended for retention, if adopted as City responsibility.
