March 25, 2025

Suitability of Adopting and Retaining 61 Canary Island Pine Trees along Serrano Blvd, and 22 Canary Island Pine Trees along Cannon St.

Micah Jean – City of Orange Tree Services Coordinator
ISA Board Certified Master Arborist WE-9971BM
ISA Tree Risk Assessment Qualified | ISA Certified Urban Forest Professional

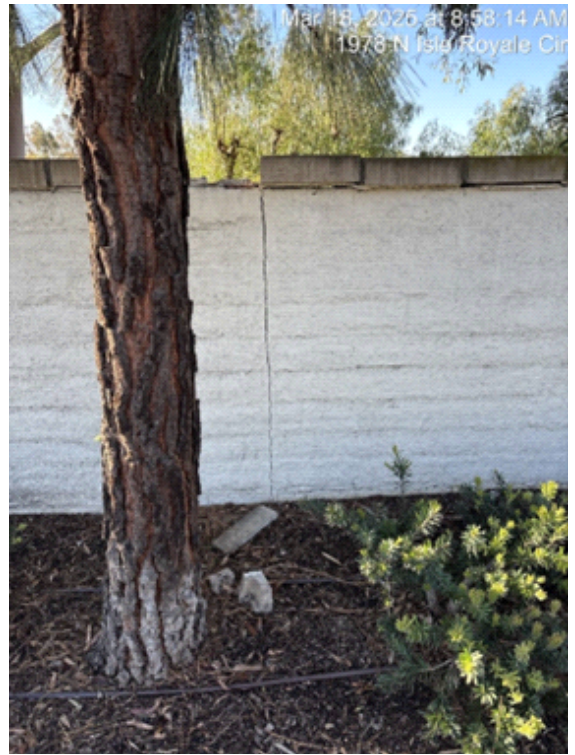
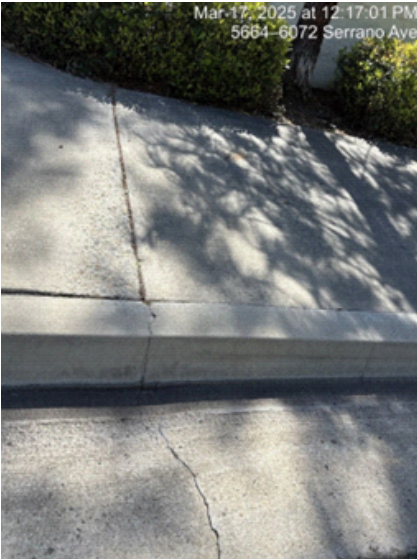
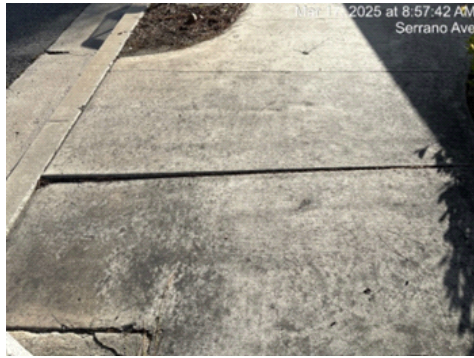
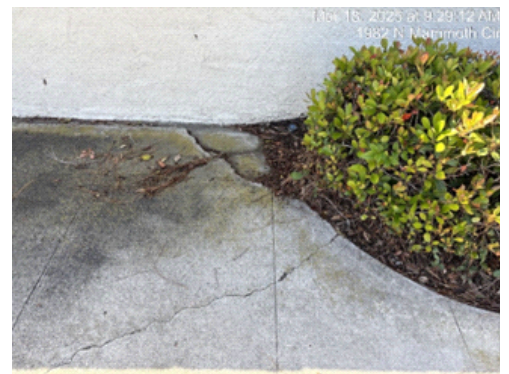
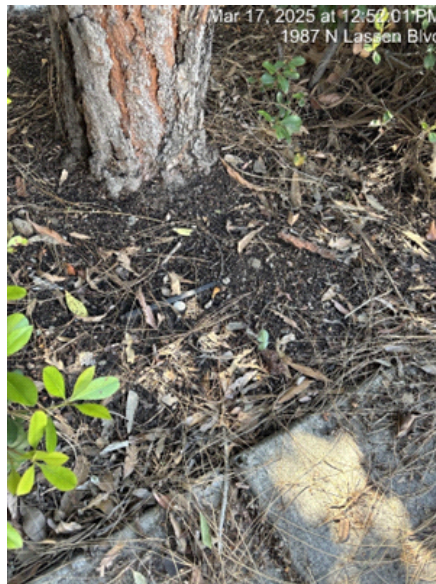
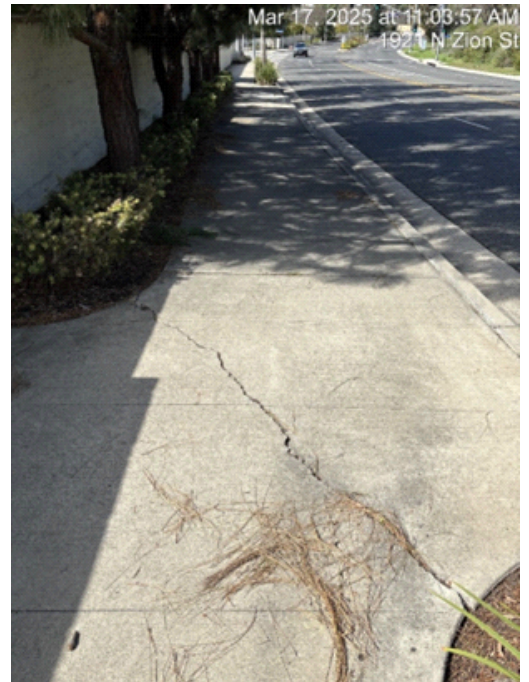
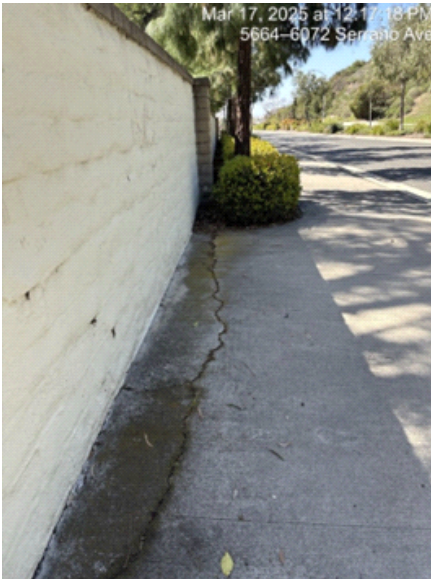
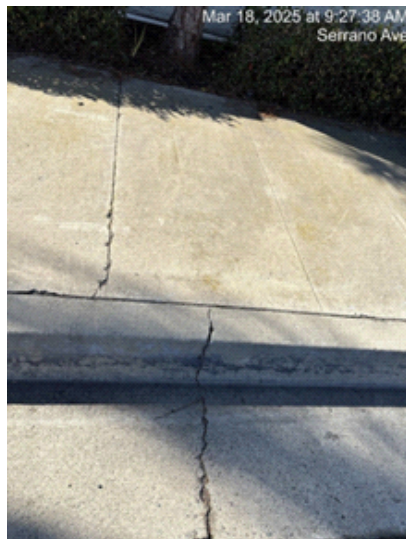
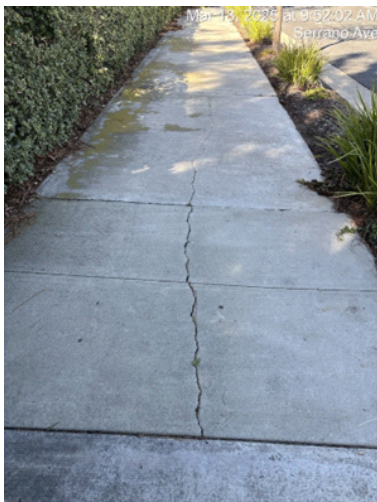
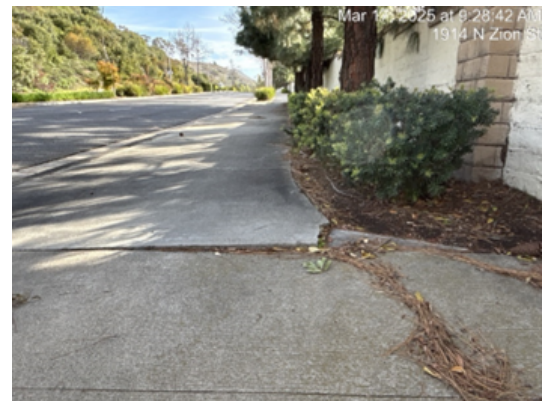
Examples of Current Infrastructure Damage

28 tree locations on Serrano Ave observed to have current damage to adjacent private wall.

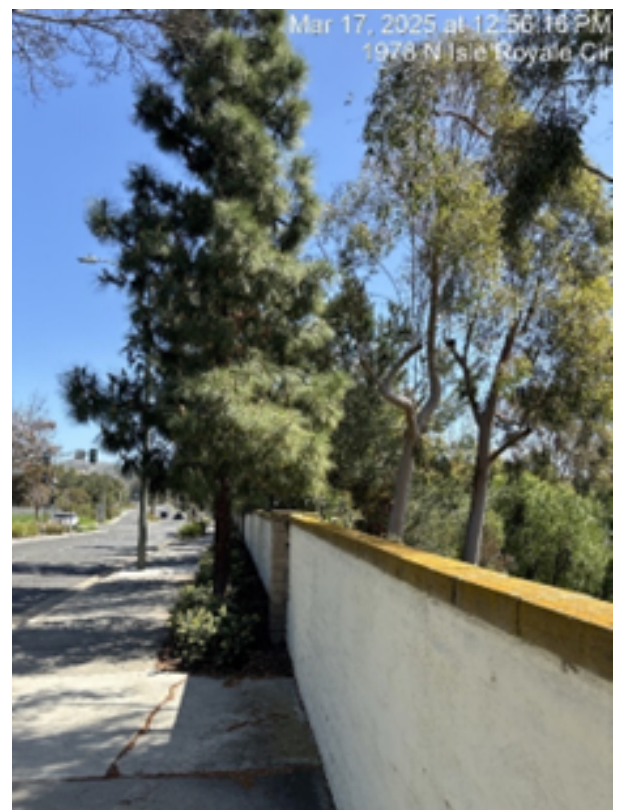
Examples of Current Infrastructure Damage

27 tree locations on Serrano Ave observed to have current damage to adjacent public infrastructure.

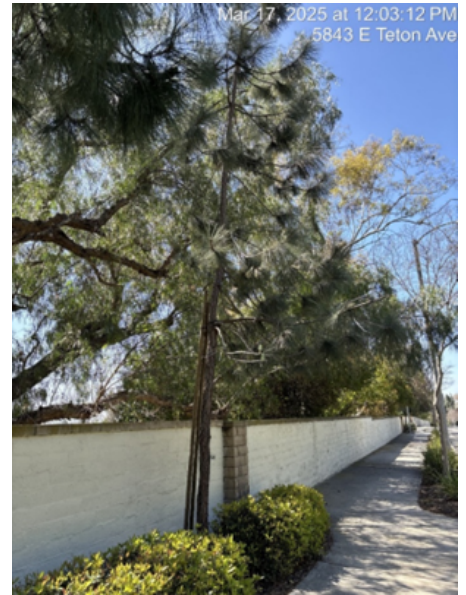
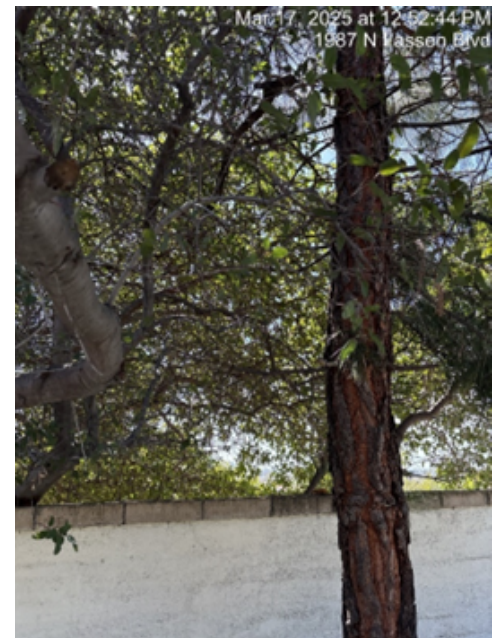
Examples of Current Conflicts with Private Tree Canopies

Competition and close proximity of trees may result in modified growth habit, such as leaning. Inadequate space between trees also increases the likelihood of branch failure, as trees make contact during inclement weather.

22 trees on Serrano Ave were observed to have canopies within 10' of private trees. 11 trees were observed to currently be in contact with private tree canopies.

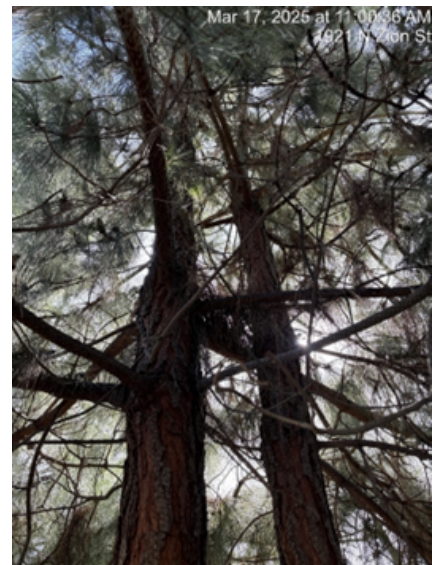
Examples of Observed Defects

Defects in main stem and branch structure were observed in 15 trees on Serrano Ave. 5 trees were observed with severe defects, such as very poor and non-correctable branch structure, previous topping, and multi-trunk.

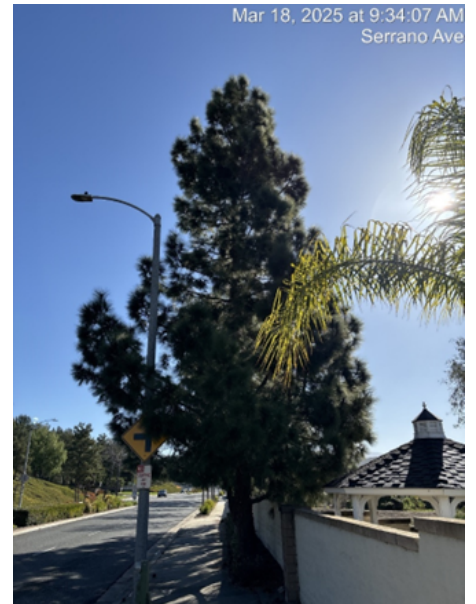
Examples of Potential Utility Conflicts

5 trees on Serrano Ave observed to be planted too close to street light poles, and do not meet the minimum required distance established by the Master Street Tree Plan (1999).

Man-hole covers and Utility vaults were observed in close proximity to some trees. Potential future conflict could involve requirement to repair Utility Infrastructure. Presence of underground installations reduce available soil volume and root space.

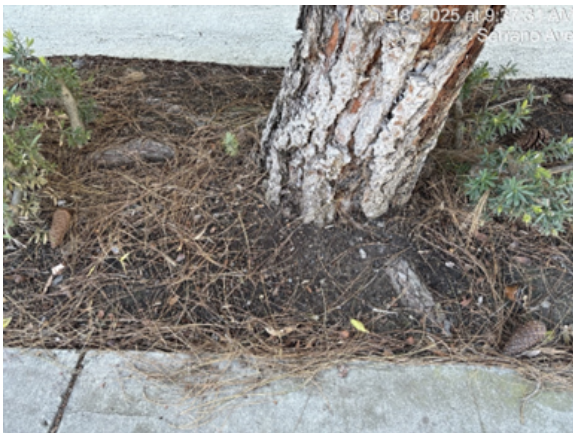
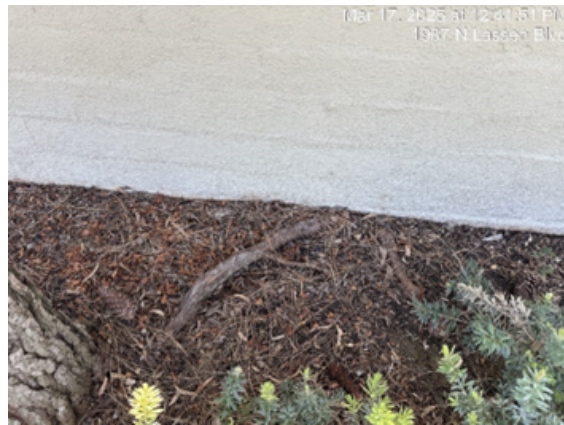
Examples of Surface Roots and Improper Root Barrier Installation

10 locations on Serrano Ave were observed with root barrier. All root barrier appeared improperly installed, with proximity as close as 4" to trunks. Root barrier installed at such close proximity to a trunk undermines the development of the root crown, the natural development of roots, and negativity effects tree health and anchorage.

Exposed surface roots were observed at 5 locations.

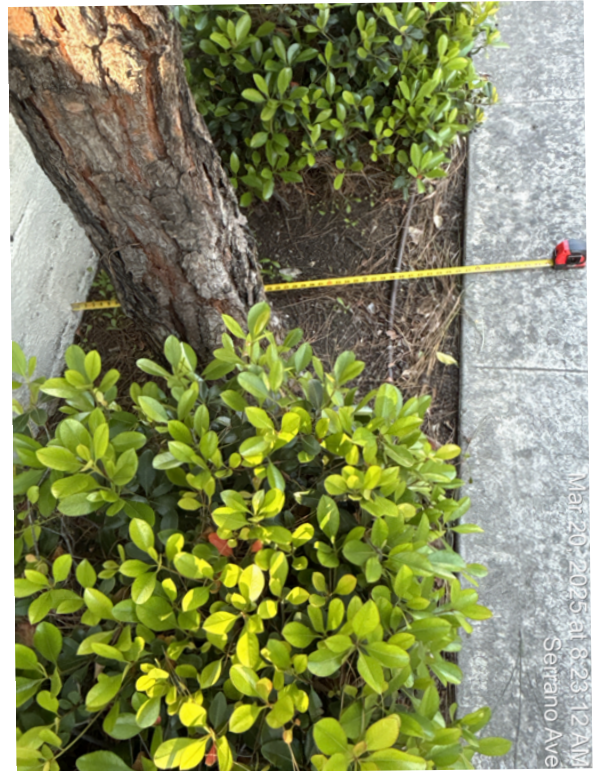
Planter Size

ABOVE: 52 trees observed to be in 4' wide planters.

61/61 Canary Island Pine Trees located on Serrano Ave are recommended for removal, if adopted as City responsibility.

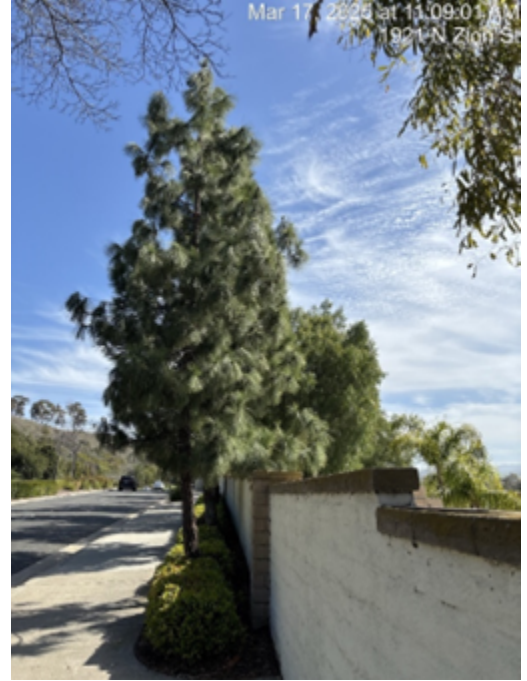
Planter Size, Comparison of Serrano Ave to Cannon St

ABOVE: 52 trees observed to be in 4' wide planters, with trunk proximity to wall from 7" to 26", and proximity to sidewalk from 9" to 28".

LEFT: 22 Canary Island Pine Trees along Cannon, with approximately 7-8' proximity to wall, and approximately 3' proximity to sidewalk.
