## MEMORANDUM

DATE	February 26, 2026	PROJECT #	25305
TO	Kevin Purvis	PROJECT	Historic Resource Assessment for 220 S. Orange Street, Orange, CA
OF	220 S Orange Street, Orange, CA	FROM	Amanda Commins, Page & Turnbull Flora Chou, Page & Turnbull
CC	Doug Ely, Architect, DSEA	VIA	Email

REGARDING **220 S. Orange Street Proposed Project Analysis: Demo & New Garage | Revised**

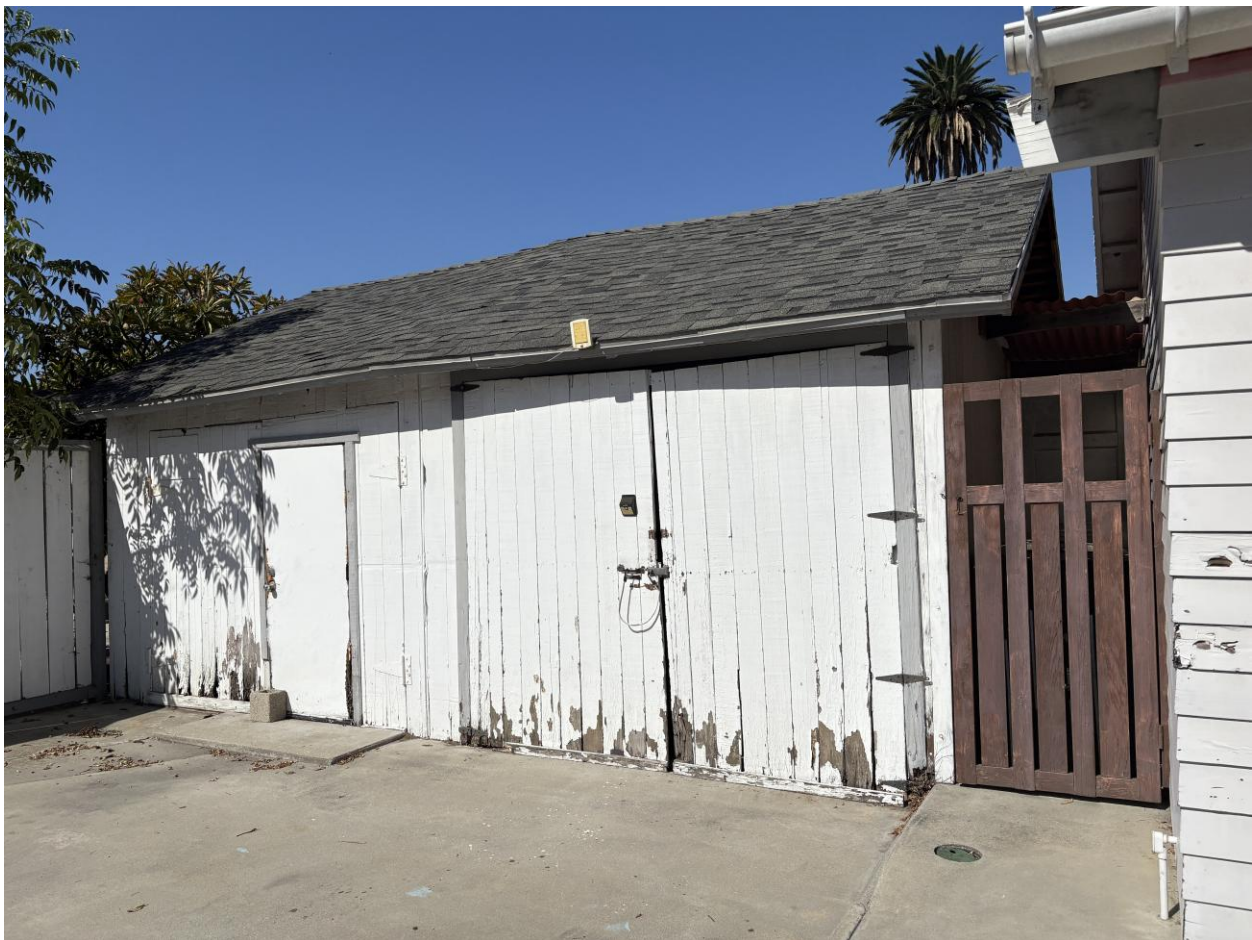
Figure 6. East façade of the garage, view southwest.

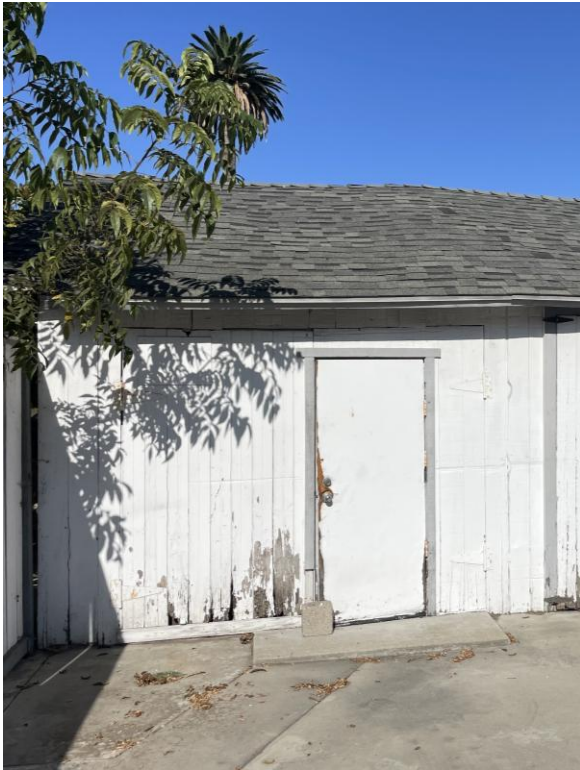
The existing detached garage is located at the northwest corner of the parcel and is accessed by a shared driveway along the north property line. The one-story building has a rectangular footprint and a side gable roof clad in asphalt shingles. The garage is modest in design, and lacks Craftsman-style features or details of any other style. In contrast to the main residence's horizontal siding, the garage's exterior walls are clad in vertical wood siding of different types and dimensions. The primary (east) façade faces the driveway and contains two bays (**Figure 6**). The north bay has a pair of vertical wood board doors surrounded by wood trim. The south bay also has a pair of vertical wood board doors, with different dimensions than the north doors, in an opening that is smaller than the north bay and does not have wood trim around the door opening. One door leaf has been modified to add a single entry door. Exterior wall cladding at the north façade, visible above and around the south bay opening, appears to be wide vertical boards that are flush to each other (**Figure 7**).

Figure 7. Detail view of primary (east) façade of garage with flush vertical boards as the siding around the garage opening, view west.

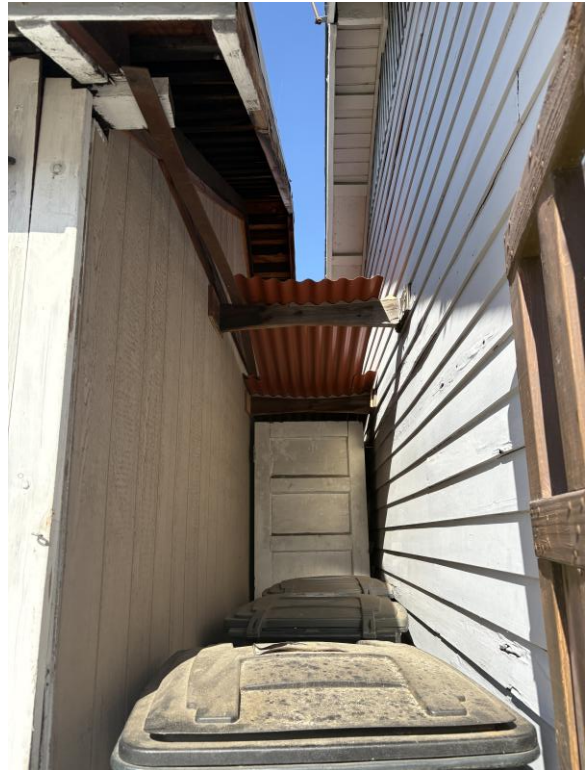
Figure 8. North façade of garage (left) that was constructed in 1996 after the neighboring garage was demolished, view west. The replacement neighboring garage is at right.

The north exterior wall of the garage was constructed in 1996 to enclose the building, once the adjacent garage at the neighboring property was demolished. The north wall is clad in flush vertical wood boards (identified as T-111 grooved siding sheets) and the façade has no openings (**Figure 8**). The south façade is concealed behind plantings and partially visible. It appears to be clad in vertical wood siding, where the vertical members are more narrow than those found at the other façades and have channels between the vertical members (**Figure 9**).

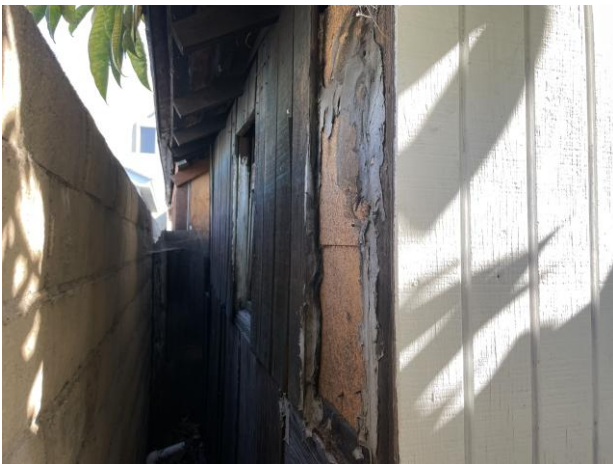
Figure 9. Rear (west) façade (left) and south façade (foreground) of the garage showing different cladding, view north. Note the expansion to enclose the eave at the north bay visible in the background.

The only other section of original exterior flush vertical wood boards that remains is at the south half of the rear (west) façade (**Figure 9**). The south façade has vertical wood siding with narrow vertical members and channels, which does not match siding at any other façade. With the exception of the 1996 north exterior wall, no records have been found to indicate when materials at the primary (east), rear (west), or south façades were changed. However, the cumulative effect is that the garage retains very little exterior materials from its original construction, and as such, it has lost integrity of materials.

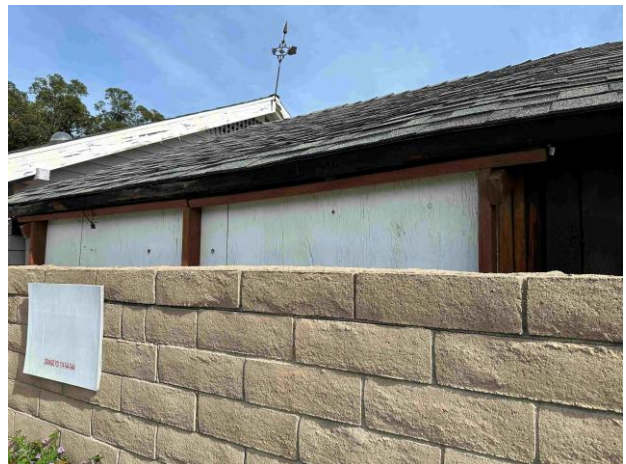
Figure 10. The north end of the garage's rear (west) façade of the garage, which is enclosed under the roof eave, view northeast. Source: DSEA, Inc., January 2026.

The rear (west) façade is also partially visible, as it is close to the concrete block wall at the rear property line. It appears to be divided into two bays as well. The south bay features wide vertical boards cladding that are flush to each other and one window opening with the sash removed (**Figure 9**). Exposed rafter tails at the slightly overhanging roof are visible here, but not seen elsewhere on the building. At the north bay, the original exterior wall appears to have been removed to expand the building under the roof eave, at an unknown date. Newer framing members, infilled with wide wood boards, comprise the exterior wall at the north bay (**Figure 10**).

The garage does not retain integrity of materials. Roofing materials have been replaced, and the north exterior wall dates to 1996. The north half of the rear (west) façade is also a newer wall (**Figure 10**). In addition, the primary (east) façade appears to retain only a small area of original flush vertical wood boards, with much of the façade comprised of the two garage doors. It is assumed that at least one pair of the doors is not original, as the two doors do not match in size, proportion, or detailing.

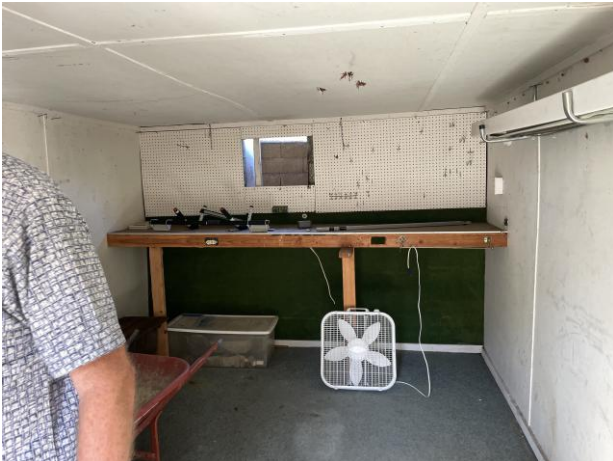
Figure 11. Interior of the south garage bay, view west.

The interior of the south bay has been modified with finished walls and ceiling panels (**Figure 11**). The north bay interior retains exposed framing and roof decking, where the non-original rear (west) and north walls are visible (**Figure 12**).

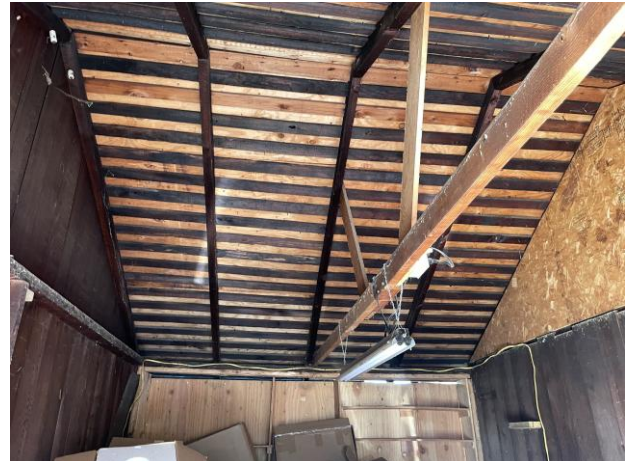
Figure 12. Interior of the north garage bay, view west. Non-original wood cladding seen at the west (center) and north walls (right)

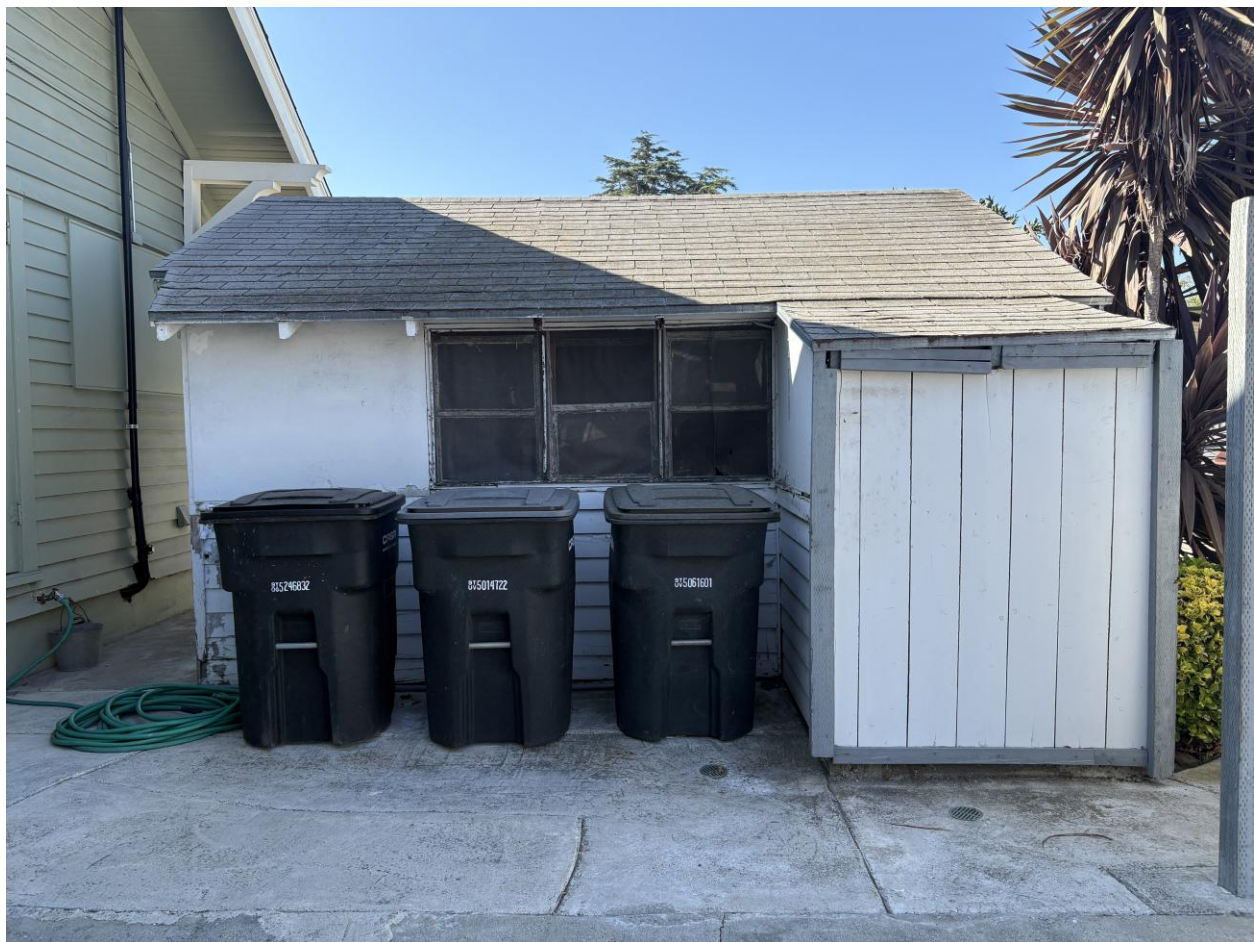
Figure 13. North façade of ancillary building, view south.

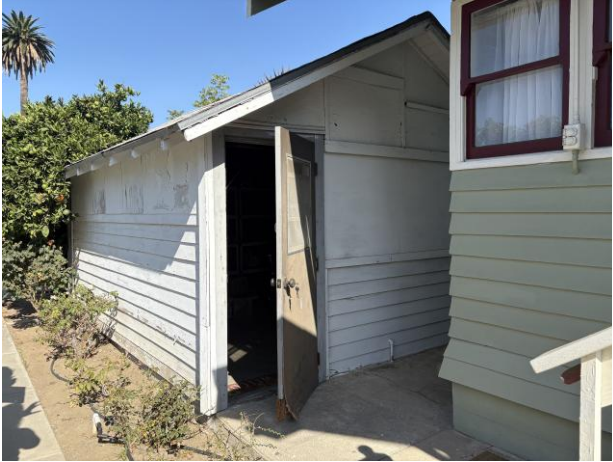
Figure 14. East façade (foreground) and south façade (left) of ancillary building, view northwest

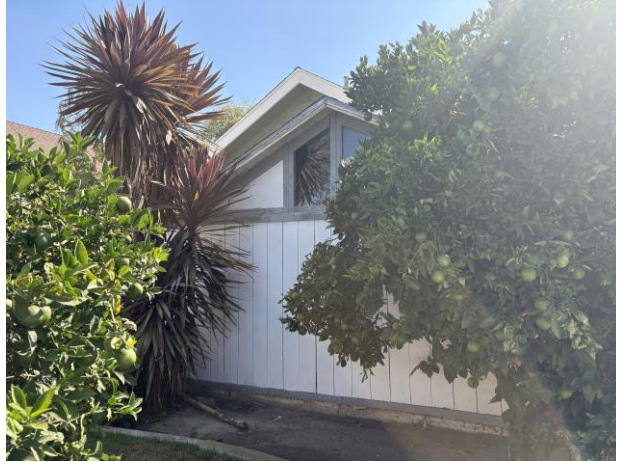
Figure 15. West façade of ancillary building, view northeast.

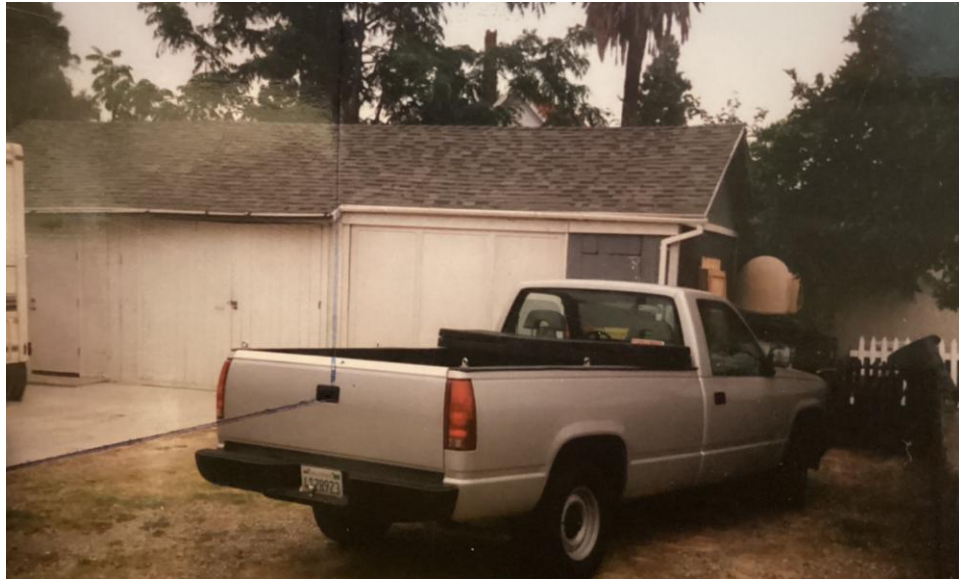
As seen on the Sanborn maps, the original design of the property included a shared driveway with an auto garage on the subject property next to a smaller garage on the neighboring property at the shared property line. The two garages shared a wall at the property line, and visually appeared to be one building (**Figure 22**). The smaller (one bay) garage on the neighboring property at 212 S. Orange Street was demolished in 1996, according to City of Orange building permits (**Figure 23**). A new garage was subsequently constructed on the neighboring property with a larger footprint and massing. As a result of the 1996 demolition, new exterior cladding was added to enclose the wall that had been previously shared with the neighbor's garage and to create the new north façade of the remaining two-bay garage at 220 S. Orange. Part of the roof of the neighboring garage was also retained and became the overhanging eave at the new north façade.

Figure 22. Image showing configuration of the existing two-bay garage at the subject property (220 S. Orange) at left and the smaller, one-bay garage at the neighboring property (212 S. Orange) at right, prior to the 1996 demolition of the neighboring garage. Source: Kevin Purvis, subject property owner. Edited by Page & Turnbull.

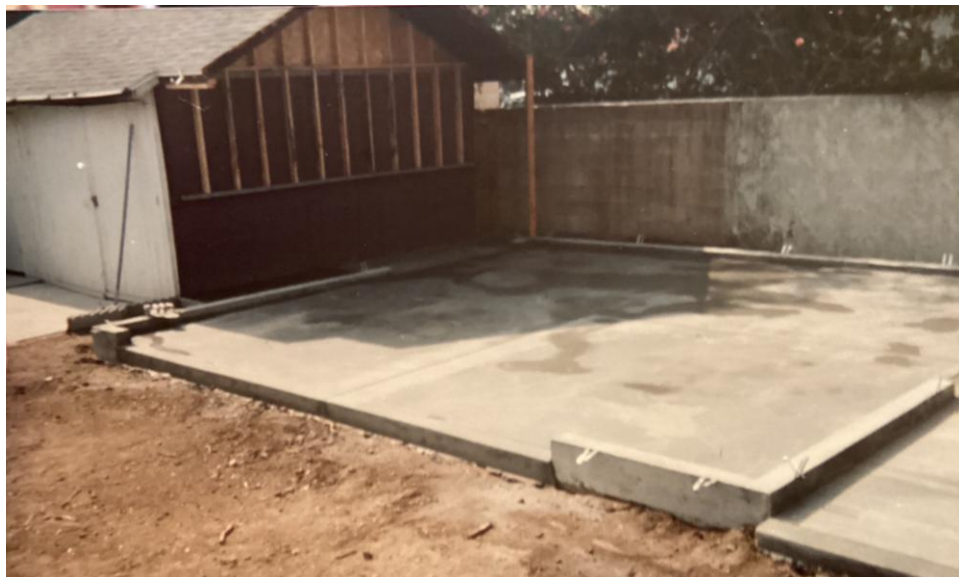
Figure 23. Image showing remaining two-bay garage at 220 S. Orange (left) with exposed framing, circa 1996. Source: Kevin Purvis, subject property owner. Edited by Page & Turnbull.
