CULTURAL RESOURCES ASSESSMENT

OLD TOWNE GATEWAY PROJECT

ASSESSOR'S PARCEL NUMBERS 039-171-12 AND 039-171-03

CITY OF ORANGE

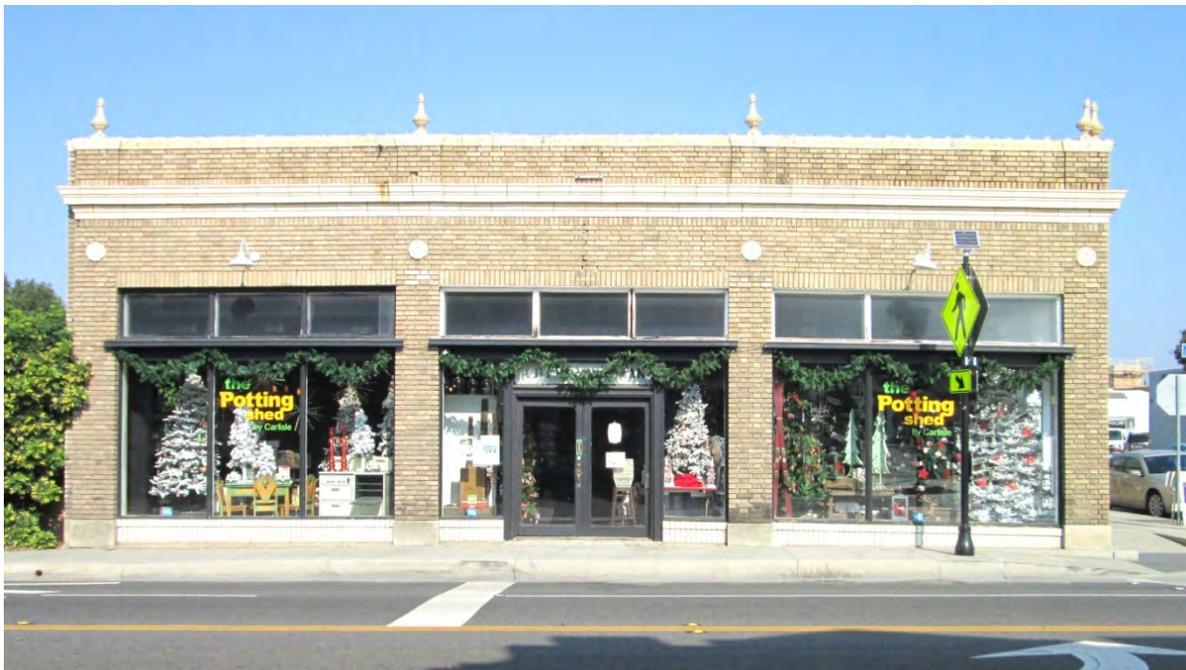
Figure 11: 401 West Chapman Avenue, façade/south elevation. View to the north (11/20/18).

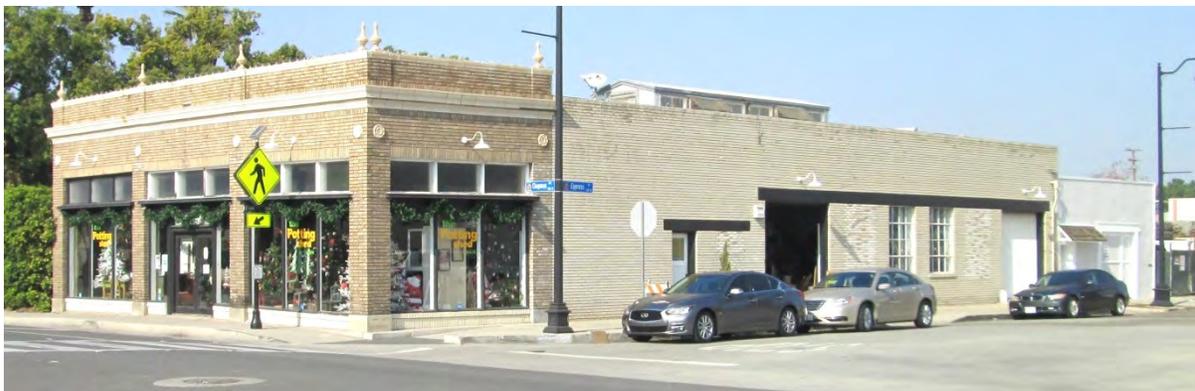
Figure 12: 401 West Chapman Avenue, façade and east elevation. View to the northwest (11/20/18).

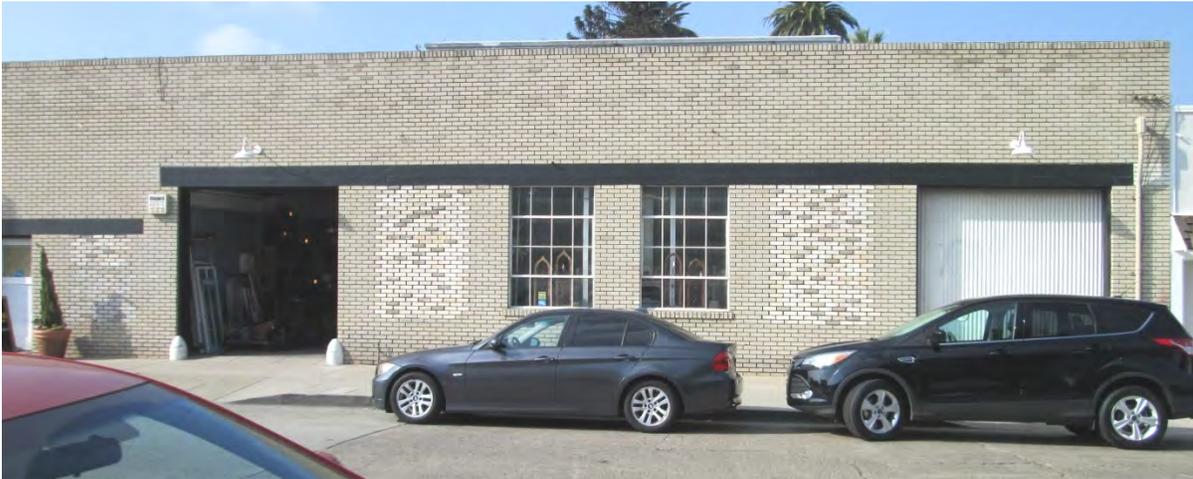
Figure 13: 401 West Chapman Avenue, east elevation detail. View to the west showing filled in windows (11/20/18).

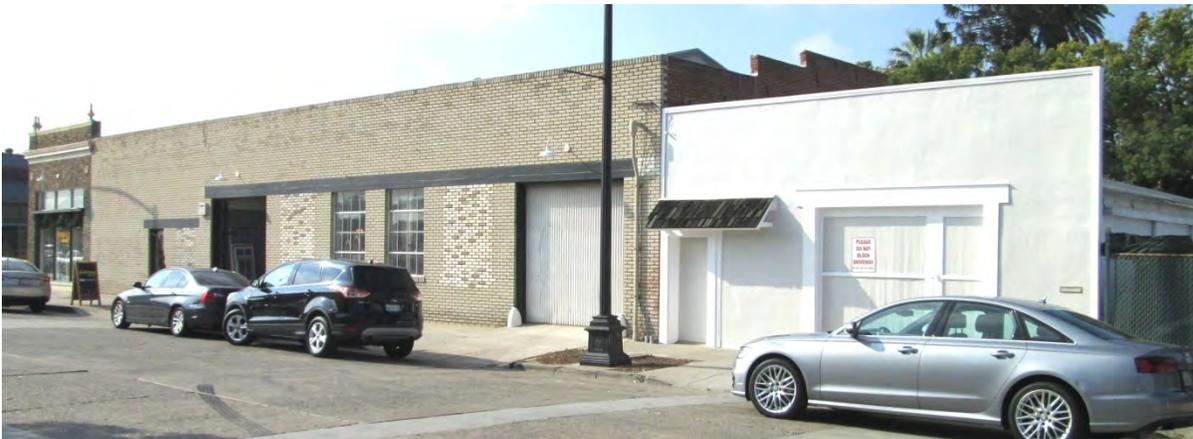
Figure 14: 401 West Chapman Avenue, east elevation, including circa 1940 addition. View to the southwest (11/20/18).

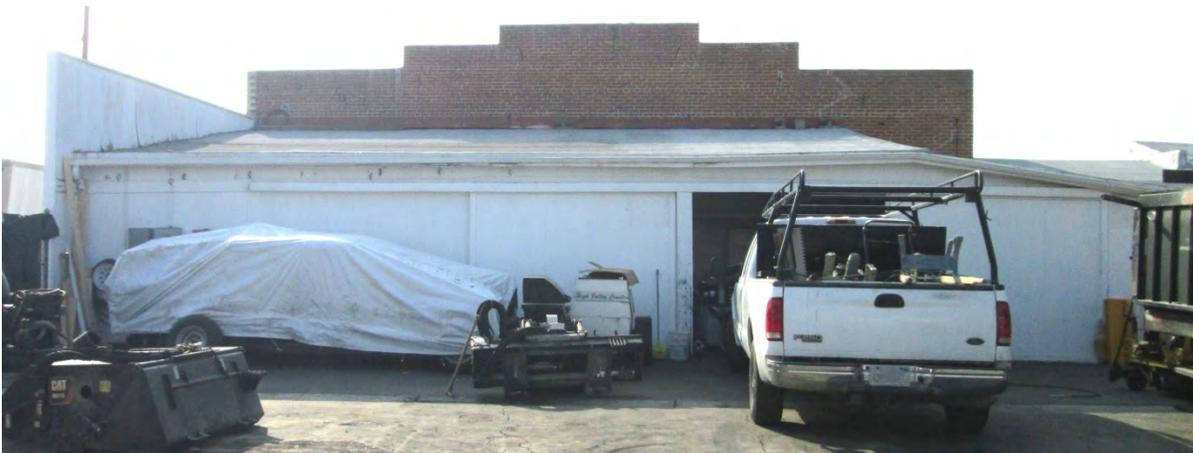
Figure 15: 401 West Chapman Avenue, rear (north) elevation. View to the south showing the circa 1940 addition (11/20/18).

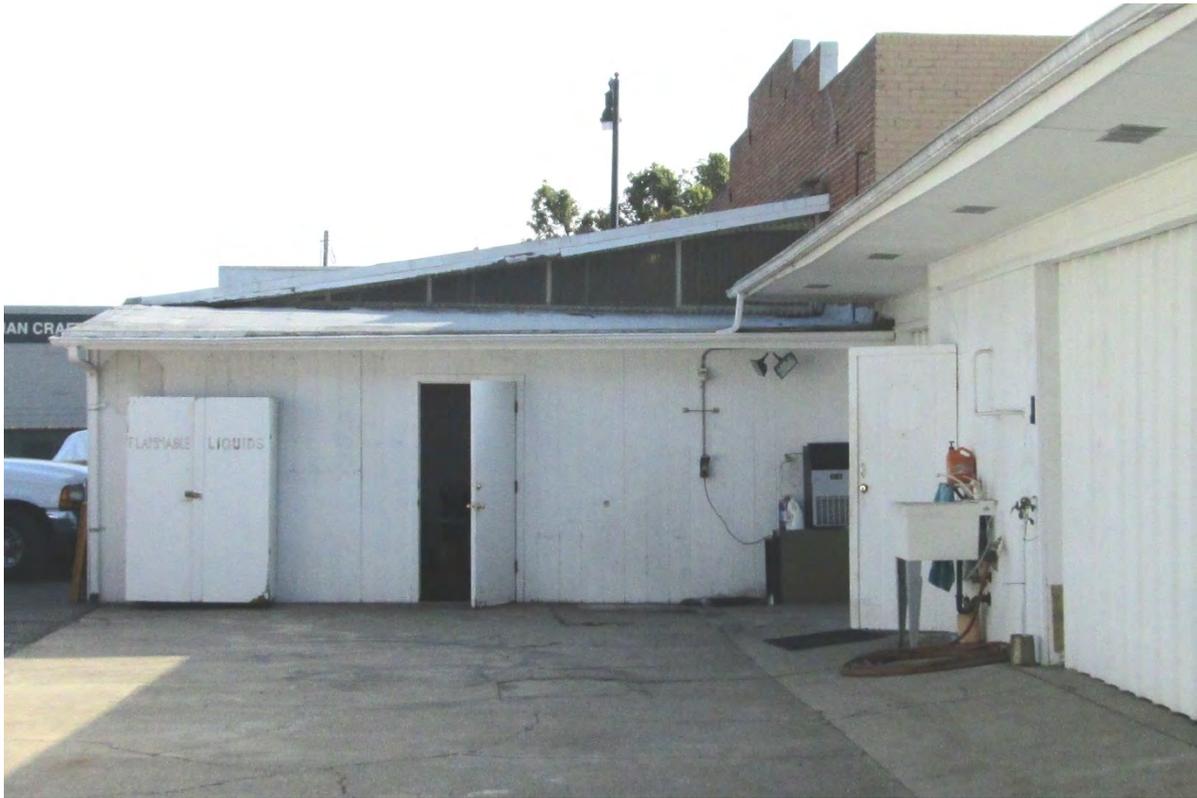
Figure 16: 401 West Chapman Avenue, west elevation and partial north elevation. View to the east (11/20/18).

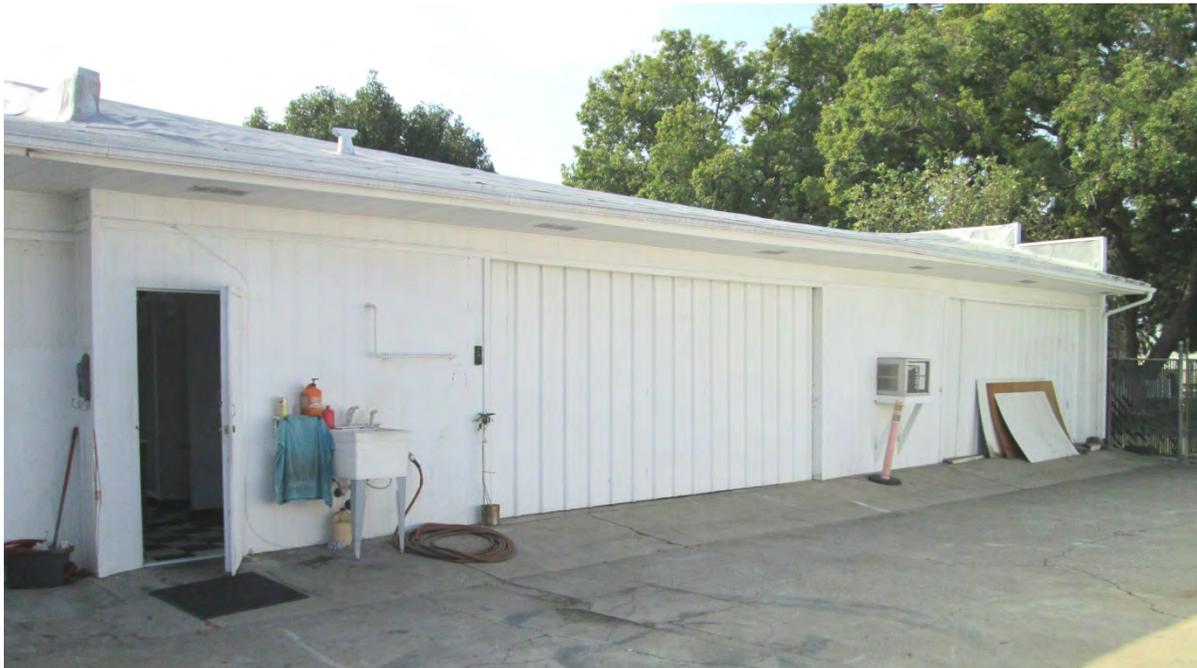
Figure 17: 403 West Chapman Avenue, north elevation. View to the southwest (11/20/18).

As previously noted, there are two additions that form an L-shape on the west side of the original building (Figures 19 through 22). The older and larger addition (1938–1947) extends west to Atchison

Street and is addressed as 403 West Chapman Avenue. It is wood-framed, rectangular in plan, and surmounted by a low-pitched, gable roof with a parapet and sheathed with composition sheets. The north elevation of this addition has non-original manufactured wood siding, a pedestrian door, and two large garage doors. The west elevation of this addition has a stepped parapet and is covered with stucco. The south elevation, which is also covered with stucco, has modern aluminum-framed sliding windows and modern French doors. This addition connects to a newer (1947–1950) and smaller wood-framed addition that is open on the south side and connects to the original building.

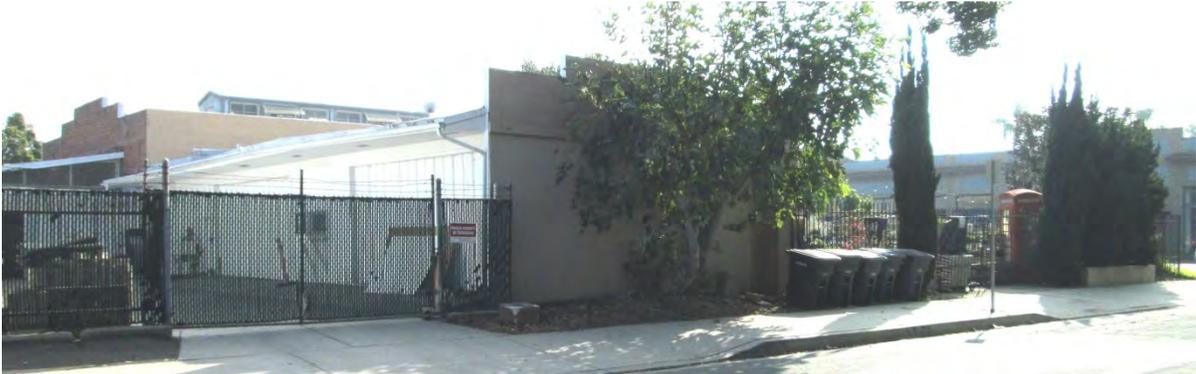
Figure 18: 403 West Chapman Avenue, north and west elevations. View to the southeast (11/20/18).

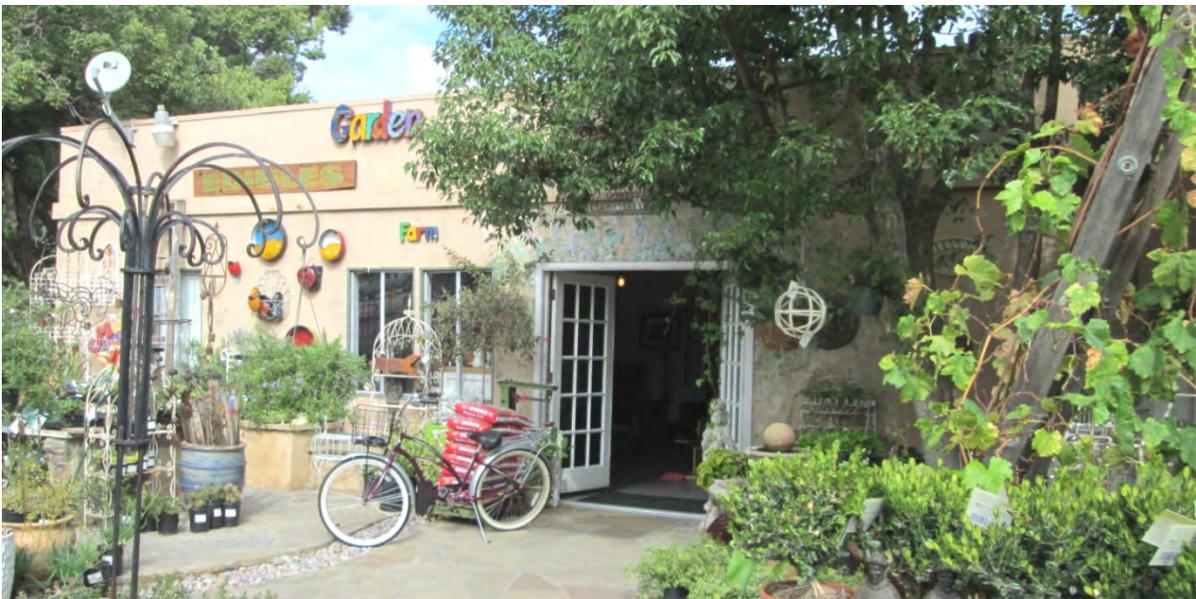
Figure 19: 403 West Chapman Avenue, south elevation. View to the northwest showing alterations (windows and doors) to this addition (10/31/17).

All of the additions to the original dealership building are in fair to good condition, but all have sustained alterations. They are utilitarian structures that do not exhibit any particular architectural style or character.

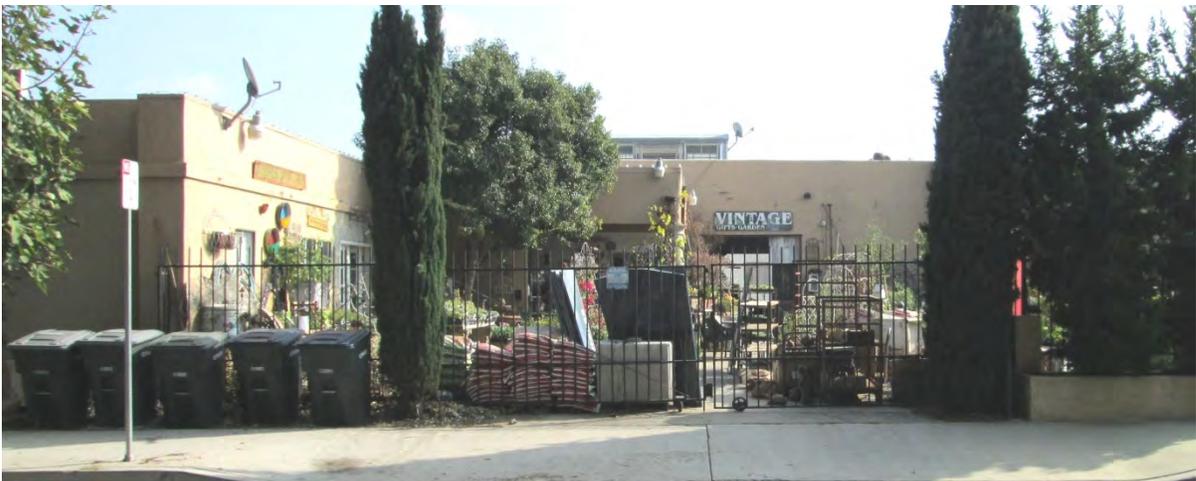
Figure 20: 401–403 West Chapman Avenue, west and south elevations. View to the east (11/20/18).

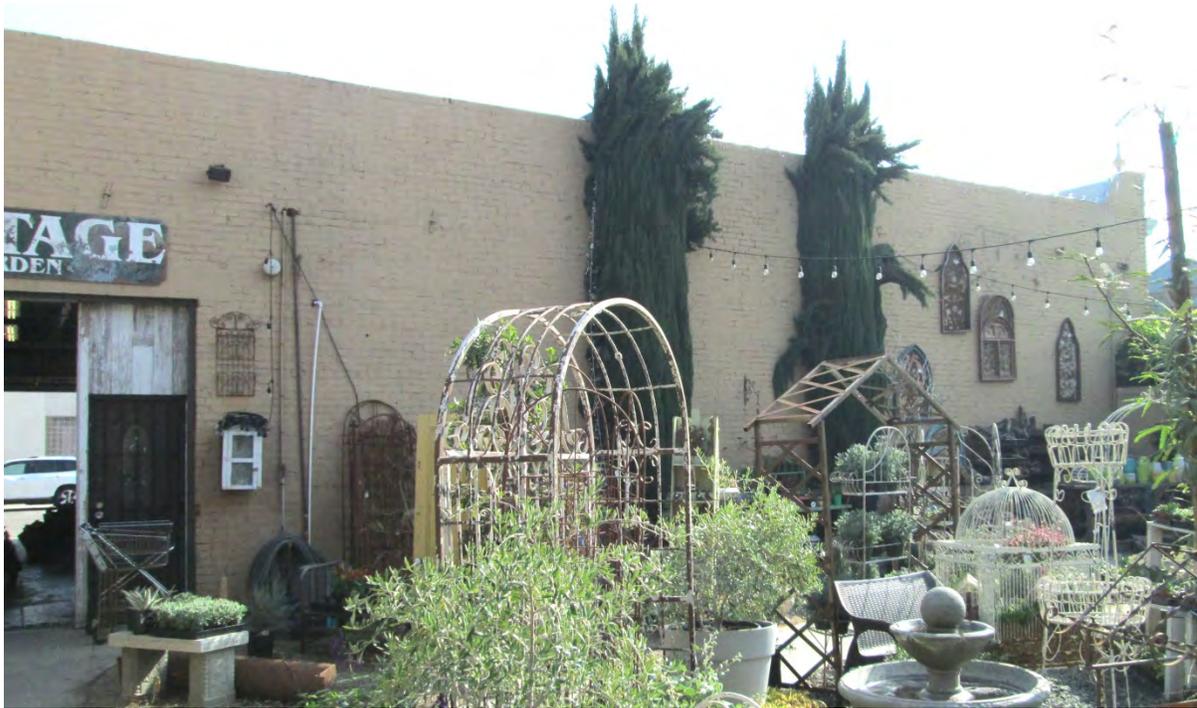
Figure 21: 401 West Chapman Avenue, portion of west elevation. View to the southeast (11/20/18).

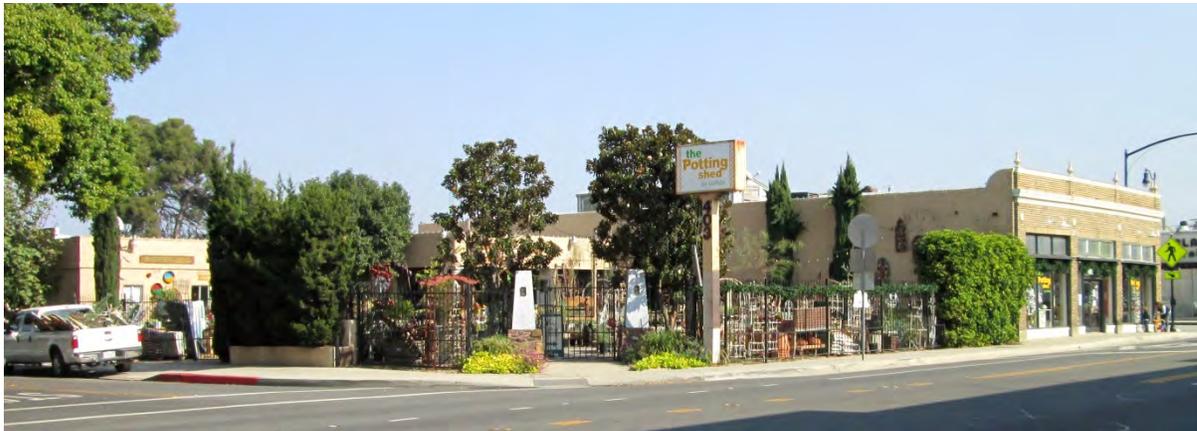
Figure 22: 401-403 West Chapman Avenue, overview of west and south elevations. View to the northeast (11/20/18).

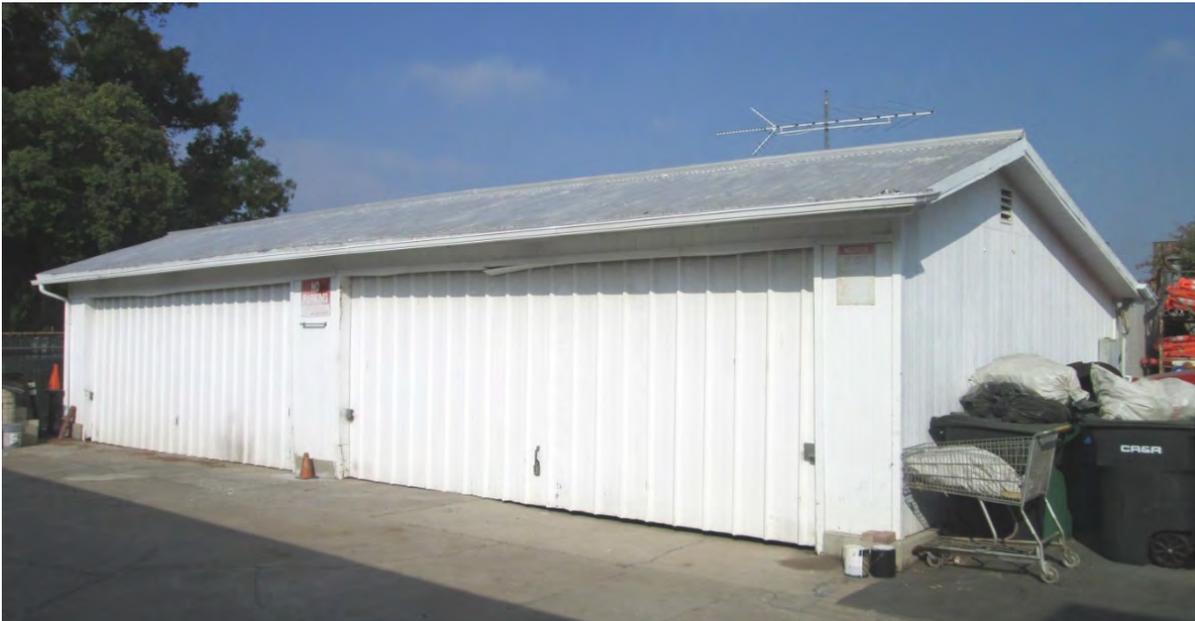
Figure 24: 107 North Atchison Street, south and east elevations. View to the northwest (11/20/18).

This vernacular free-standing garage is adjacent to North Atchison Street (Figures 23 and 24). It is rectangular in plan and surmounted by a catslide gable roof sheathed with corrugated metal. It has narrow eaves and the exterior walls are clad with non-original manufactured wood siding. Aside from small attic vents, there are no openings on the east or west sides. The south elevation has two large garage doors. The north elevation was obscured from view. The building is in good condition, but the non-original wood siding has compromised its integrity.

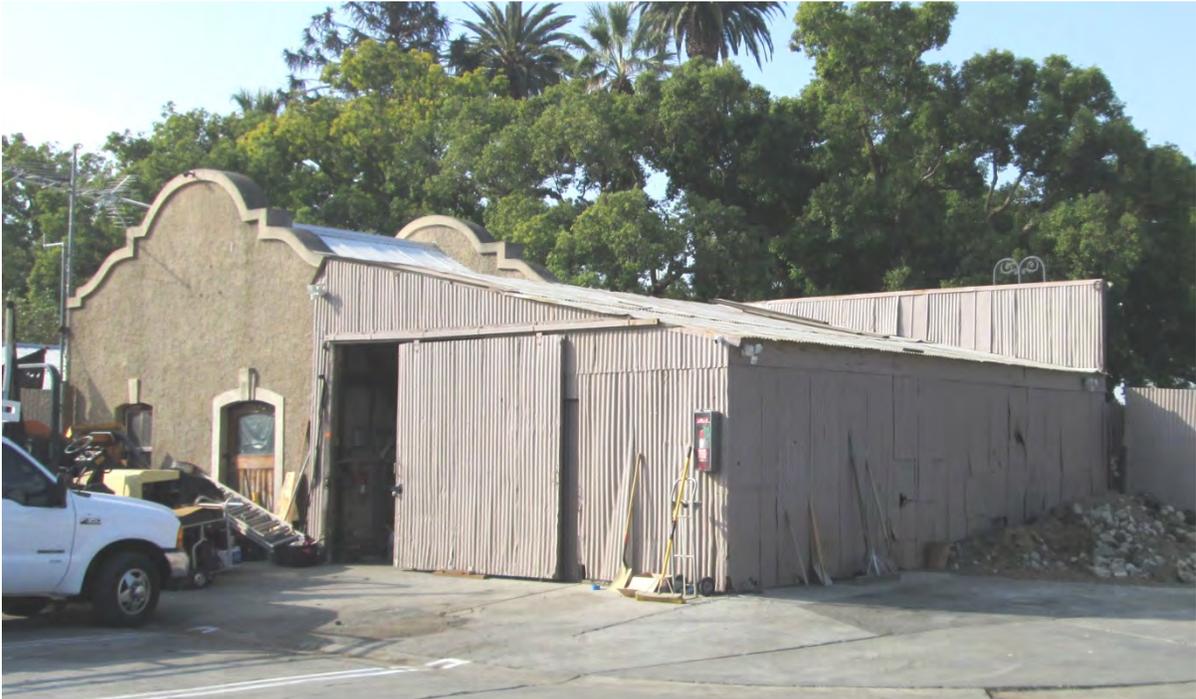
Figure 26: 135 North Atchison Street, east and north elevations. View to the southwest (11/20/18).

exterior walls are covered with stucco. The east elevation has a wood-framed, four-paned double-hung window and a wood and glass door, both of which appear to be original. The door and the window are each recessed in segmental arched openings accented with concrete “keystones.” The door also has wide concrete trim. The north and south elevations of the Mission Revival style building have windows identical to the one in the east elevation (the north one is visible from inside the metal addition). The visible parts of the building are in good condition and retain a high degree of integrity.

The L-shaped corrugated metal addition wraps around the west and north sides of the Mission Revival style building completely obscuring these elevations of the original building and compromising the building’s integrity. The addition appears to consist of two buildings, both with gable roofs with parapets sheathed with corrugated metal. There are openings on the south, west, and east sides. The addition is in poor condition and, judging from the patchwork of metal panels, has sustained various alterations. Based on what is visible within the addition and through the windows, it is possible that, if revealed, the original elevations may retain at least a moderate degree of integrity.

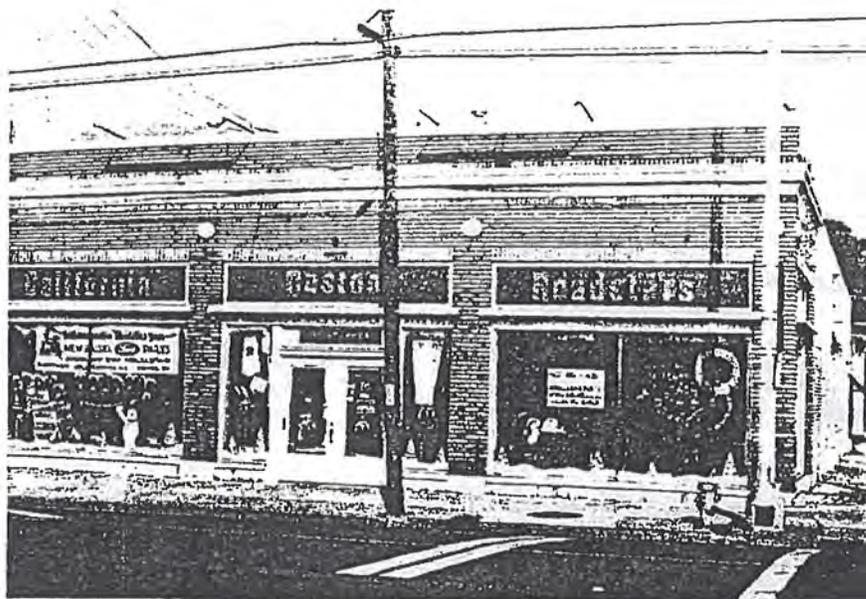
(1168) 401 West Chapman Year Built: circa 1920 Style: Brick Commercial

Distinguishing Features: This is a single-story building of brick and originally and still used for commercial purposes. As typical with the commercial buildings of this era, the lower portion of the store front is devoted almost exclusively to showcase windows. The double door entry features wood doors with a single plate glass window and transom window above. Transom windows were located across all of the windows on the lower portion of the building, but signs have since been placed in these transoms. Horizontal banding distinguishes the cornice.
