State of California - The Resources Agency  
DEPARTMENT OF PARKS AND RECREATION  
PRIMARY RECORD

CLARK\_S\_133\_\_APN\_390-672-06

Orange County Assessor Records (2005). Chattel Architecture (2005)  
Historic Resources Survey. AEGIS (1991) Historic Building Inventory  
Update. Heritage Orange County, Inc. (1982) Orange Historic Survey.

\*B5. Architectural Style: Hip Roof Cottage

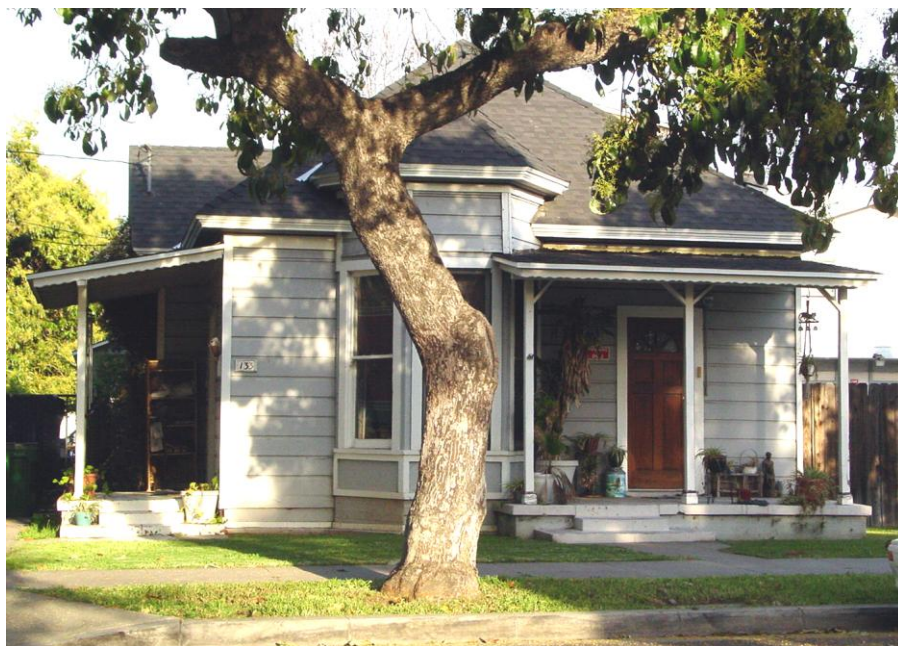
P5b. Description of Photo:

Box plan with pyramid roof. Front portion of roof extends to form porch overhang and is supported by wood posts. Angled bay window on front facade rises up through main roof and is topped by a conical roof itself. Windows are high, vertical, double-hung windows. Some modifications have been made to the house, including addition of dormer on side, new siding, and lattice work connecting porch posts.

Some modifications have been made to the house, including addition of dormer on side, new siding, and lattice work connecting porch posts. Since the 1982 survey, this structure has been altered with appropriate removal of inappropriate siding and lattice work.

Structural Integrity: Fair Condition - Minor and reversible or appropriate changes to original structure.

Site Integrity: Accessory structure or major addition and other inappropriate changes that compromises the scale or association with the site.
