State of California - The Resources Agency
DEPARTMENT OF PARKS AND RECREATION
PRIMARY RECORD

ATCHISON_N_107__APN_039-171-12

Orange County Assessor Records (2005). Chattel Architecture (2005)
Historic Resources Survey.

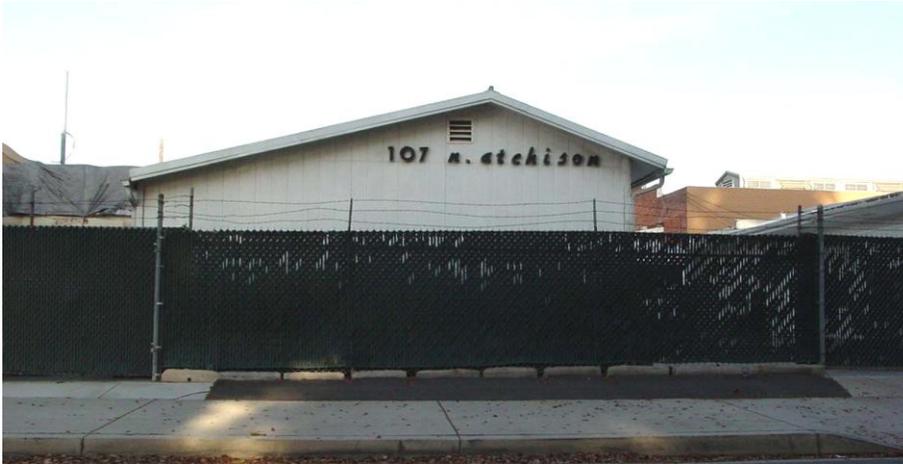
P5b. Description of Photo: 2005
(View, date, accession #)

Materials: Frame - Wood siding

At this site and prior to this building, City directories listed the Park Hotel at 117 N. Atchison in 1925. As of 1930, the hotel had been demolished.

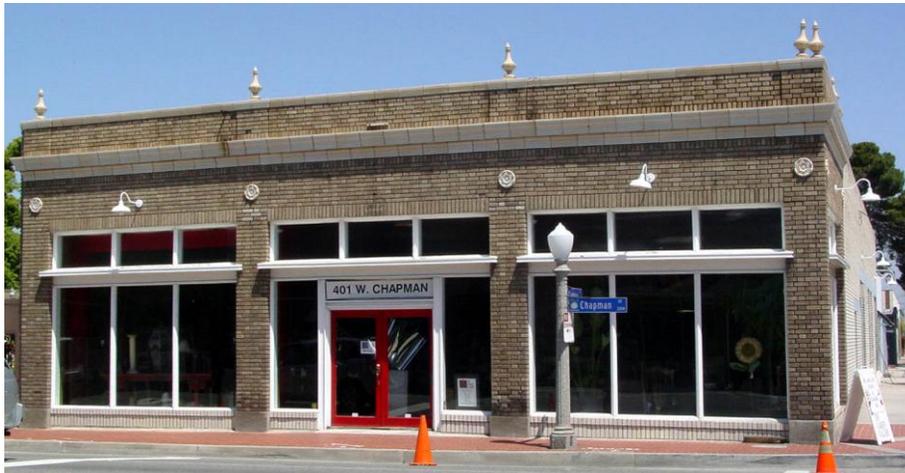
P5b. Description of Photo: 2005
(View, date, accession #)

Materials: Masonry - Brick

Brick Commercial. As typical with commercial buildings of this era, the lower portion of the store front is devoted almost exclusively to showcase windows. The double door entry features wood doors with a single, plate glass window and transom above. Transom windows were located across all of the windows on the lower portion of the building, but signs have since been placed in these transoms. Horizontal banding distinguishes

Structural Integrity: Good Condition - No apparent change to original structure.

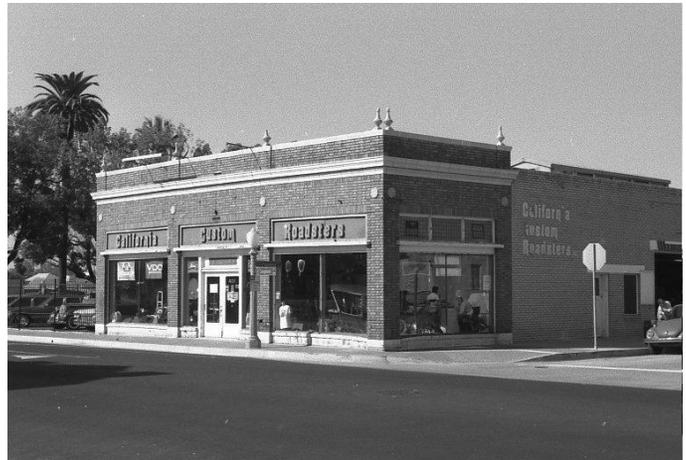
Description of Photo: 1991

shes the cornice. Since its construction, this single-story brick building has been used for commercial purposes.

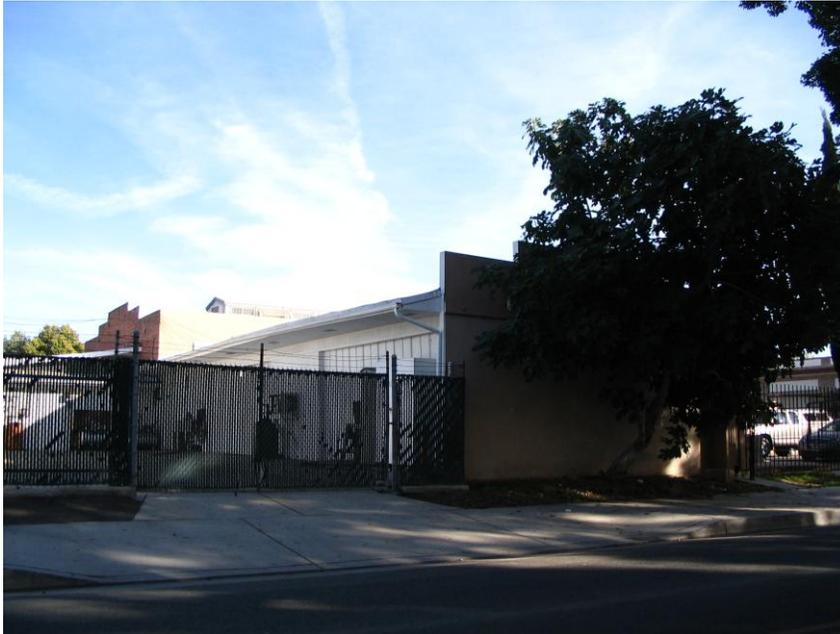
P5b. Description of Photo: 2011
(View, date, accession #)

Materials: Frame - Stucco or plaster & metal siding

Small industrial building attached to the rear of the 1920's brick building at 401 W. Chapman Ave..

Structural Integrity: Good Condition - Low level of alteration.

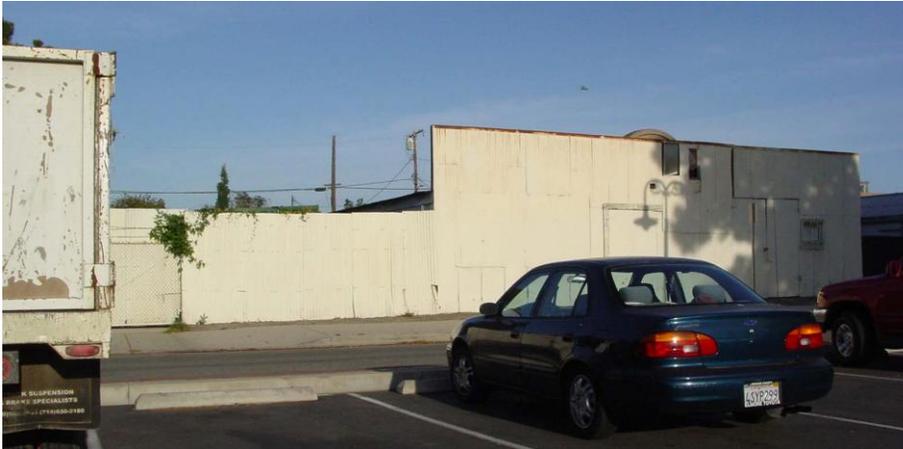
P5b. Description of Photo: 2005
(View, date, accession #)

Materials: Frame - Stucco or plaster

The very nice Mission style building has been hidden from the street by an addition with a corrugated metal wall facing the street. The original building is a rectangle with a Mission style parapet on the east and west ends. The walls are a heavy texture concrete and there is a smooth concrete band along the top of the parapet. In the west wall, which is now an interior wall, there is a wide segmental arch opening with a

Structural Integrity: Fair Condition - A collection of minor, inappropriate changes to original structure.

The old Mission style building originally served as a transformer station (1922 Sanborn Maps), yet was quickly converted to a commercial use. The addition and remodel likely occurred during the use change. City Directories indicate it was the auto repair shop for the Schwab Chevrolet dealership in 1927-28, and continued to service the new dealers, Sackett-Doty Company in 1929, and Cruzen and Smith, and Mansur Motors in 1940. Past owners/occupants: (401-403 W. Chapman) 1927-1928 - Schwab Chevrolet dealers (P.E. Schwab); 1929 - Sackett-Doty Co. autos; 1930 - vacant; 1932 - H. Vernon Doty Chevrolet; 1940 - Mansur Motors (401 W. Chapman and Cruzen and Smith (402 W. Chapman); 1949-1950 - Mansur Motors (401 W. Chapman) and Chapman Guaranty Chevrolet (402 W. Chapman); 1991 - All City Import car dealer (403 W. Chapman). This s

Recommended Action: Amend contributor to NR District

Detail: Resource located within Old Towne Orange National Register Historic District boundaries.
Recommend District amendment to complete district inventory.

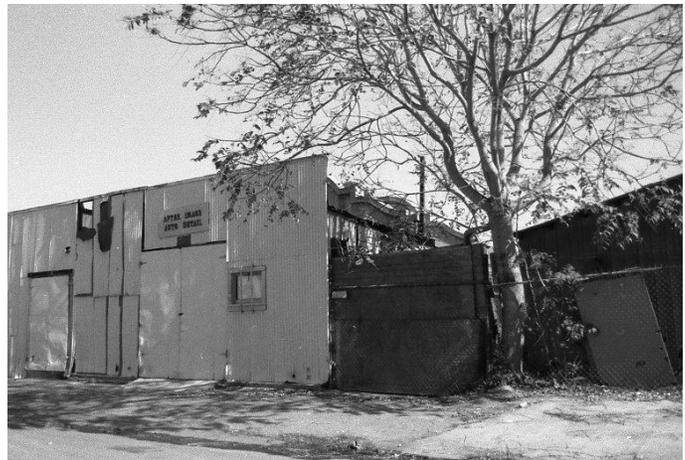
trim band and keystone. There are two large wood sash, double-hung windows set in a segmental arch opening. These also have a keystone at the top. The same motif is repeated on the east wall in one wide door and single window. Another corrugated addition hides the north wall. The original building appears to be intact and could be restored with the removal of the additions.
