August 20, 2021
Project No. 2589-001
Design Review for the Proposed Project Located at
204 W. Chapman Avenue, Orange, CA 92866

MEMORANDUM FOR THE RECORD

SUBJECT: Design Review for the Proposed Project Located at 204
W. Chapman Avenue, Orange, CA 92866

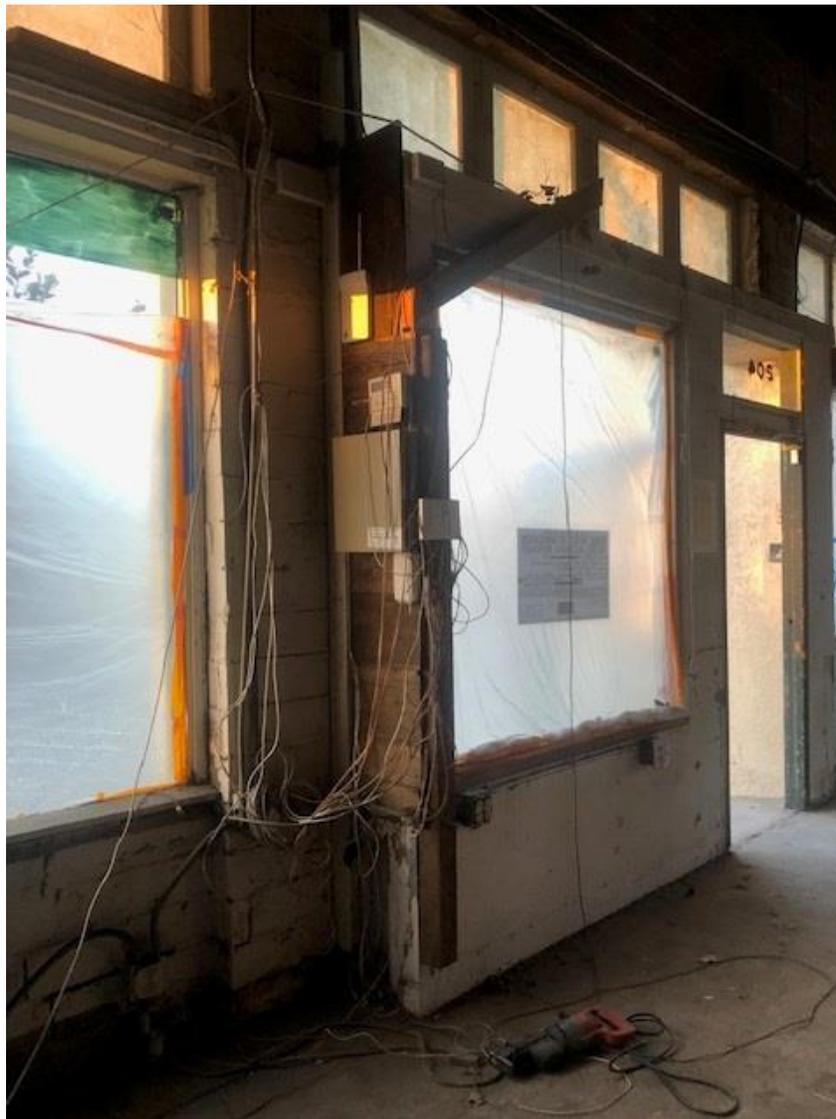
1925 Historic Photograph; Figure 2, 1970 Historic Photograph). The primary façade faces W. Chapman Avenue and has four large wood display windows which are slightly recessed creating narrow sills along the bottom. Pilasters with brick capitols are located between each opening along the primary and eastern façades. The display windows are large, fixed single-pane windows with a band of four divided transoms above. Some latches and chains on the transom windows are visible from the interior of the space. The primary entrance is at-grade and is deeply recessed into the building. The entrance door is a multi-light wood door with a fixed transom above. There is a large, single-pane window to the west of the entrance. Based on the material/style of the current entrance door and interior alterations, the entrance door and fixed window/bulkhead to the west do not appear to be original and was further recessed into the building at an unknown date (Figure 1, *Entrance Alteration*).

Figure 1. Entrance Alteration (interior view)
SOURCE: Sapphos Environmental, Inc., 2021

The proposed project seeks to retain, repair, or salvage the remaining known historic material on the building as it pertains to window and door openings. The primary entrance door alcove, which is recessed will be retained, and the non-original entrance door and single fixed-pane window will be replaced. The door will be replaced with a single fixed-pane glass door with faux wood surround to match the surrounding existing wood windows as well as a full height single-pane fixed window to the west. The glass door allows for the retention of an interior/exterior connection which would have been present on a retail space when the building was constructed as well as allow for the new door to be discreet. The wood four divided-light transoms above the entrance alcove will be retained/restored and visible from the public right-of-way.

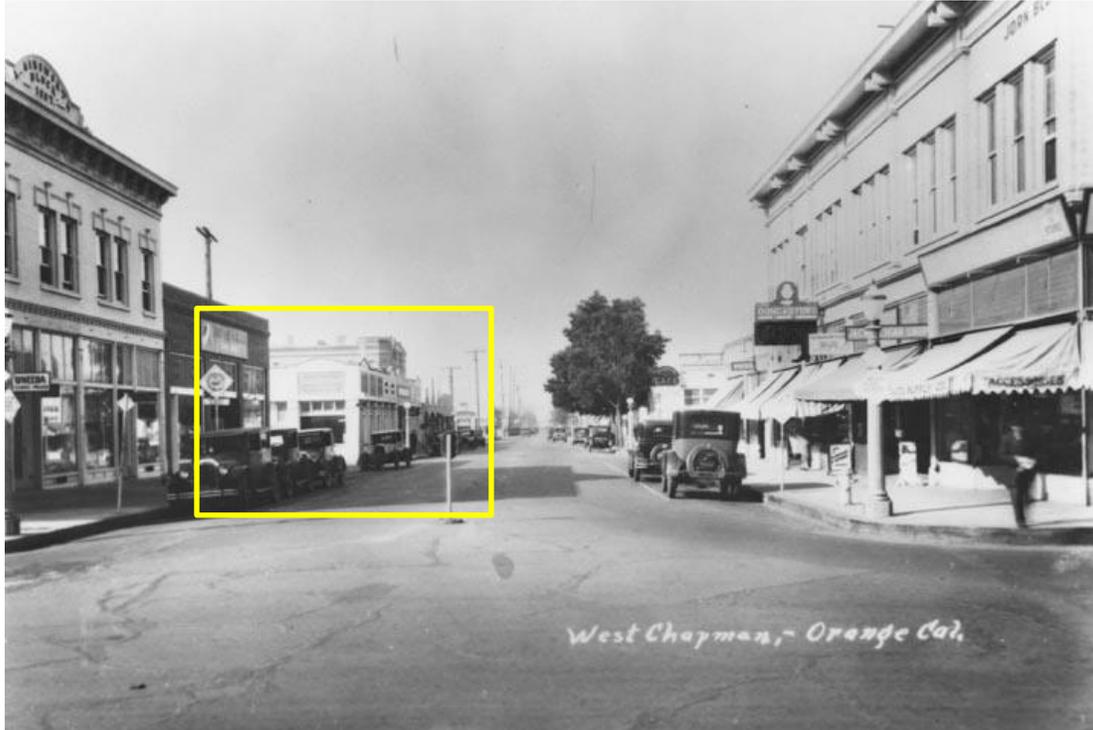
Figure 2. 1925 Historic Photograph
SOURCE: *City of Orange Planning Department*

The southern façade includes three wood four-divided light wood casement windows with a higher sill, like that shown in the 1925 historic photograph (Figure 2). A loading bay door is located at the western end of the façade. The loading bay door has also been altered with a metal roll-up security door. The roof has four skylights, which are original to the construction of the building based on Sanborn Fire Insurance Maps.

The proposed project seeks to make minimal alterations to the façade/roofline of the building. Based on a 1925 historic photograph, the subject property originally had pediments along the primary and eastern façade parapet with a brick cornice. The building was also most likely originally clad in finally textured stucco. National Park Service Technical Preservation Brief No. 22, *The Preservation and Repair of Historic Plaster* (Brief No. 22) states that small-scale commercial buildings during the 19th and early 20th century were commonly clad in this material as it was inexpensive, gave the

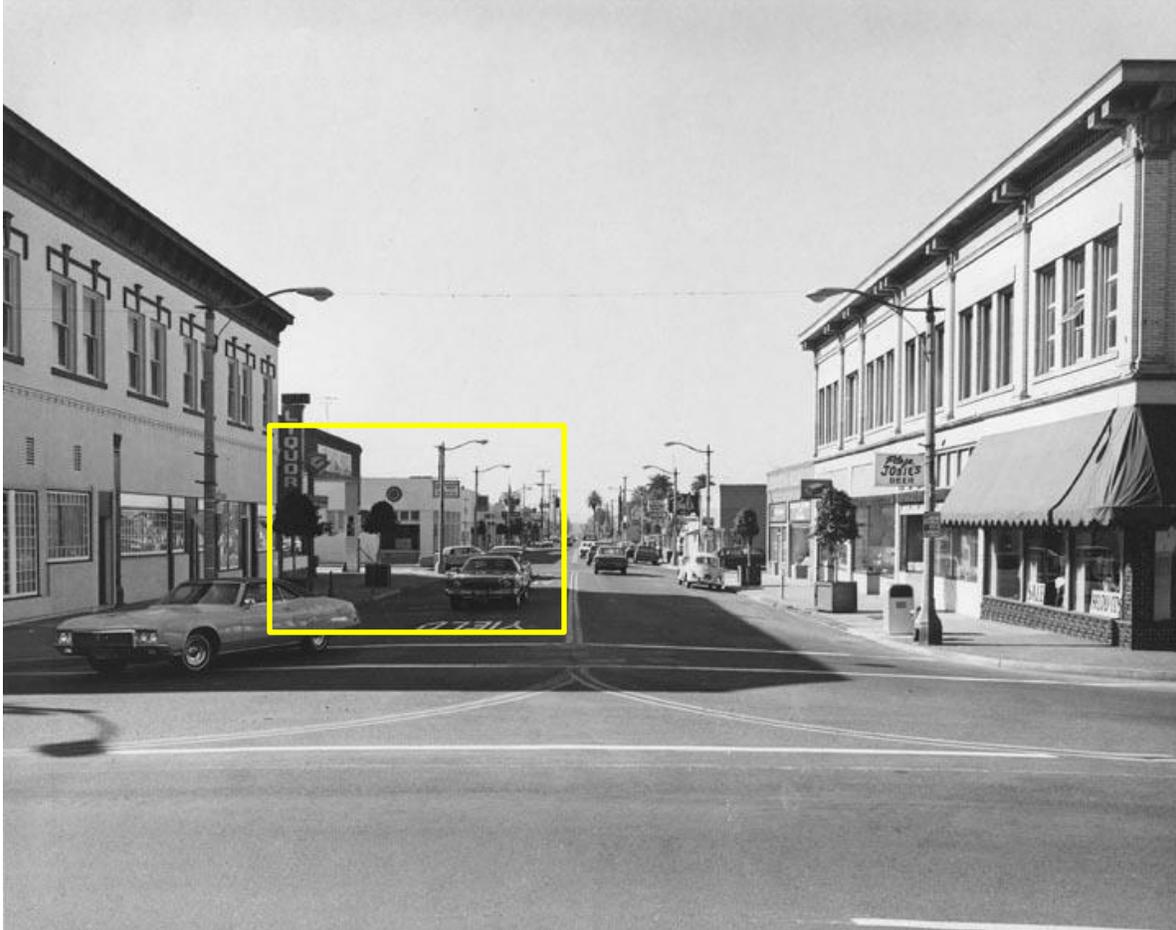
The eastern façade is divided into eight openings (referenced as opening Nos. 6, 7, 8, 9, 10A–C, and 11). The four northern openings have the same display windows found on the primary façade. Based on historic photographs from 1925, the northern-most display window (No. 6) appears to be original. The historic photograph from 1925 also shows that the opening south of this window (No. 7) originally had a wood four-divided light with a higher sill, similar to the windows found on the rear of the building, and these two windows remained until at least 1970 (Figure 2, 1925 *Historic Photograph*; Figure 3, 1970 *Historic Photograph*).

Figure 3. 1970 Historic Photograph
SOURCE: *City of Orange Planning Department*

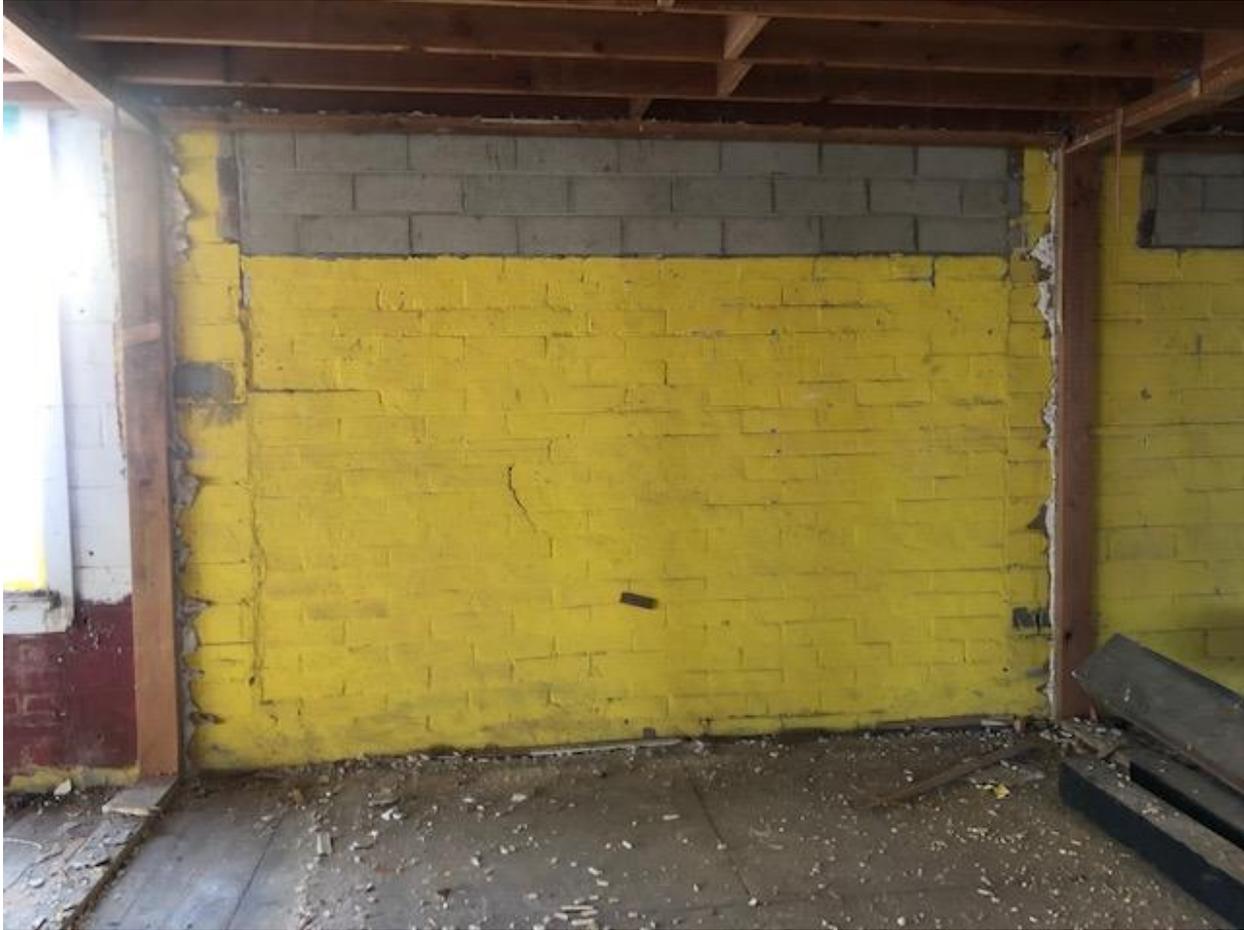
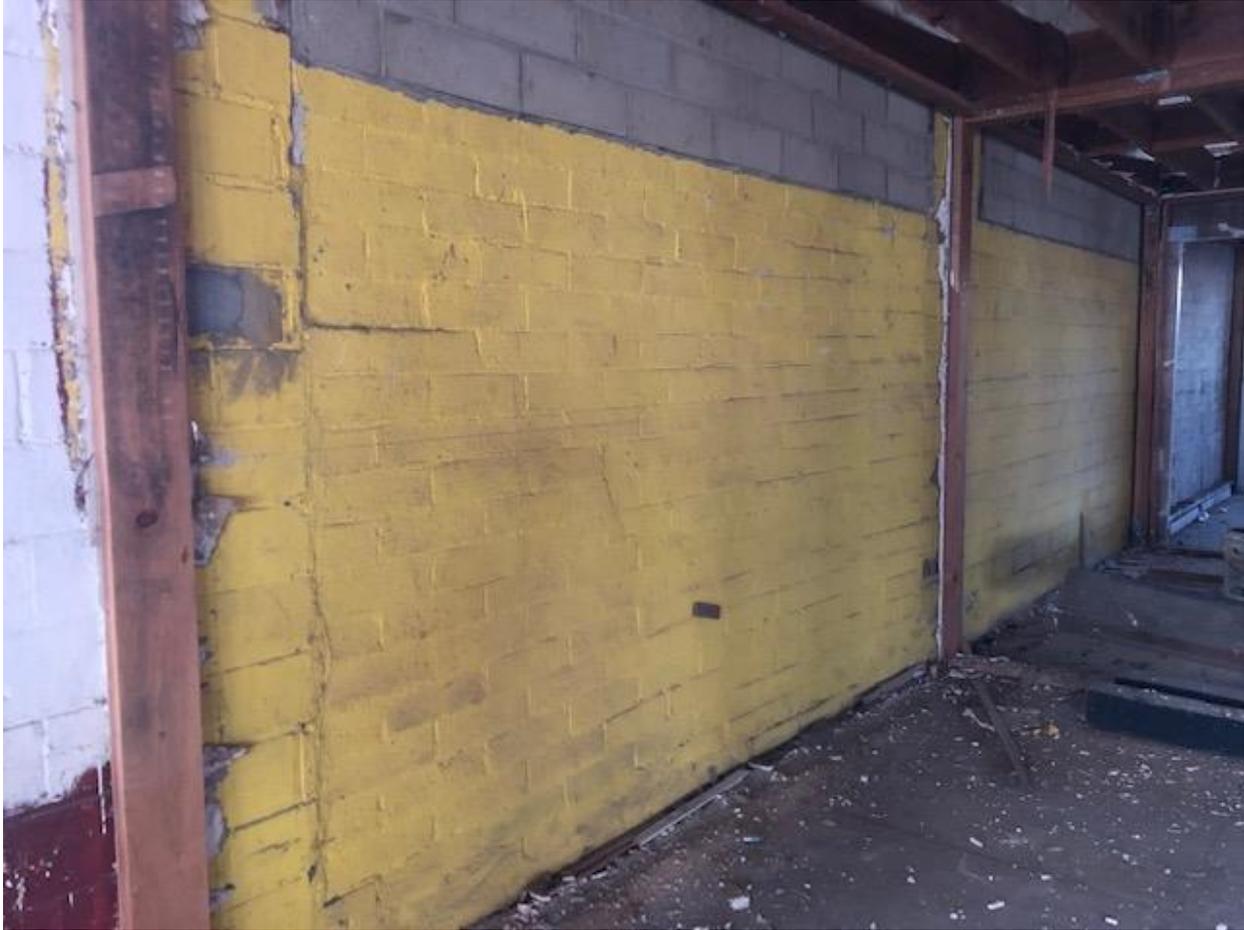
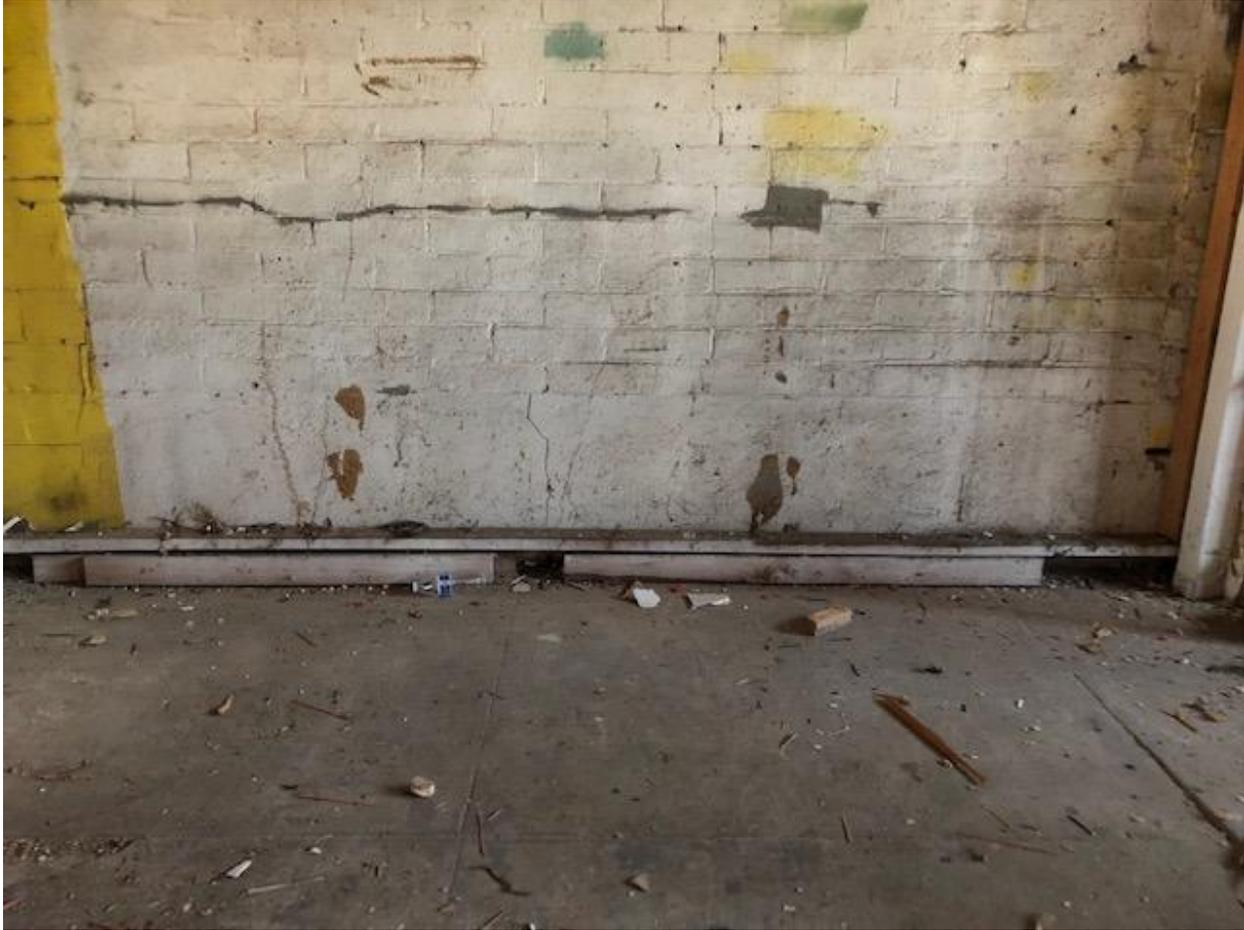
There is no photographic documentation of the original windows in the remaining six openings (Nos. 8, 9, 10A–C, and 11). Based on interior and exterior building scarring and infill, it appears that the windows in these six openings had multiple style and height interactions over the years with differing brick, block, and mortar infill visible on the interior of the building (Figures 4A–C, *Window Infill/Building Scarring*).

Figure 4A. Window Infill/Building Scarring (interior view)
SOURCE: *Sapphos Environmental, Inc., 2021*

Figure 4B. Window Infill/Building Scarring (interior view)
SOURCE: *Sapphos Environmental, Inc., 2021*

Figure 4C. Window Infill/Building Scarring (interior view)

After 1970, at least three additional display windows were added to the eastern façade in openings Nos. 7, 8, and 9, making up the current four display windows. Exterior and interior building scarring suggests three additional display windows in openings Nos. 10A–C were added to the eastern façade and later infilled at an unknown date. A loading bay door, No. 11, is located in the southern-most opening of the façade. The Sanborn Fire Insurance Maps from 1922 to 1950 do not indicate an opening at this location. This bay door was presumably added after 1950 and is not original.

iterations overtime. The proposed project would install four divided light accordion-style windows with a sill difference of 18 inches between the original northern corner display window and the proposed windows in the five openings south of the corner unit. The current display windows along this façade are not original to the building and were added sometime after 1970, thus the materials are not historic fabric of the building. The addition of the four divided light accordion-style windows is more in line with the wood four divided light casement window which historically appeared south of the northern corner unit.¹² Historically the openings along this façade contained some sort of fenestration pattern, and re-opening the bays along Olive Street with a type more in-line with the historic fenestration and a sill 18-inches higher to differentiate it from the display windows allows recognition of the historic façade as “utilitarian” while allowing for the creation of a new use with minimal alteration.

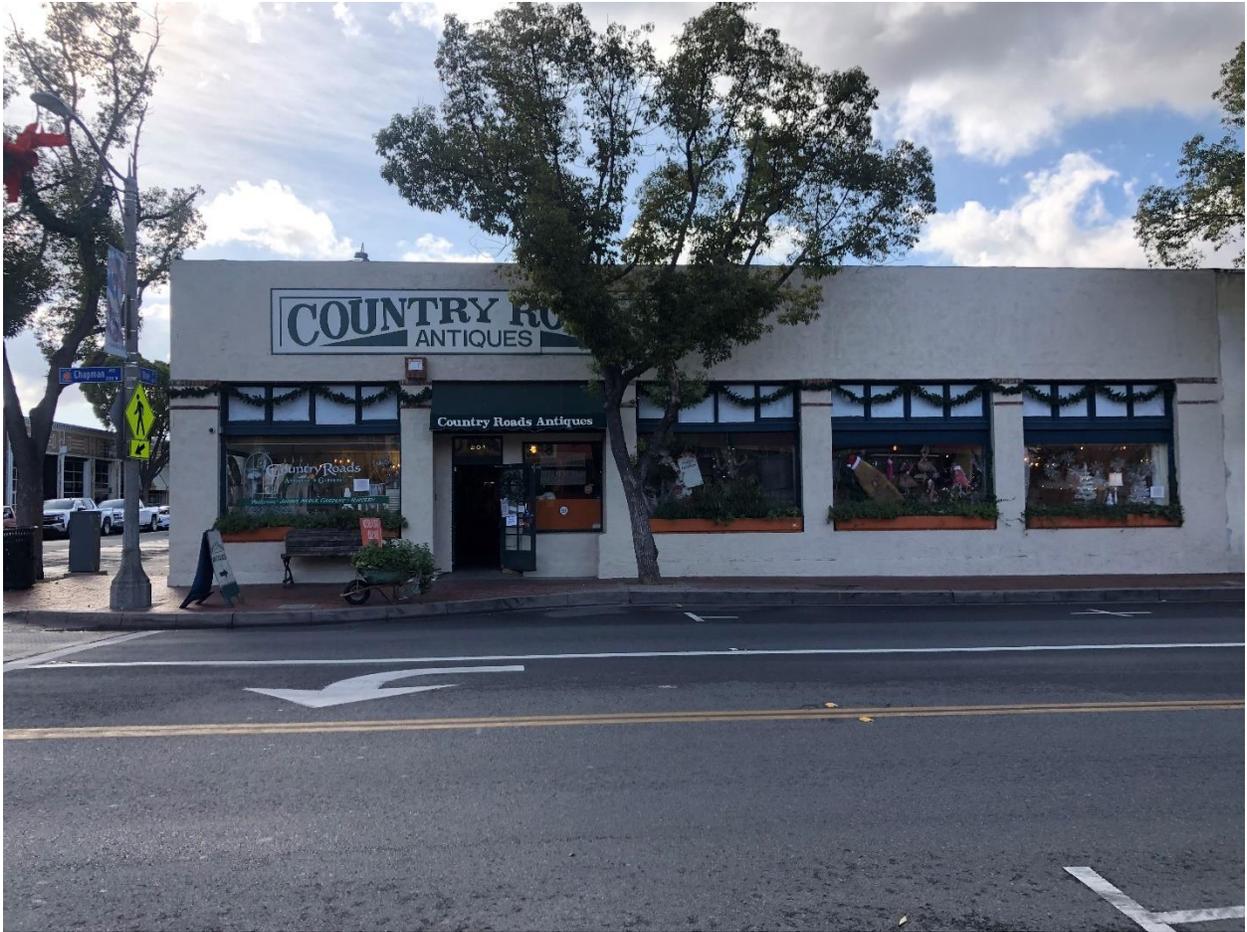
2. Primary Façade, 204 W. Chapman Avenue (view south);
December 14, 2020

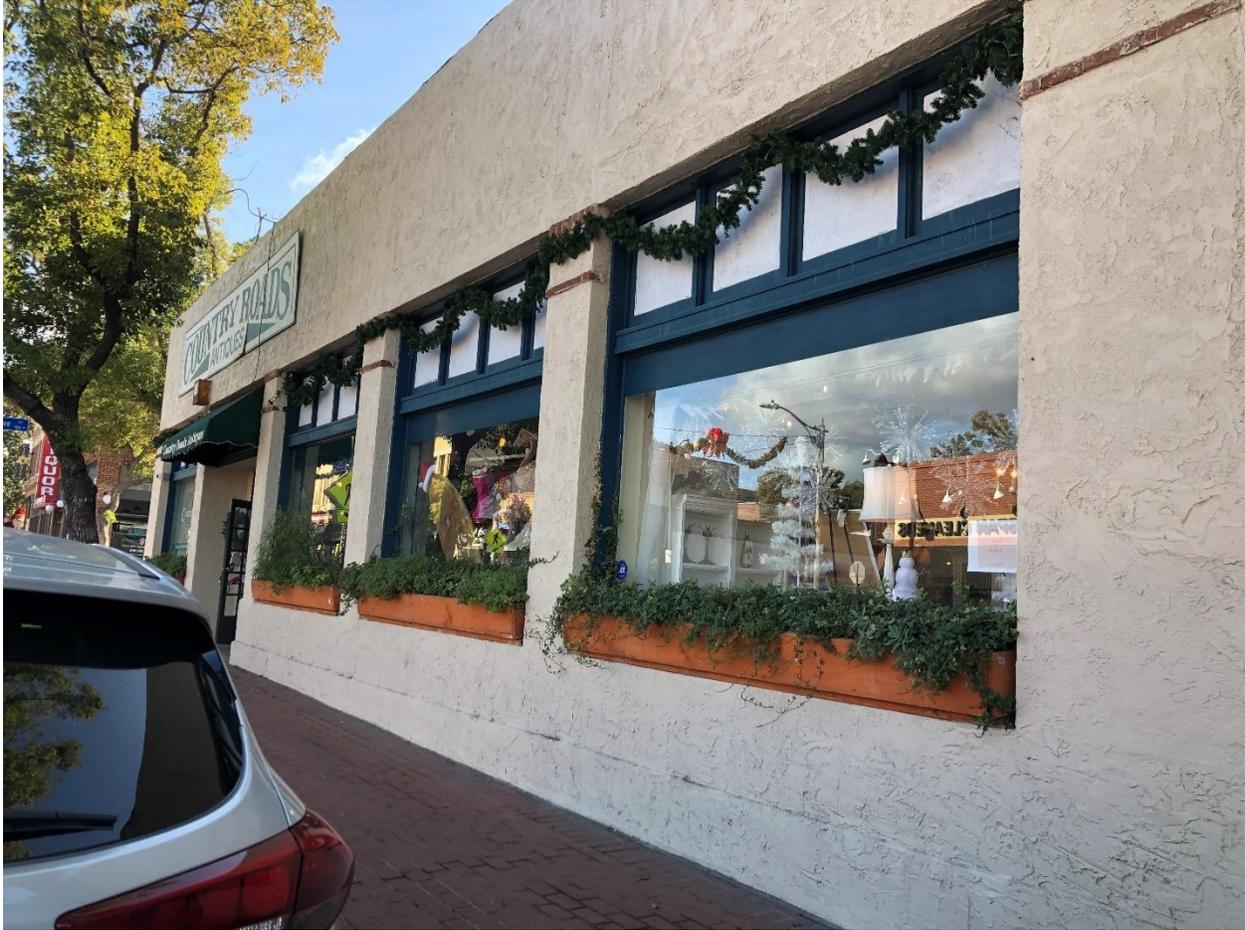
3. Display Windows on Primary Façade, 204 W. Chapman Avenue (view southeast);
December 14, 2020

The display windows along W. Chapman Avenue will be retained in place. The wood transom and display window surrounds will be repaired where possible and replaced in kind where deterioration is too great. The display windows along W. Chapman Avenue are significant to the building, retaining its characterization as an early-20th-century commercial space and their retention helps preserve the building's characterization as such. The proposed project would replace the glass in the single fixed-pane display windows along W. Chapman Avenue and at the northern corner of Olive Street to create operable awning style units.¹¹ The window openings themselves, along with the remaining historic material, will be retained/repared where possible or replaced in kind where too deteriorated. The aesthetic of single fixed-pane display windows along the primary façade will be maintained yet the operability of the windows will allow for indoor/outdoor connection of the dining space. The transom windows above the display windows will be retained/repared were possible and replaced in kind where deterioration is too great. The transom windows which are still operable will remain operable with interior latched and chains extant, and those that are inoperable will remain inoperable.

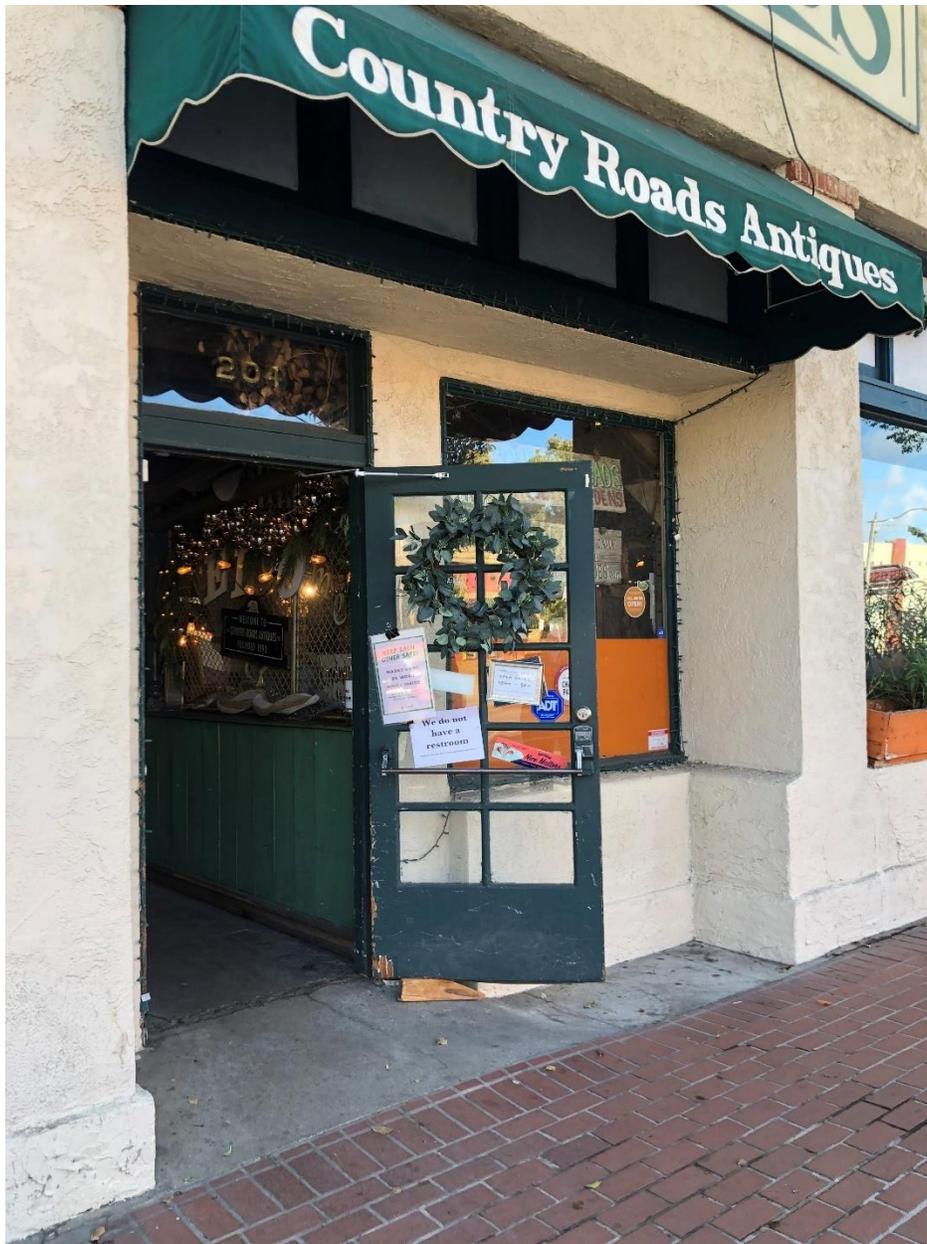
4. Primary Entrance, 204 W. Chapman Avenue (view southwest);
December 14, 2020

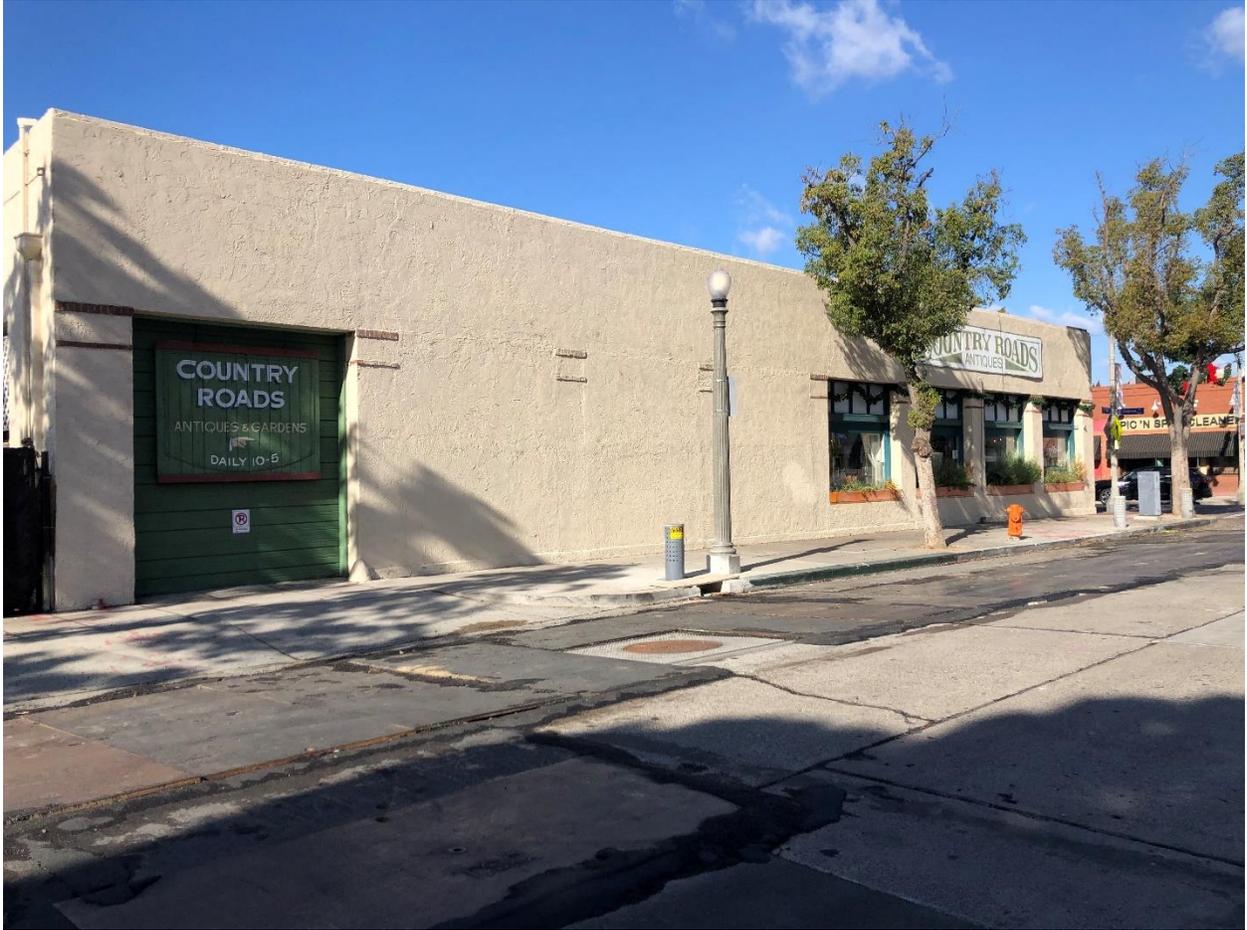
5. Eastern Façade, 204 W. Chapman Avenue (view northwest);
December 14, 2020

Additionally, the automotive bay door at the southern end of the eastern façade is not original to the building. The proposed project will salvage one wood four divided light casement window from the southern façade (the other two to remain in place) and relocate it to the southern-most bay. The salvaging of the window and the placement of it on the Olive Street façade retains the historic material of the building while acknowledging the potential historic window fenestration of this façade based on evident scarring. The bay between the salvaged window and the proposed accordion windows will be left infilled to differentiate the old from the new and separate the various fenestration patterns on the façade.

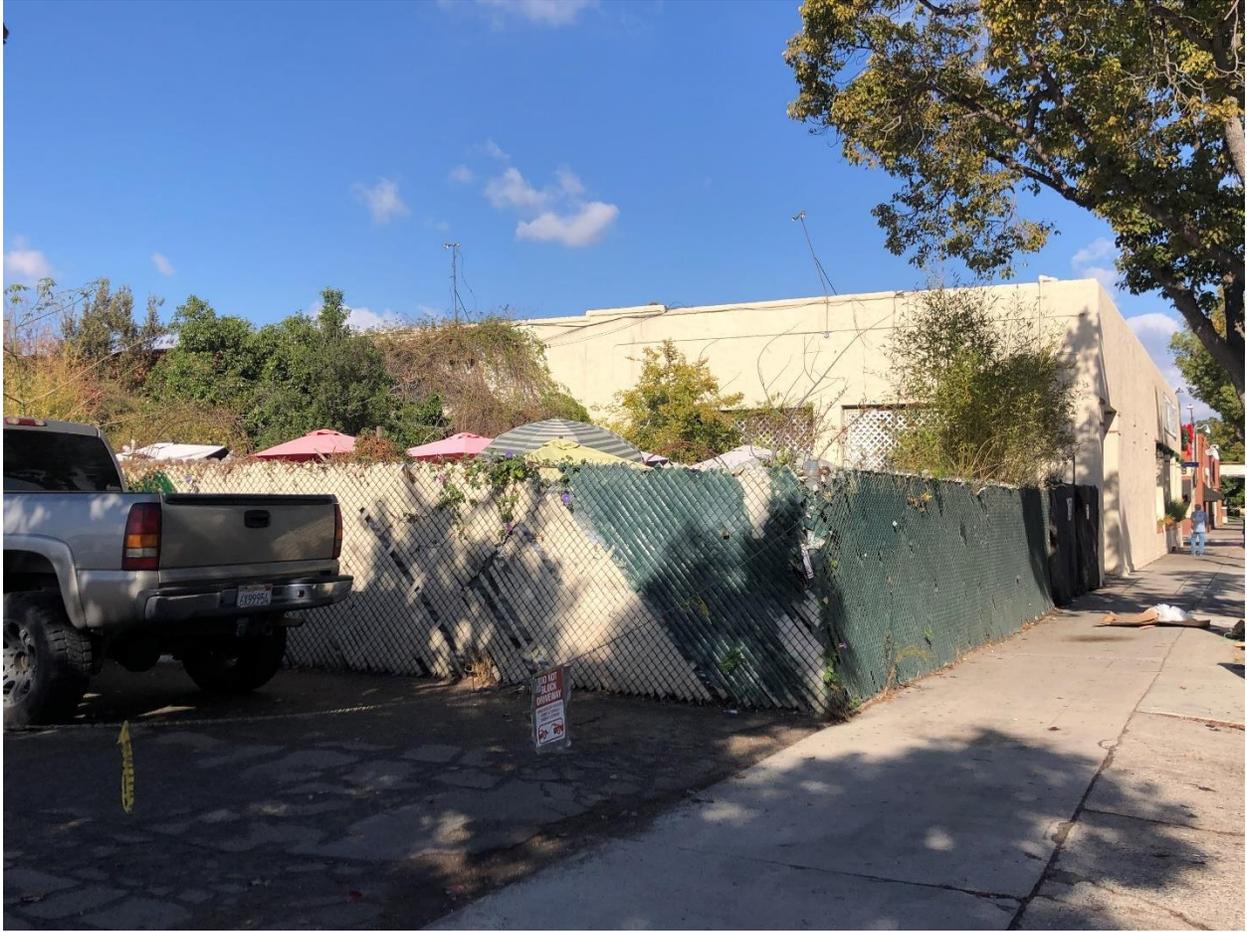
6. Southern Façade, 204 W. Chapman Avenue (view northwest);
December 14, 2020

Although the pediments were removed, and the brick cornice was removed/covered prior to 1970, some of the original brick cornice remains on the southern façade. The proposed project will expose/repair the remaining historic brick cornice on the southern façade to honor the original building design.

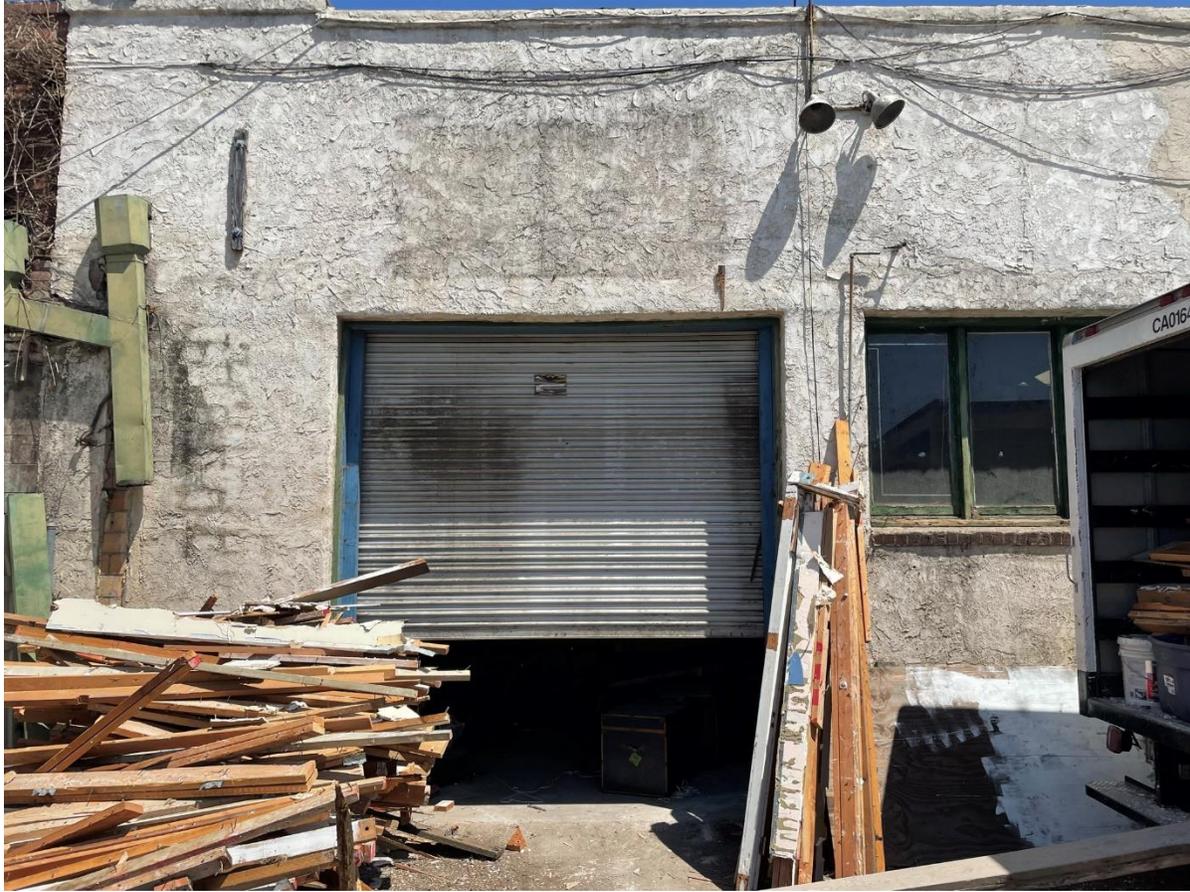
8. Southern façade loading bay door, 204 W. Chapman Avenue (view northwest);
August 6, 2021

The remaining two wood four divided light casement windows in the southern façade will remain in place. The central window opening (the window being repurposed to the eastern façade) will be converted to a modular roll-up door, with matching lintel height to the existing windows and thin mullions to make the design discreet with an historic appearance, for interior pedestrian connection to the rear patio. Additionally, the automotive bay door at the western end of the façade will be infilled with a thin wood partition wall, slightly recessed from the southern elevation, and removable. This alteration allows for the addition of a pedestrian door with egress to the back of house so no additional opening into the building occurs while also acknowledging the automotive opening that was originally there. The wood partition wall is reversable and since the metal roll-up door is not original, no historic material will be removed. The changes to this non-primary façade are minor and located on a non-street-facing façade, making their impact minimal.

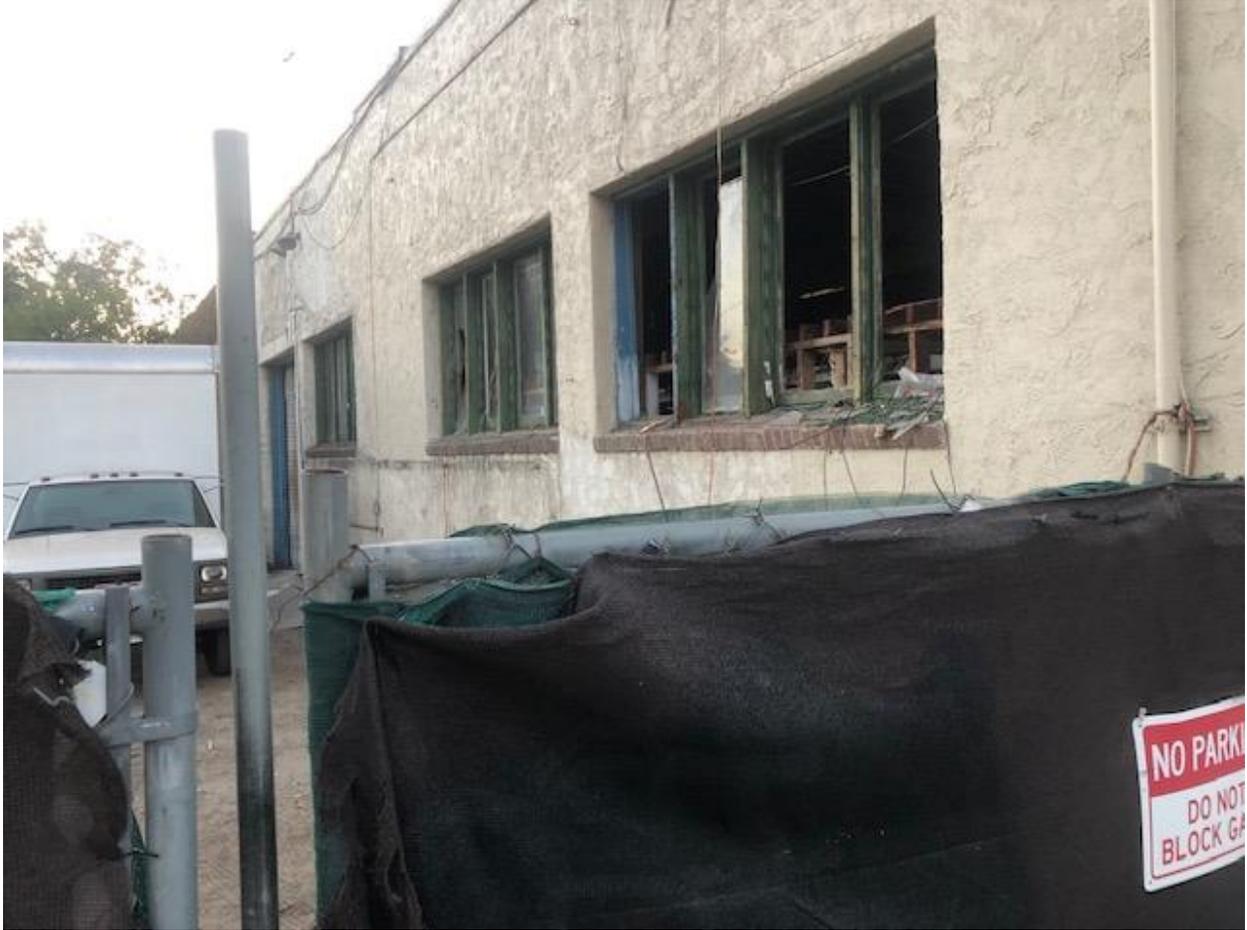
9. Southern façade boarded windows, 204 W. Chapman Avenue (view northwest);
July 21, 2021

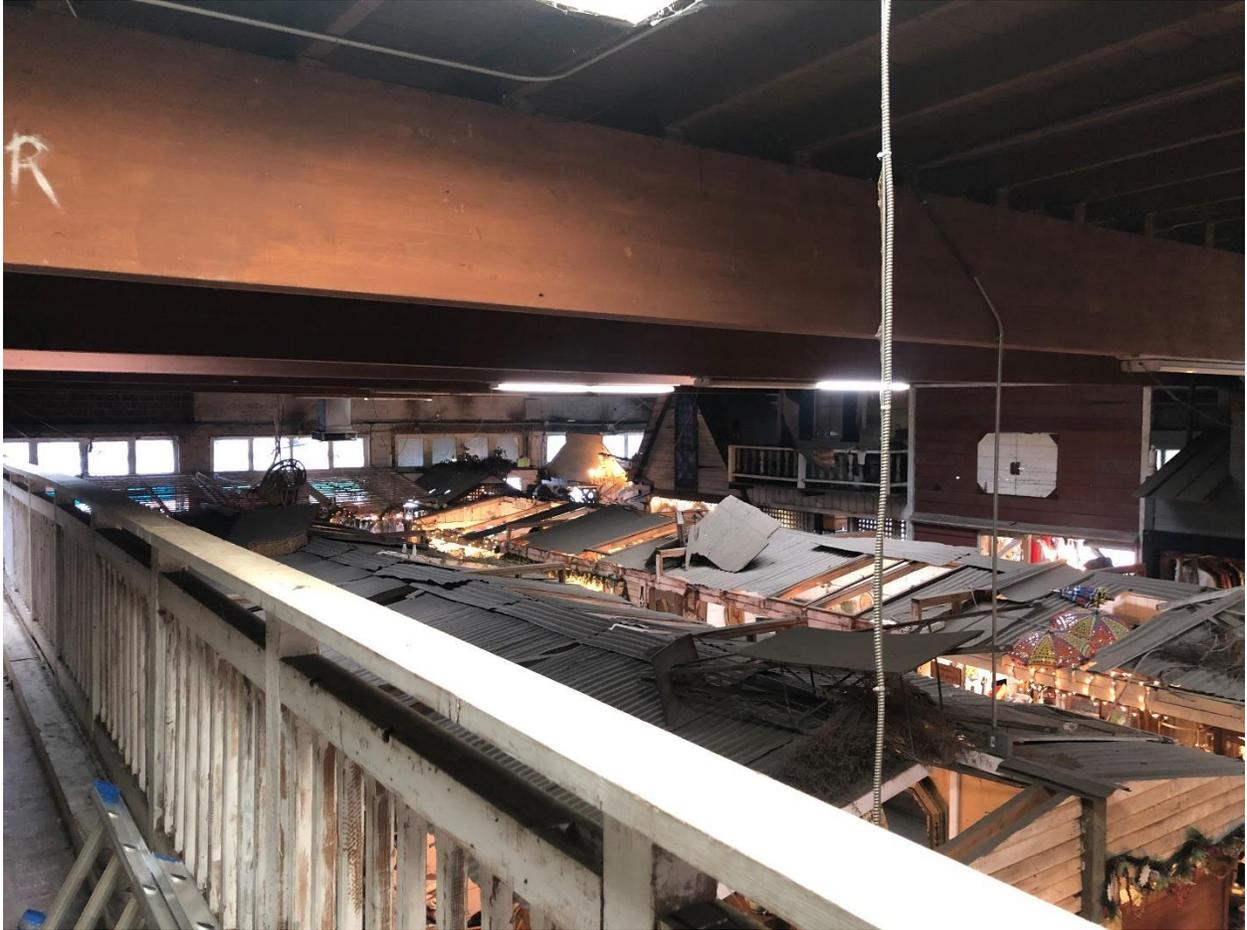
12. View from interior mezzanine / Open rafter ceiling and wood glulam beams,
204 W. Chapman Avenue (view northeast);
December 14, 2020

The CDF of the interior of the building that was found to be significant was the open, exposed rafter ceilings. The proposed project will enclose a portion of the western end of the interior for kitchen space, which will include a drop ceiling. This space will not be public-facing, and the open volume of the dining room, which will highlight the original interior roof form, will be maintained. Additionally, the drop ceiling in the kitchen will be reversible, and no historic material will be removed or altered. Over its lifespan, the building has historically housed multiple businesses at once making the use of interior partitions and sections a common feature of its history. Although one display window at the western end will be enclosed within the kitchen space, currently none of the windows are visible from the interior, and the proposed project will result in a minor change to this feature in light of the building as a whole.
