State of California - The Resources Agency  
DEPARTMENT OF PARKS AND RECREATION  
PRIMARY RECORD

CHAPMAN\_W\_237\_\_APN\_039-173-10

c. Address: 237 - W CHAPMAN AVE, # \_\_\_\_\_ City: Orange Zip: 92866

B1. Historic Name: Super Service Station

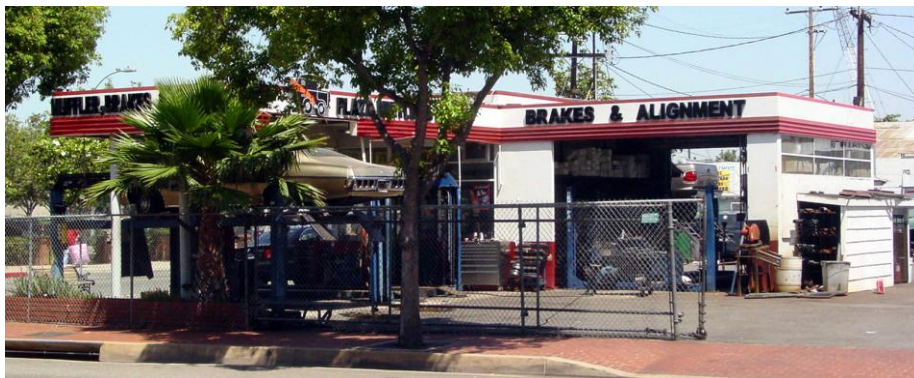
P5b. Description of Photo: 2005  
(View, date, accession #)

Materials: Frame - Metal siding

This structure consists of two projecting bays, each supported by columns. The roof of each of these bays is in the curvilinear style with banding typical of Moderne structures.

Structural Integrity: Good Condition - No apparent change to original structure.
