# Steve F. Andresen / Arborist Services

January 22, 2025

RE: Arborist Report – Revision No.1  
City of Orange Conditional Use Permit No. 3230-24, Major Site Plan Review No. 1174-24, and Design Review No. 5151-24  
Village Town Center Commercial Building  
2355 N. Tustin Avenue, Orange California  
APN: 372-642-32

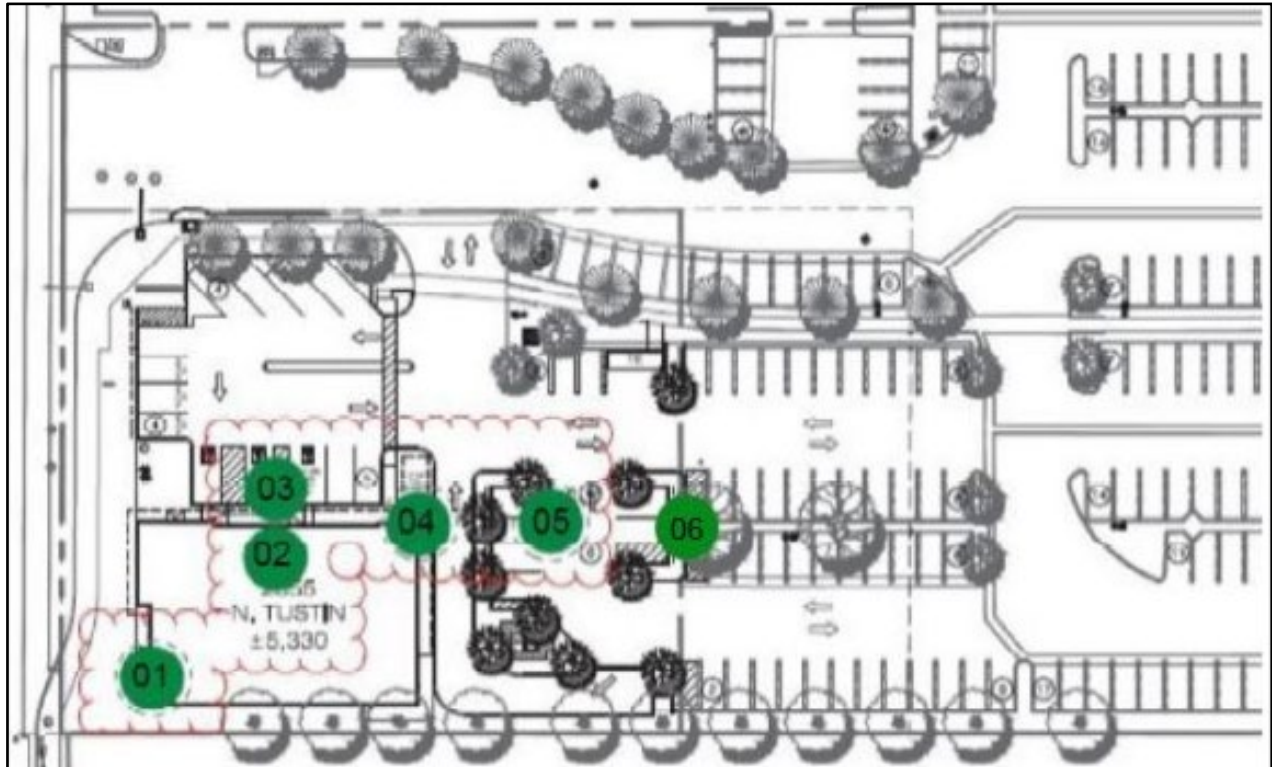
**Proposed Site Plan with Tree locations**

The purpose of the Arborist Report ("Report") is to comply with City of Oange requirements for you to obtain a tree removal permit ("Permit") for the proposed new construction of a 5,330 square foot commercial building "(Project)". The Project is located at 2355 N. Tustin Avenue, Orange California ("Property") referenced above. The Project as planned will require the removal of six (6) existing trees ("Trees").
