George Taylor Loudon AIA

## Historical Cultural Resources Assessment Report: Hangar Building 527 West Almond Avenue & 180 South Cypress Street; Orange CA

Proposed Adaptive Reuse Development for the Friends Church Orange

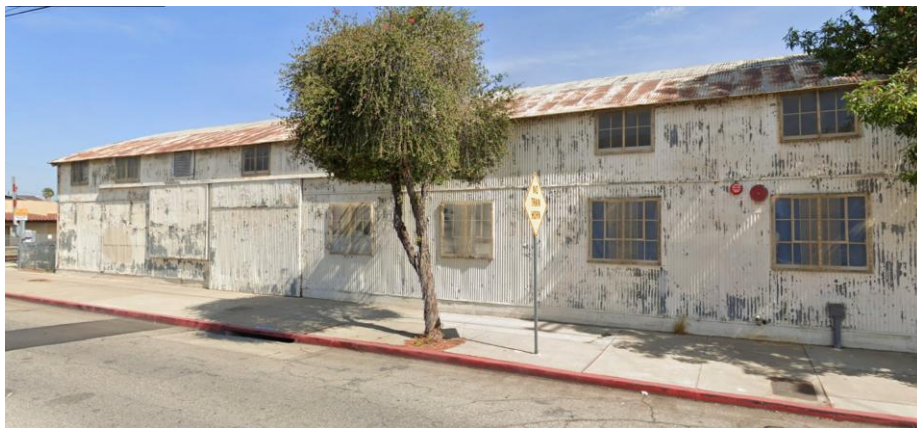
Figure #2: South façade at Almond Avenue, prior to recent repainting in 2025;

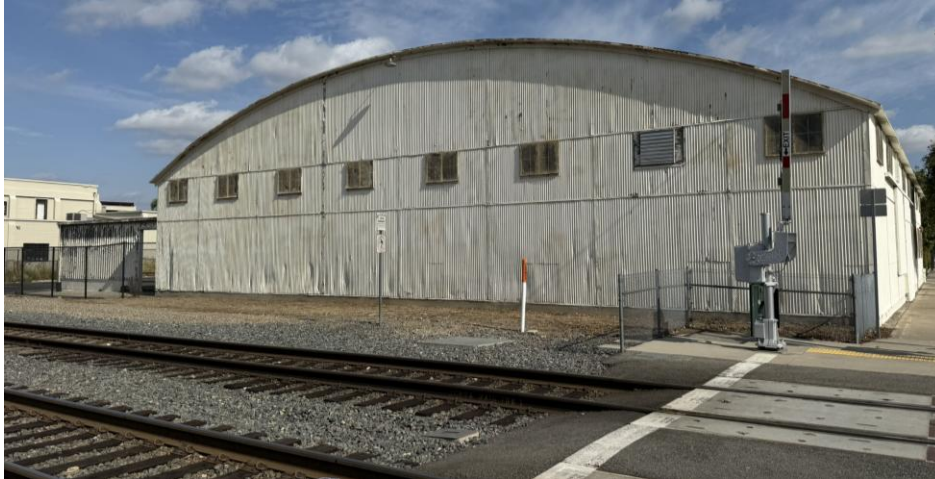
Figure # 3: west façade existing conditions, primary façade along the railroad, photo date 2024

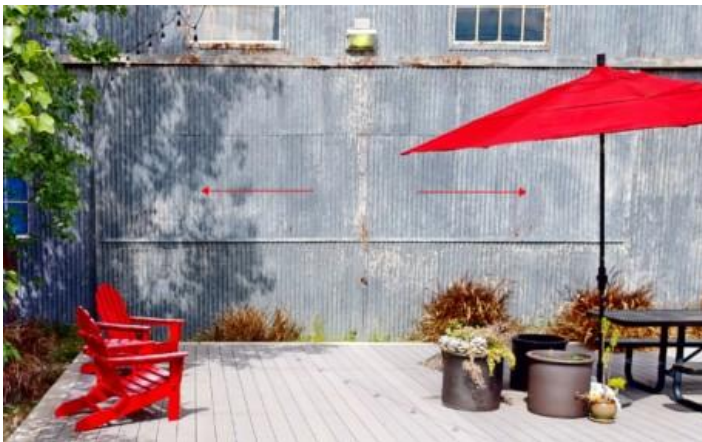
Figure #6: east façade detail of the original bi-parting sliding doors, view from courtyard.

We recommend retaining the two existing sliding door panels, allowing for the new entry which is a precedent of the original location of the entranceway reconstruction. It may be perceived as a bit quirky with the juxtaposition of sliding door facade panels and window, but we believe it is consistent with the warehouse narrative and the sense of progression of program and function per SoIS #3,

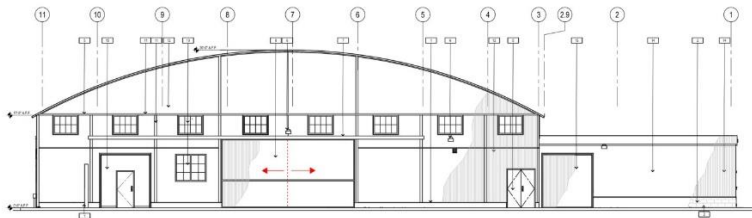
Figure # 7: east secondary façade existing conditions; AO Drawing shows original location of bi-parting sliding corrugated metal door panels noted with red directional arrows.

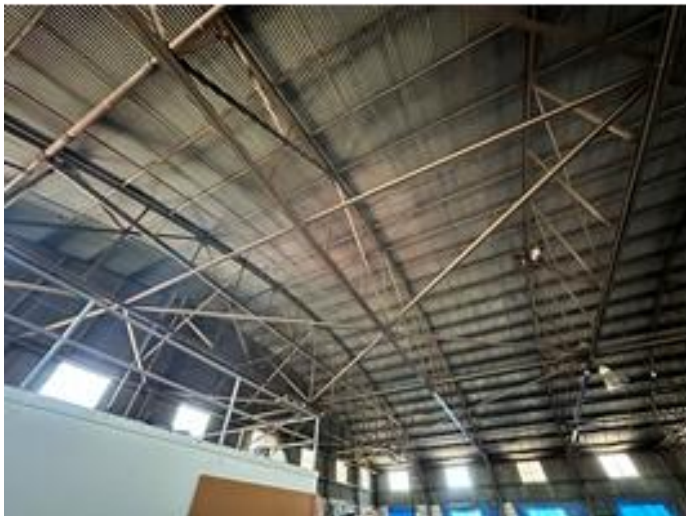
Figure # 23: Interior volume with the later alteration of the northeast mezzanine, view southeast; later addition of a Mezzanine floor level is visible at the lower left of image.

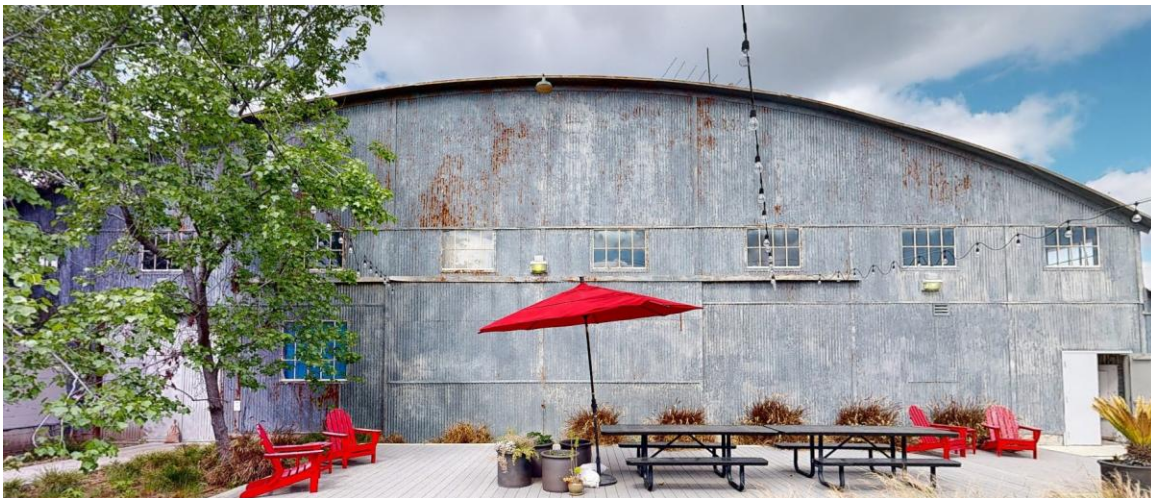
Figure # 29: secondary east façade overview.

Material deterioration of the south and east exterior facades in particular is notable. At times in multiple locations where rusted conditions have resulted in material loss of original façade finish integrity. The south façade was recently painted completed prior to commencement of preparation for this HRAR. Otherwise, the need for facade panel replacement can be assessed with documentary photographs. The Rehabilitation Standards allow for matching corresponding with original material and profile where the materially secure conditions warrant. Refer to HRAR Figure #2 for the site photograph of the south façade at Almond Avenue prior to the recent painting. At the project site the design project team assessed that some locations of material loss could exceed areas of sufficient material integrity, where areas of patching become a greater extent than original material.

The Secretary's *Standards* prioritize repair and/ or rehabilitation of existing materials rather than complete replacement. Existing metal panels at locations that are visibly too deteriorated for repair/rehabilitation can justify controlled removal when there becomes less original material remaining than bondo or similar synthetic patching compound. A Field Report is recommended to create a façade survey that describes the various conditions and types of material failure and a justification as to why replacement is appropriate over rehabilitation. A replacement patch or “dutch” repair would need to match exactly in profile, dimensions and finish to insure acceptance.

The project design intent is to rehabilitate the original corrugated metal façade with limited alterations of the exterior façade. It is a project requirement that replacement corrugated metal siding will match the material profiles and dimensions of the original materials to match existing. To generate custom profiled materials that sufficiently match the existing original could prove to be an infeasible effort.

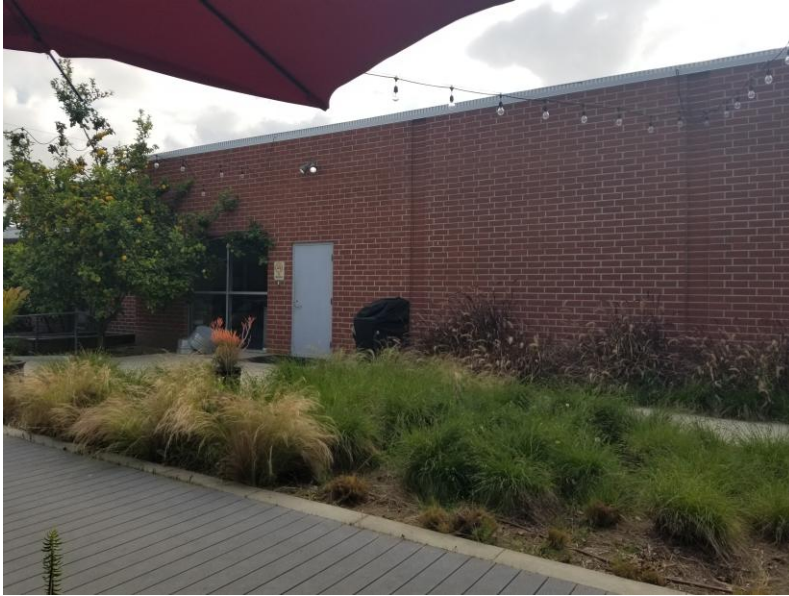
**Figure #31 : “Existing East Building” west facing façade at landscaping courtyard area adjacent to the Hangar Building. Minimal alterations are proposed for the exterior facades.**
