March 25, 2025

Suitability of Adopting and Retaining 61 Canary Island Pine Trees along Serrano Blvd, and 22 Canary Island Pine Trees along Cannon St.

Micah Jean – City of Orange Tree Services Coordinator
ISA Board Certified Master Arborist WE-9971BM
ISA Tree Risk Assessment Qualified | ISA Certified Urban Forest Professional

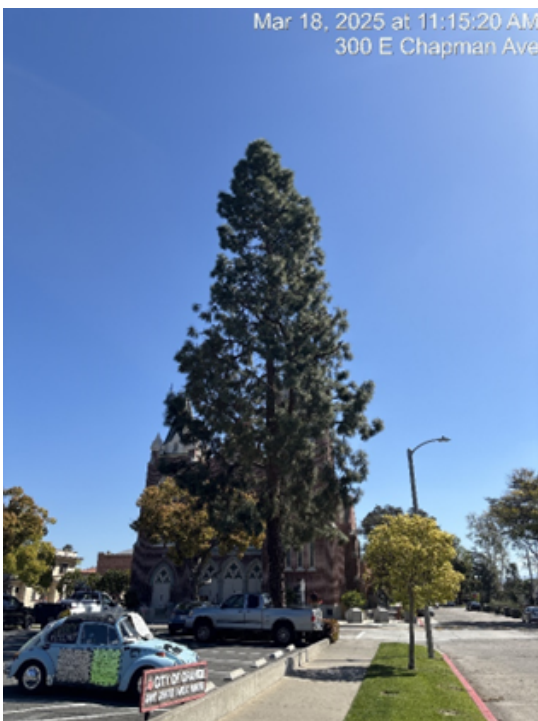
ABOVE: 52 trees observed to be in 4' wide planters.

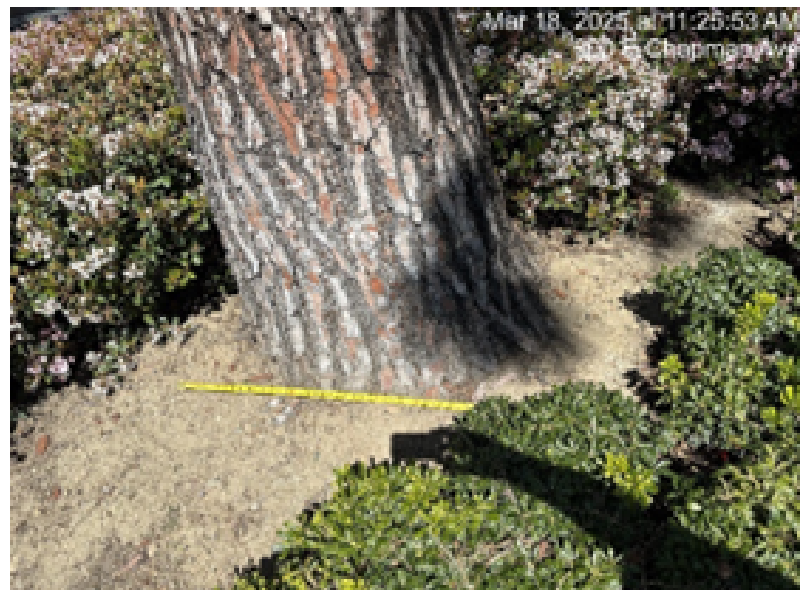
BELOW: Example of mature Canary Island Pine at 300 E Chapman Ave parking lot. Tree measured to be 36" DBH, and approximately 40" at base. Note that the trunk flare and root crown extend further on the far side.
